WAMBERAL TERMINAL COASTAL PROTECTION ASSESSMENT

Stage 2 – Coastal Protection Amenity Assessment

December 2021

Prepared for:
Central Coast Council

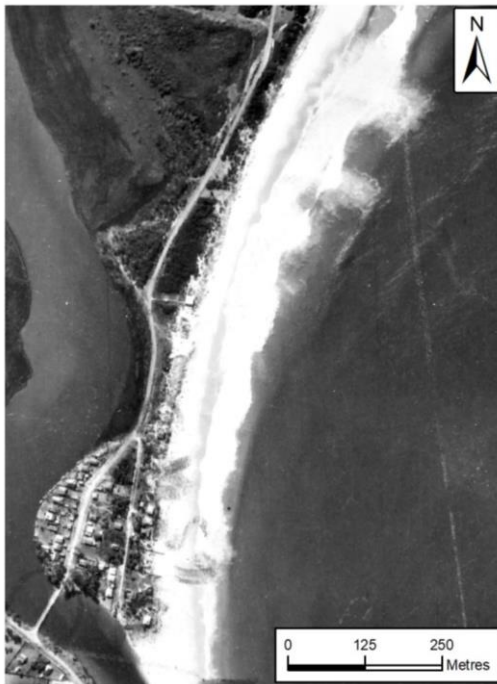
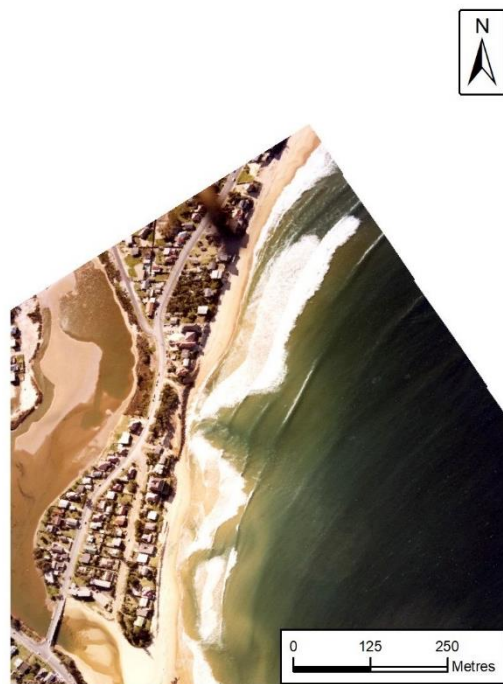
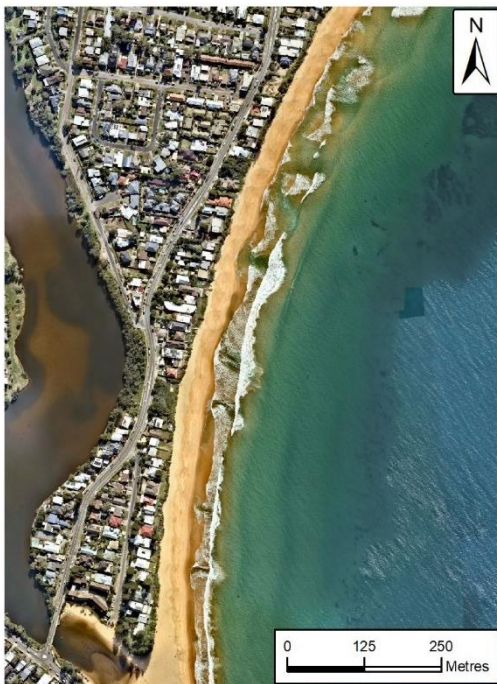
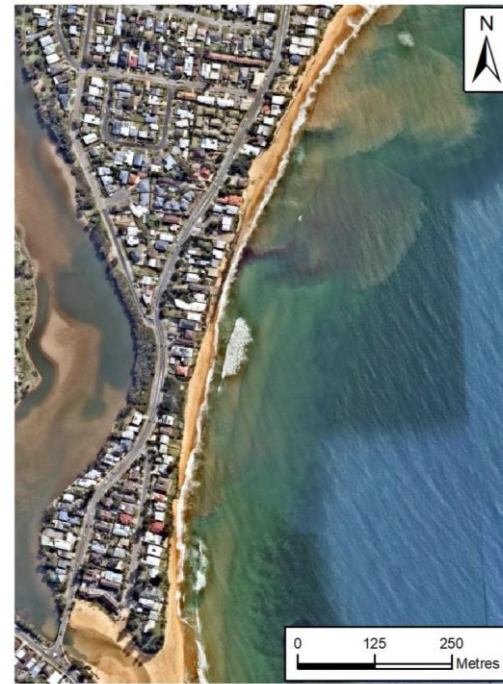
Figure 2.1: Examples of aerial images from the compiled catalogue

Historical images were digitised from the NSW Department of Planning, Industry and Environment (DPIE, formerly OEH) photogrammetry archive and supplemented with additional imagery from the NSW Spatial Services image archive. These images were georeferenced using a number of control points of recognisable features such as street intersections or building footprints that were extracted from a reference Nearmap image.

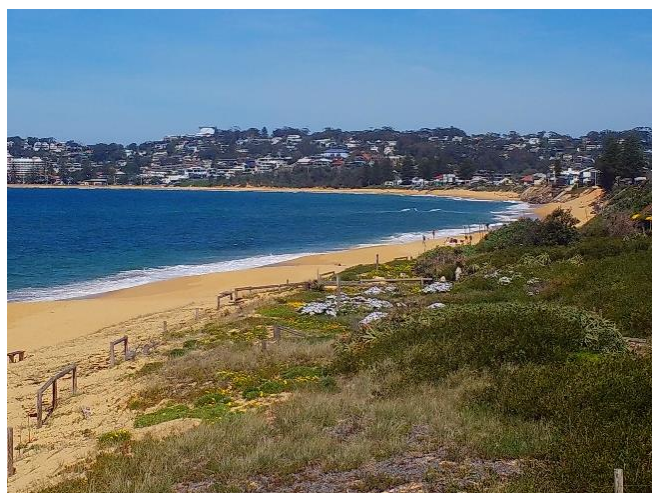
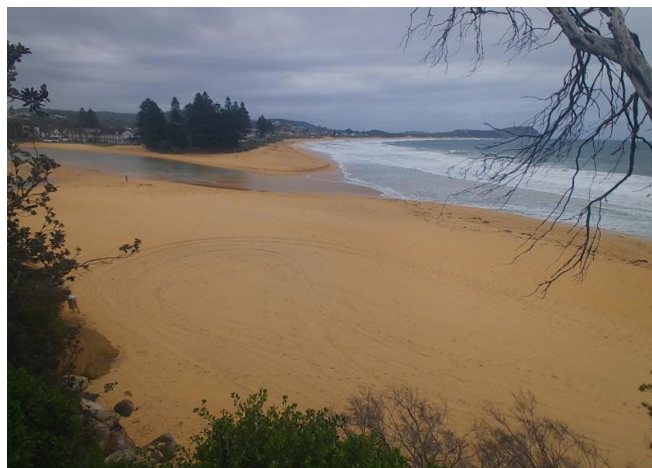
Figure 3.4: Monitoring cameras installed at Wamberal SLSC and Terrigal Lagoon in 2020

Camera based monitoring systems were established by WRL in early 2020 to monitor beach width change at Wamberal. These systems are still operational and were installed above Terrigal Lagoon facing north in April 2019 and onto the Wamberal Beach lifeguard tower looking south in July 2020 immediately after the storm event (Figure 3.4). These customised systems transmit images every 15 minutes during daylight hours and are used to monitor shoreline change using a custom-built coastal imaging software package using the methodology described in Harley et al. (2019). The impact of the July 2020 storm on beach width is shown in Figure 3.5, while recovery of the beach following the storm is shown in Figure 3.6 and Figure 3.7

Camera 1: Wamberal SLSC looking south

Camera 2: Terrigal Lagoon looking north

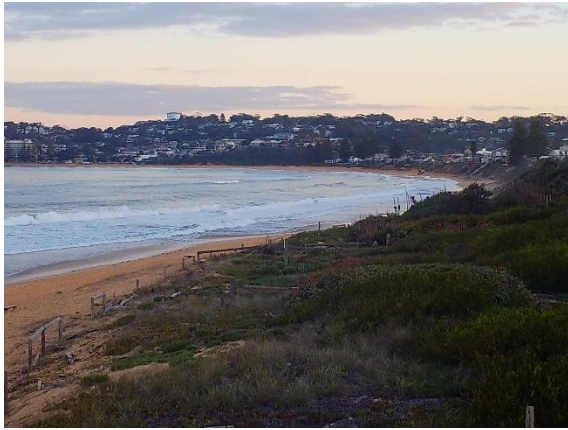
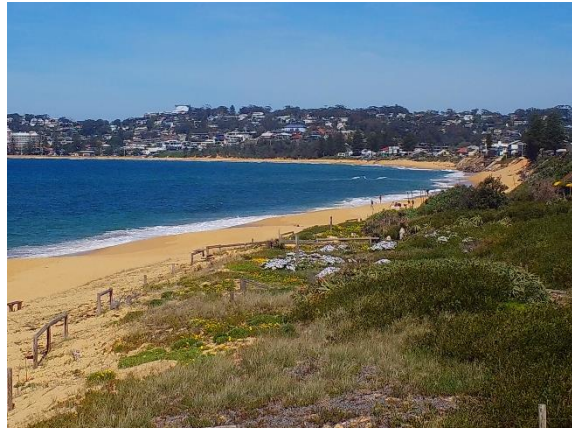
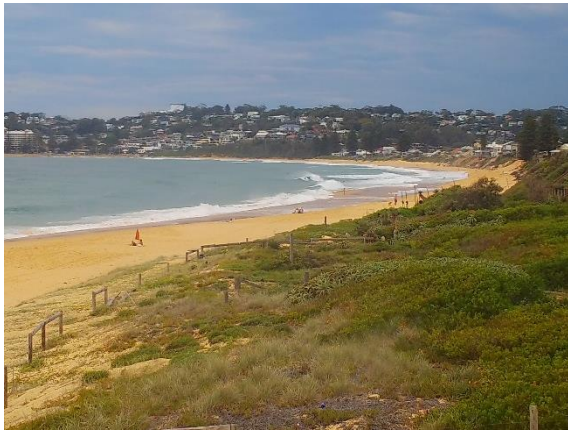
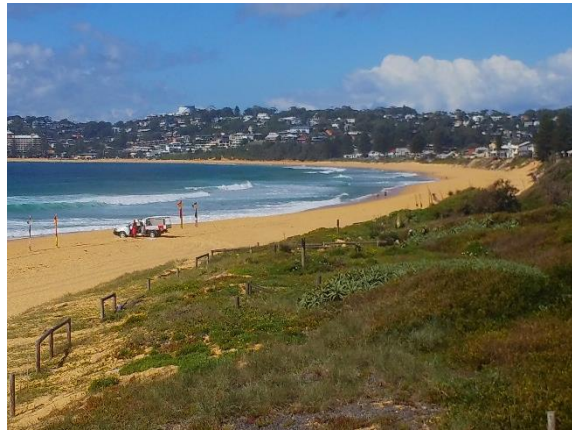
Post Storm- July 2020

2 months post storm- Sept 2020

6 months post storm- Dec 2020

8 months post storm- Mar 2021

Images taken at approximately mid to high tide.

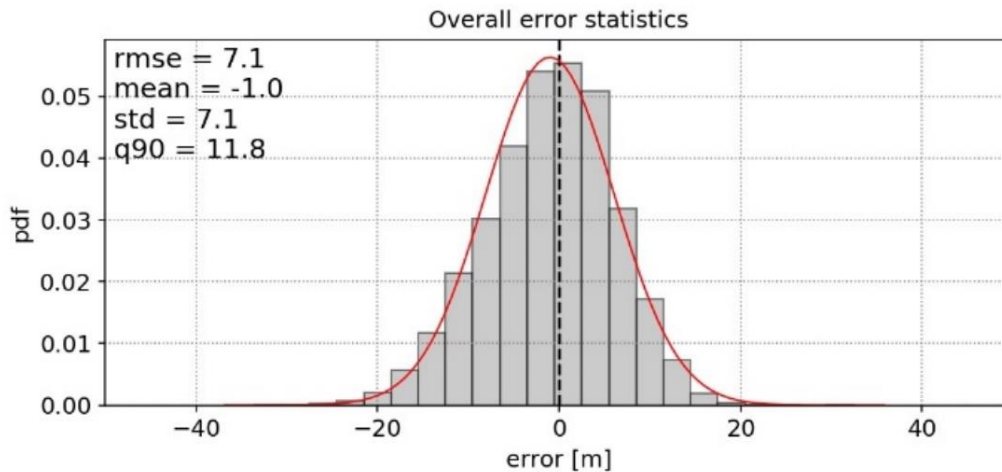
Figure 3.8 Accuracy of satellite derived shorelines compared to ground truth measurements

The ability to accurately track shoreline variability at Wamberal Beach was tested against a set of shorelines mapped from verified techniques including DPIE photogrammetry, quadbike mounted RTK-GPS, drone photogrammetry and manned aircraft LiDAR. A ten (10) day moving average window comparing 50 satellite derived shorelines to ground truth data produced a root mean square error (RMSE) of 7 m with a slight tendency for the method to underpredict the width of the beach (Figure 3.8 and Figure 3.9). This accuracy is comparable to a horizontal RMSE of 10 m obtained from application of the technique to the Narrabeen-Collaroy monitoring dataset (Vos et al, 2019). While the resolution of satellite imagery has improved substantially over time, with a pixel footprint reducing from 30 m to 10 m, analysis by Vos et al (2019.) indicates that the accuracy of satellite derived shorelines do not appear to vary much between satellite missions (Figure 3.9).

This demonstrates the robustness of the sub pixel shoreline mapping technique when applied to the lower resolution images and suggests that the dominant source of error is introduced by inaccuracies in the tidal correction process due to wave run up or assumed beach slope. It also demonstrates reliability in the shorelines derived from the earlier lower resolution Landsat missions.

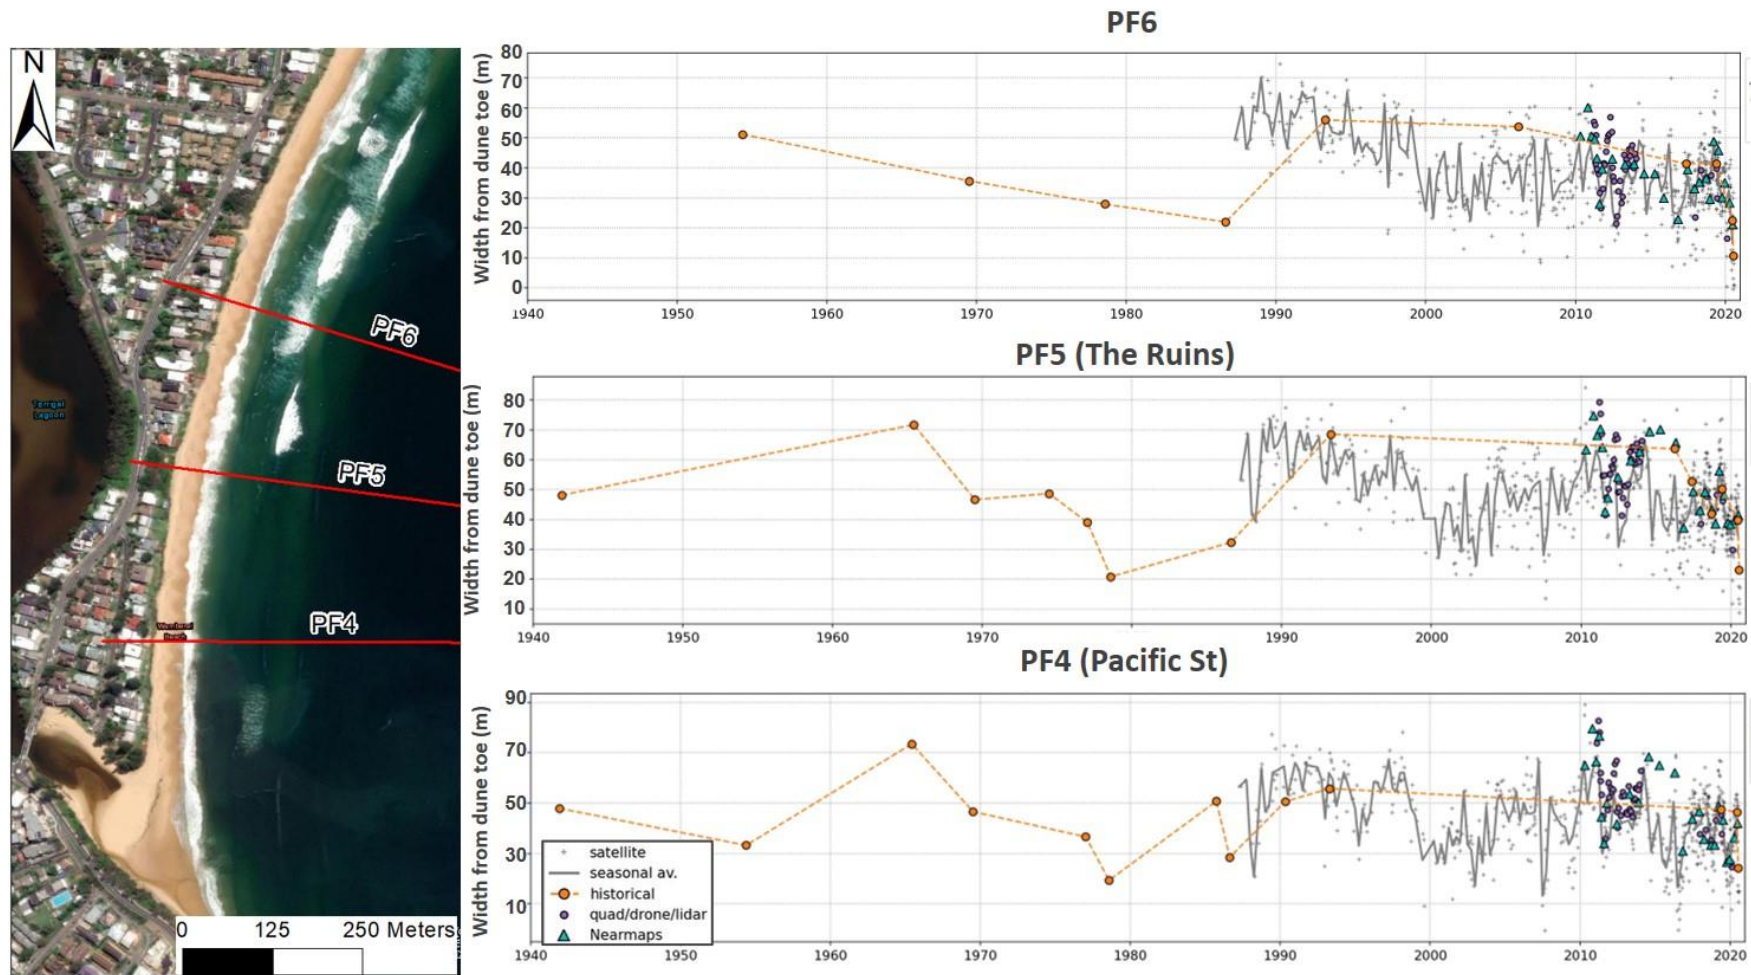
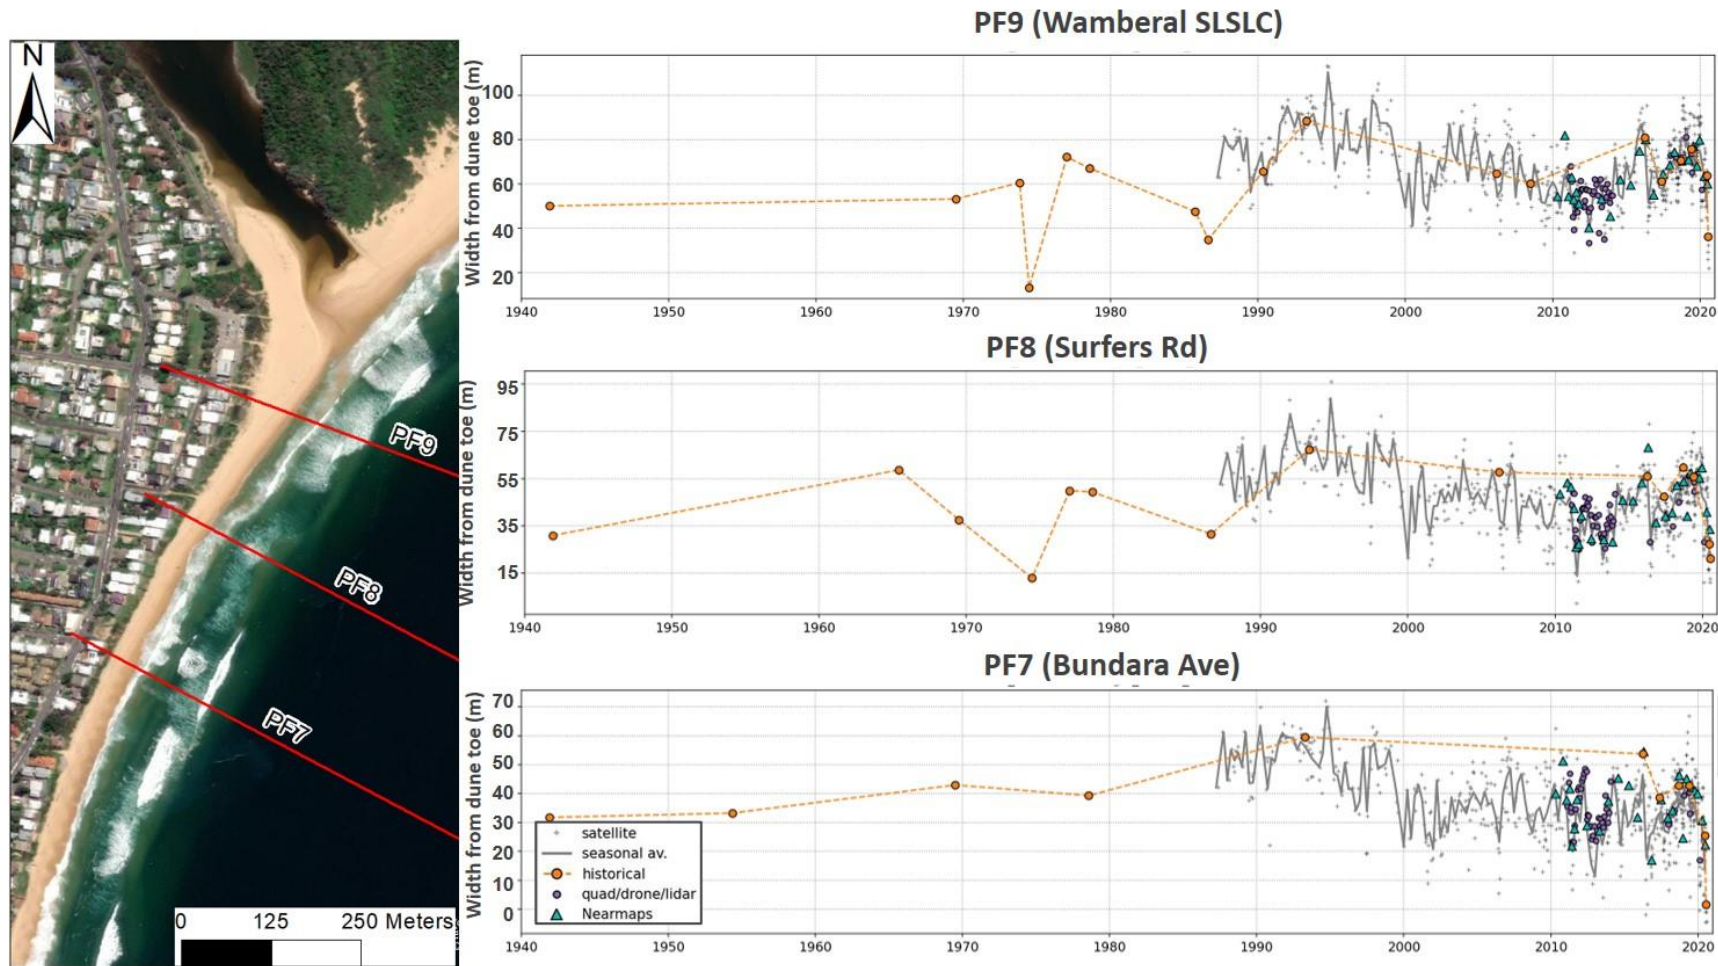
Figure 3.10: 80 years of beach width at Wamberal, 1941 to present day

- There is close agreement in beach width data extracted from each of the data sources demonstrating confidence in the variety of methods used in this study;
- The envelope of natural beach width fluctuation (difference between widest and narrowest beach state) is approximately 80 m;
- The data indicates that in the early 1990s Wamberal Beach was the widest (approx. 50-80 m) it has been in the 80 years of data for the site;
- The narrowest beach widths occurred in the late 1970s and in 2020 (sections of beach reaching less than 10 m width and resulting in damage to beachfront houses);
- Satellite derived data indicates that since the 1990s, the beach has undergone a long-term recession, though this is less evident from the longer term (though more temporally sporadic) photogrammetry data.

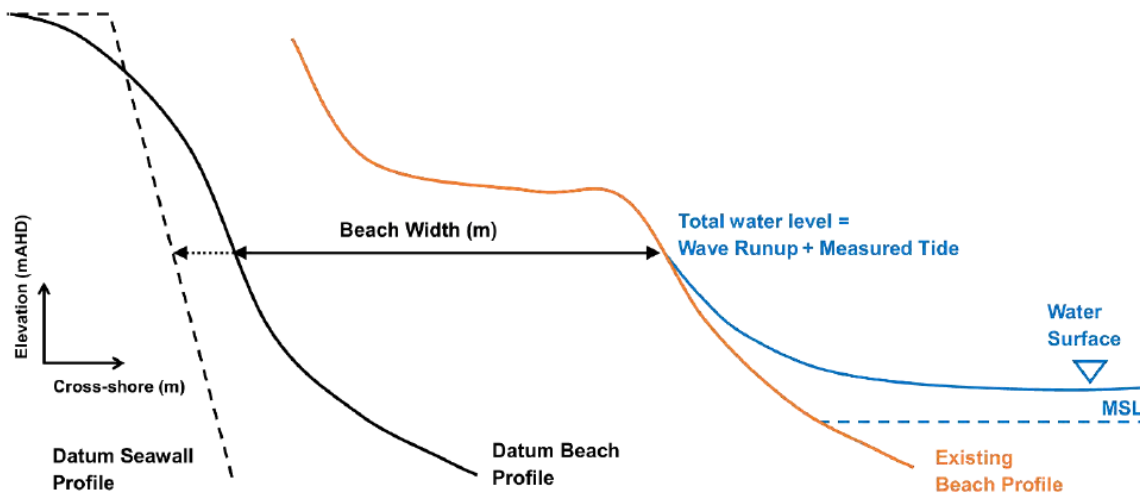
Figure 4.1: Definition of beach width

Beach width is defined as the dry area of beach extending from the top of the wave runup to a baseline feature at the back of the beach (Figure 4.1). The baseline is typically considered to be either a fixed object that bounds the beach such as a seawall, fence or cliff, or is a pre-defined stable position on a beach profile such as vegetation line or erosion scarp. The limiting feature at Wamberal Beach is either existing ad-hoc rock protection, a seawall (to be constructed) or a dune scarp generally associated with the most eroded state of the beach. Wave runup reaching the baseline feature defines the case with zero beach width. i.e. when the seawall, scarp or other feature is directly exposed to wave runup. A beach width model has been developed for Wamberal in this study to create hourly dry beach width for a period of 10 years. The beach width model incorporates measured offshore wave height, modelled nearshore wave height, measured tide, measured and modelled wave runup, and measured beach profile measurements (see Section 3), to create a continuous beach width timeseries. The beach width model was applied at six profiles located between Terrigal and Wamberal Lagoon entrances as shown in Figure 4.3.

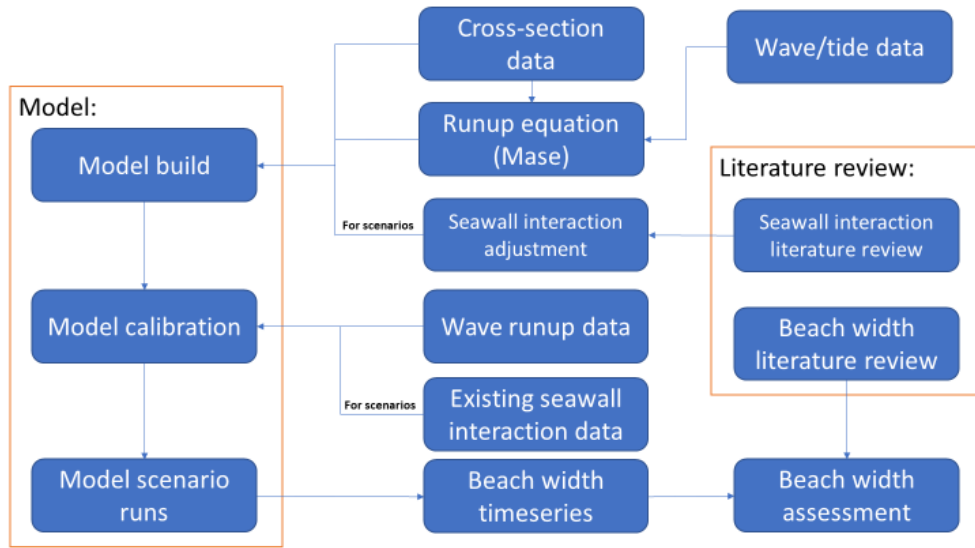
Figure 4.2: Beach Width amenity model development

Since wave runup is continuously changing with waves and tides, and the beach profile is also continually evolving, the dry beach width varies with time. This means that during some periods there may be limited beach width during large waves and high tides when the beach is narrow, while there may still be useable beach at low tide. During other periods, a substantial beach width will be present for extended periods.

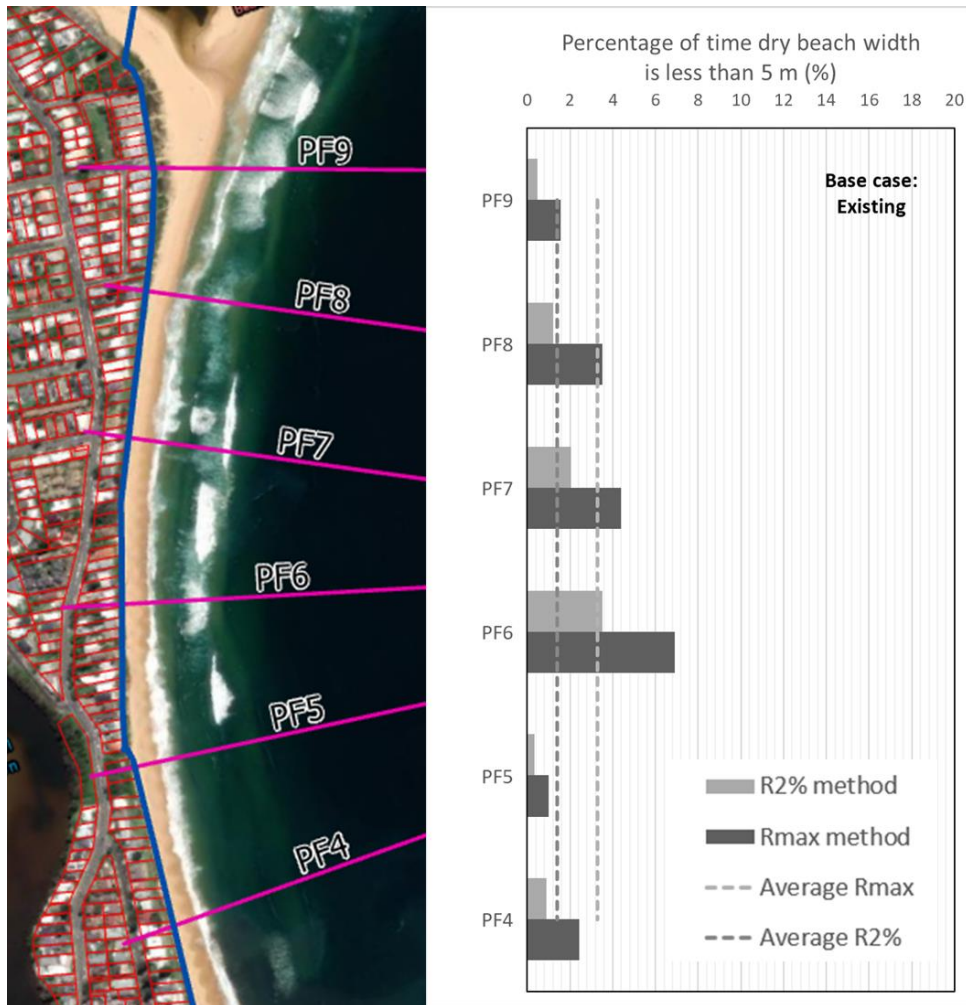
Figure 4.6: Percentage of time spent below 5 m beach width for existing scenario

The model results for the base case (existing) are summarised in Figure 4.6 . As described in Section 4, a dry beach width of 5 m (above the wave runup limit) has been adopted as the minimum acceptable for amenity at Wamberal Beach. These results show the percentage of time that the existing beach was less than 5 m in width over the 10 year period for a model using the maximum wave runup height (Rmax) and the wave runup height that is exceeded by 2% of waves for a given period of time (R2%).

The modelling identified alongshore variability in the results with a ‘pinch point’ in the centre of the beach (Profile 6 and 7) where the beach was less likely to maintain a 5 m dry beach width compared to locations further north and south along the beach. In this central region, the existing beach spent a higher proportion of time (approximately 3 – 7%) less than a 5 m width. At these locations, the results highlight the effect on beach width of existing rock protection encroaching further into the active beach profile. At other locations the percentage of time spent below a 5 m beach width was 2% or less. While the results varied alongshore, on average the existing beach spent approximately 3.3% of the time over the 10 year period less than 5 m in width using Rmax and 1.4% of the time when using R2%.

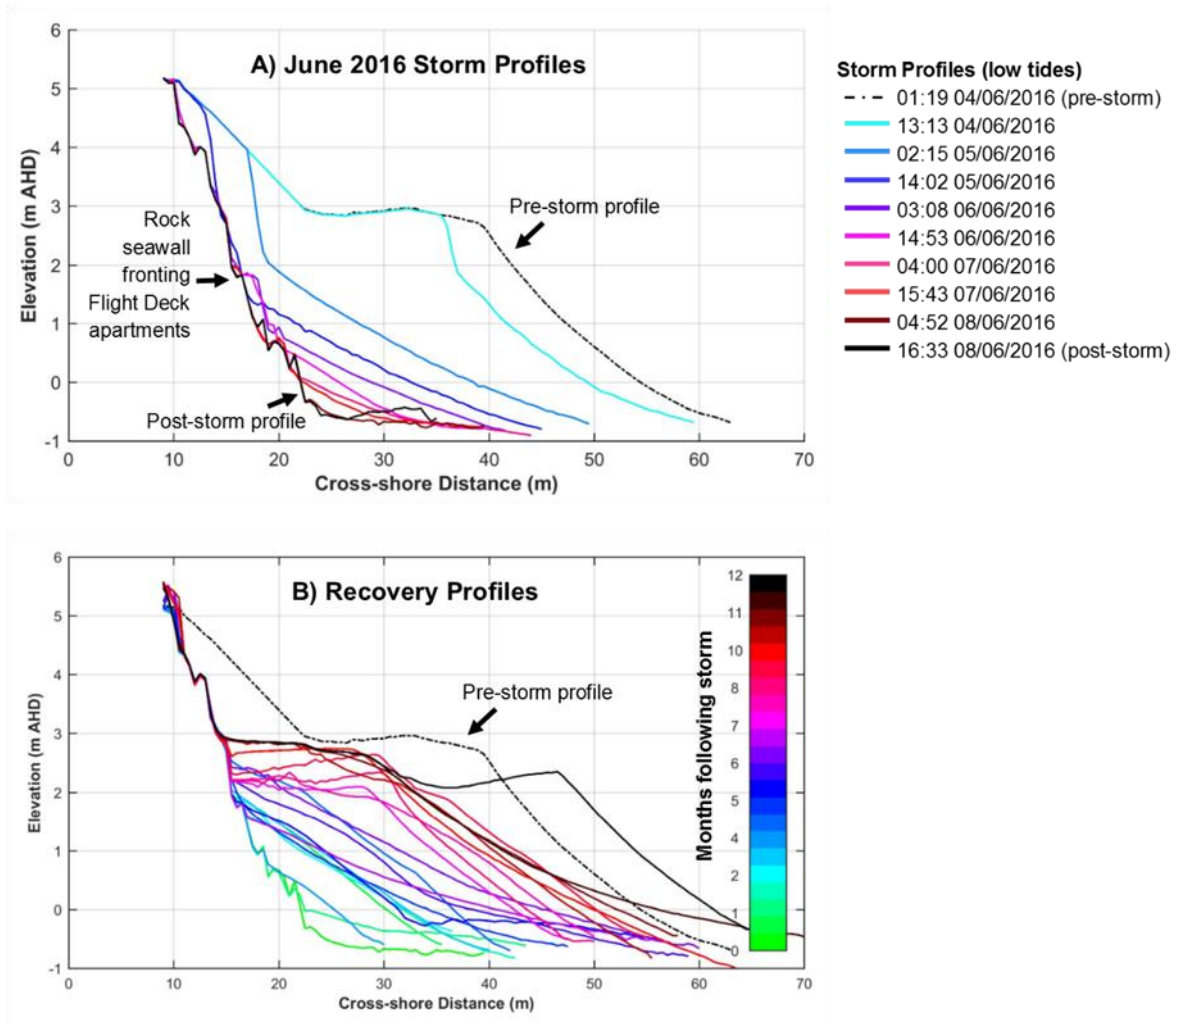
Figure 5.6: Observations of storm erosion and beach recovery fronting rock protection

Observations from the LiDAR during and after the June 2016 storm when the rock seawall fronting Flight Deck apartments was exposed are shown in Figure 5.6. Significant wave reflection off the face of the seawall was observed over the course of the storm event. A scour of the beach profile at the base of the rock wall between elevations from 1 m AHD down to -0.5 m AHD is shown over the latter half of the storm, occurring at a rate of approximately 0.4 to 0.1 m³/m/h. This scour gradually declined to minimal as the storm subsided and then filled back in with initial wave-driven beach recovery processes at rates of approximately 0.1 – 0.2 m³/m/day in the initial 1 – 2 months following the storm. Within 12 months after the storm, the berm had recovered beyond its pre-storm width, approximately 30 m landward of the rock wall and to a height of 2 to 3 m AHD. However, the volume in the upper beach profile lost during the storm was yet to recover, dependent on slower aeolian recovery processes (also seen in Figure 5.7).

Note: Fixed LiDAR observations of (a) storm erosion and (b) beach recovery fronting rock protection at Flight Deck apartments, Collaroy-Narrabeen Beach during the June 2016 storm

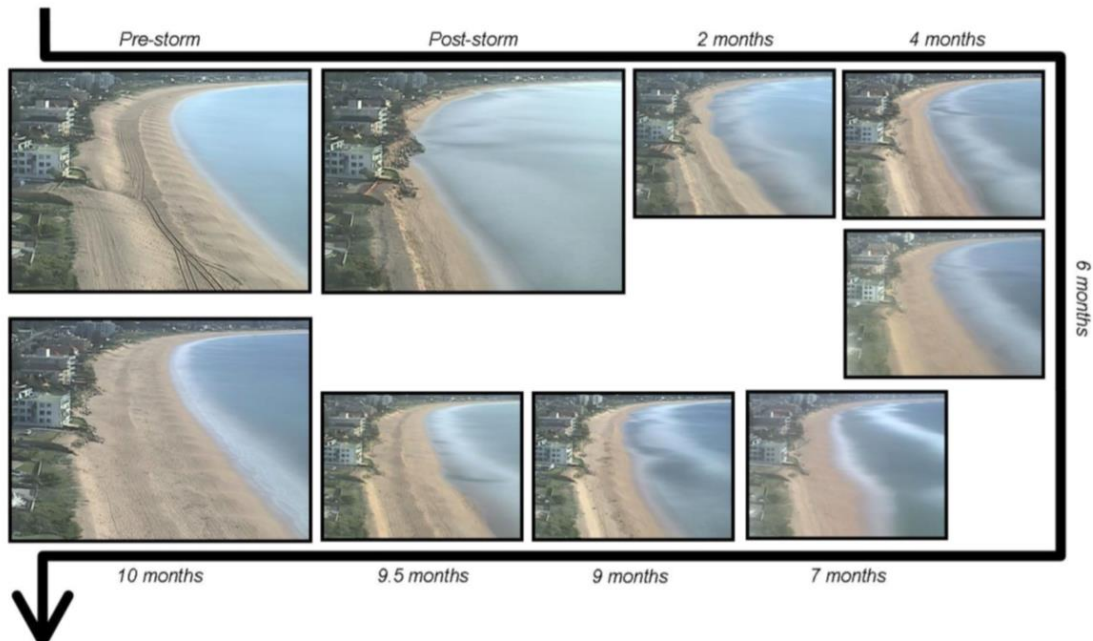
Figure 5.7: Beach recovery at Collaroy-Narrabeen Beach in June 2007

Once sediment returns to the shoreline, swash processes rework this sediment up onto the subaerial beach to rebuild the berm as shown in Figure 5.7. A high-frequency scanning LiDAR at Collaroy Beach at Flight Deck Apartment Building was used to capture this process investigating tide-by-tide recovery following a storm in April 2015 (Phillips et al. 2018; 2019). Principal modes of berm recovery were classified based on ocean water level and nearshore wave conditions as the beach built back to its pre-storm state over the months following the storm.

Note: Beach recovery and the return of shoreline and berm morphology to pre-storm conditions following storm erosion at Collaroy-Narrabeen Beach in June 2007. Images taken at approximately mid to low tide. From Phillips (2018).

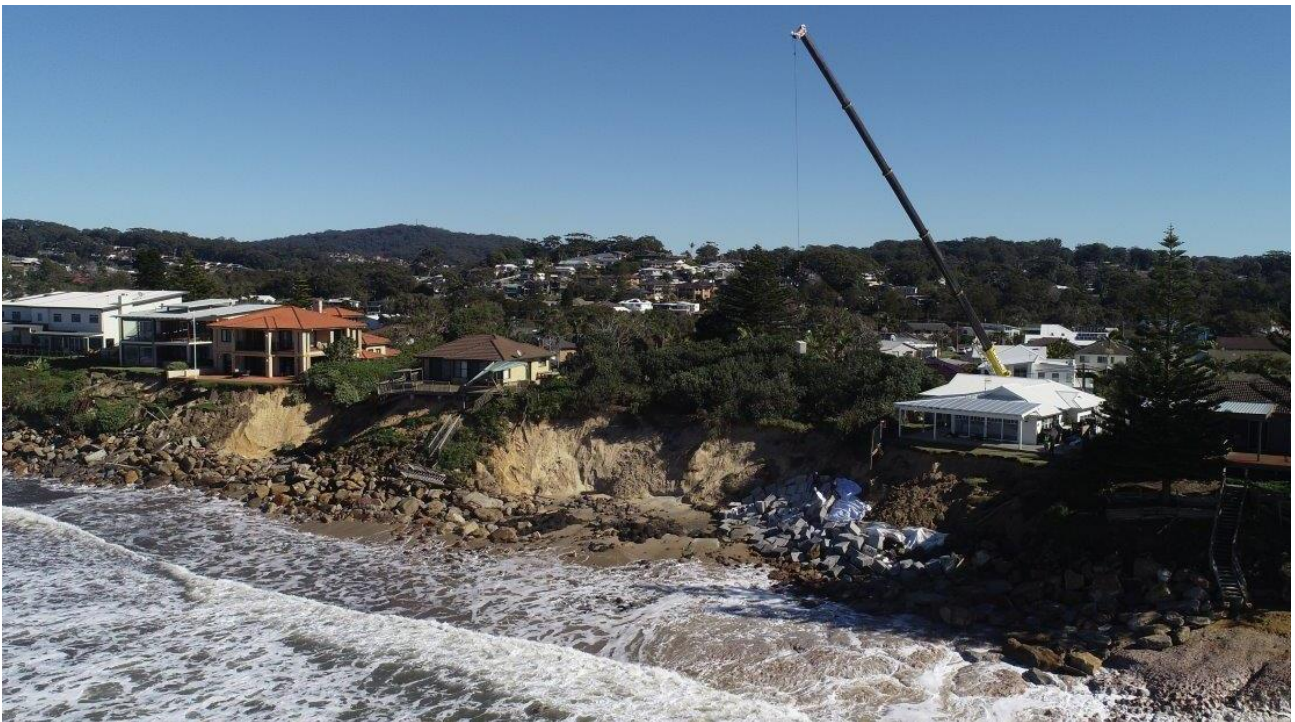
Figure 5.8: Wamberal Beach after storm erosion on 20th July 2020. MHL drone survey.

These materials are exposed and mobilised with storm erosion events, causing public safety concerns and inhibiting alongshore beach access such that sections of the beach have required to be closed to the public for periods of time after storms. Often these materials are left strewn on the beach by waves creating hazards for beach users as shown in Figure 5.8.

During construction, it is strongly recommended that any existing ad-hoc material and emergency rock toe protection works seaward of the proposed new seawall be removed to enhance beach amenity, or where suitable used as fill where required landward of the seawall. Any existing rock protection removed with construction should be replaced by sand nourishment wherever possible to extend the level of the natural beach berm or foredune seaward of the seawall. All sand excavated during the construction of the proposed seawall should be screened (to remove any oversized materials) and placed seaward of the works with any necessary fill landward of the seawall comprised of the separated materials (if suitable) and/or suitable clean fill that would be imported to the site. This will maximise the amount of sand added to the beach area as a result of the works and largely improve existing beach amenity.

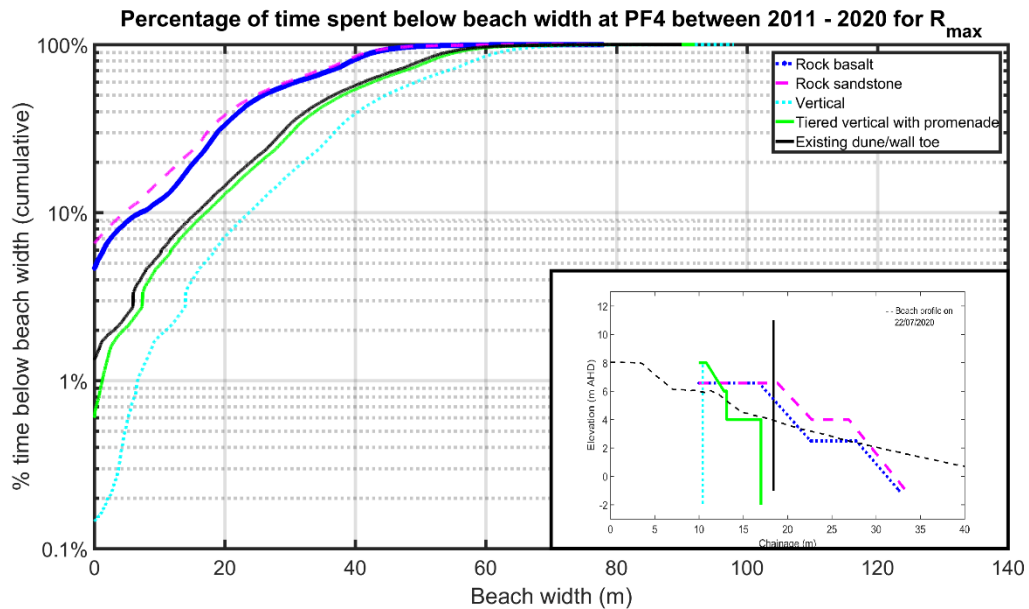
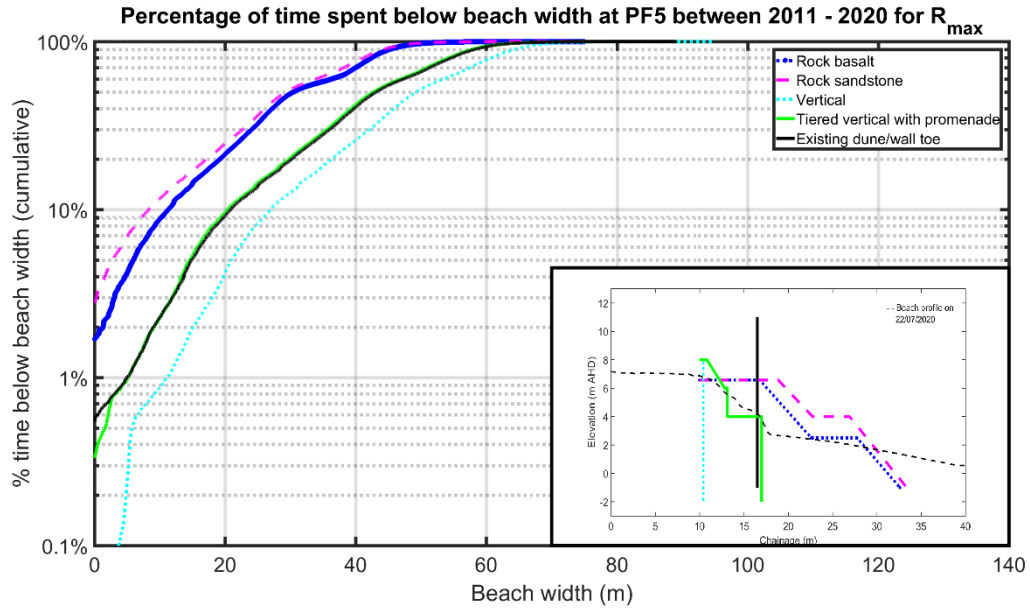
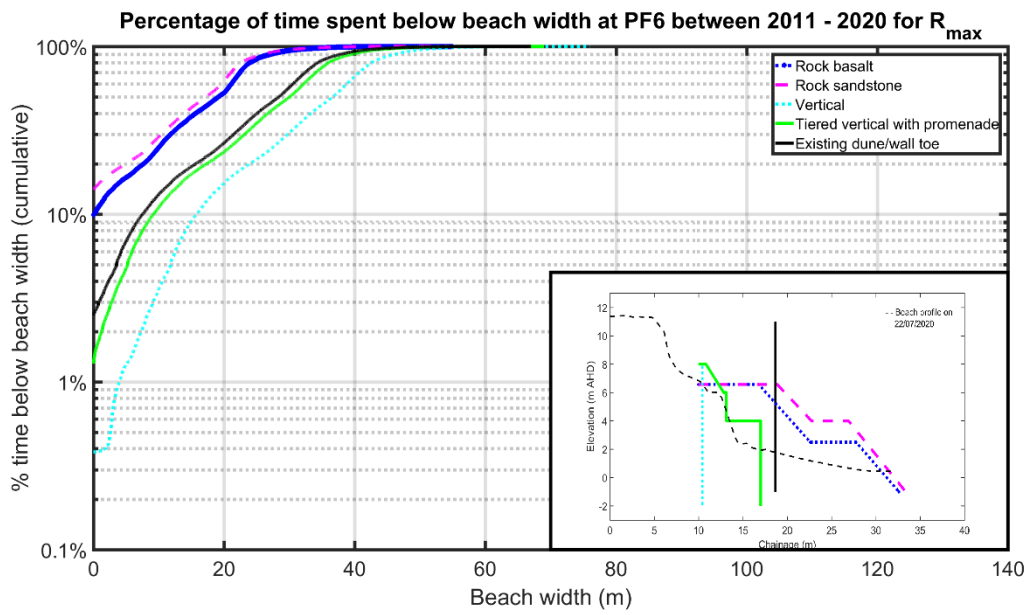
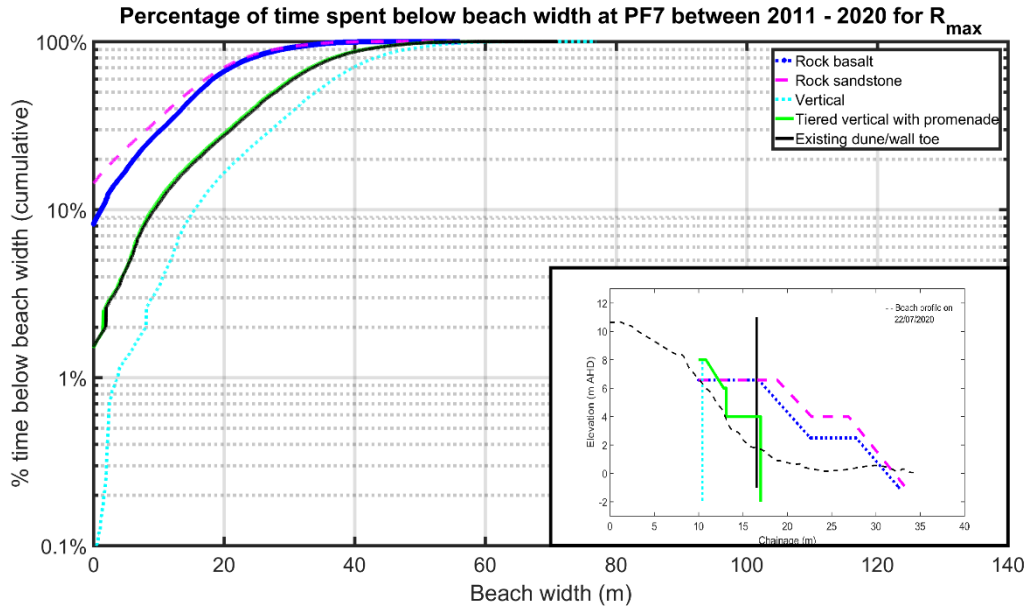
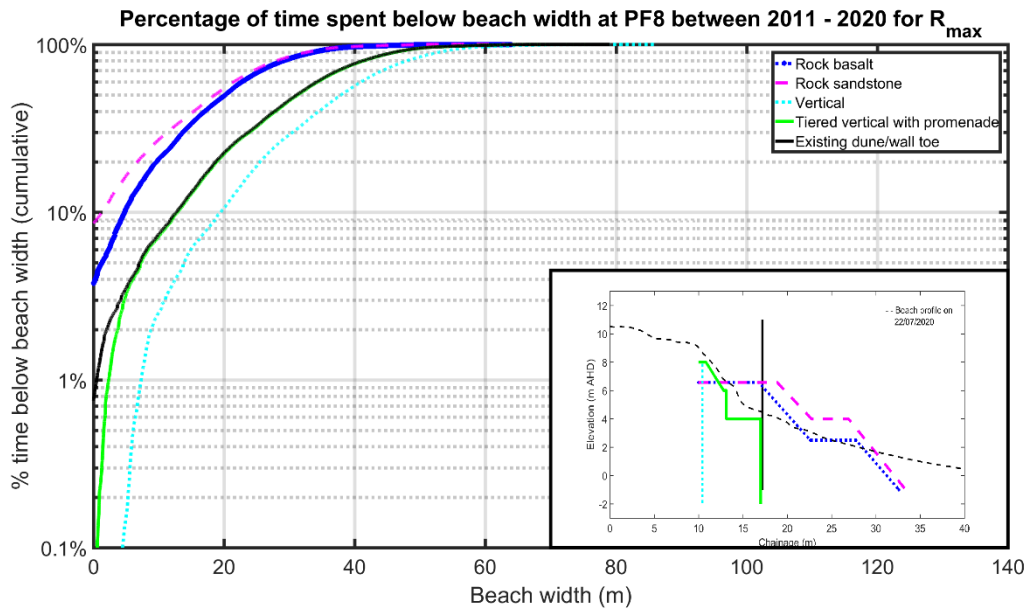
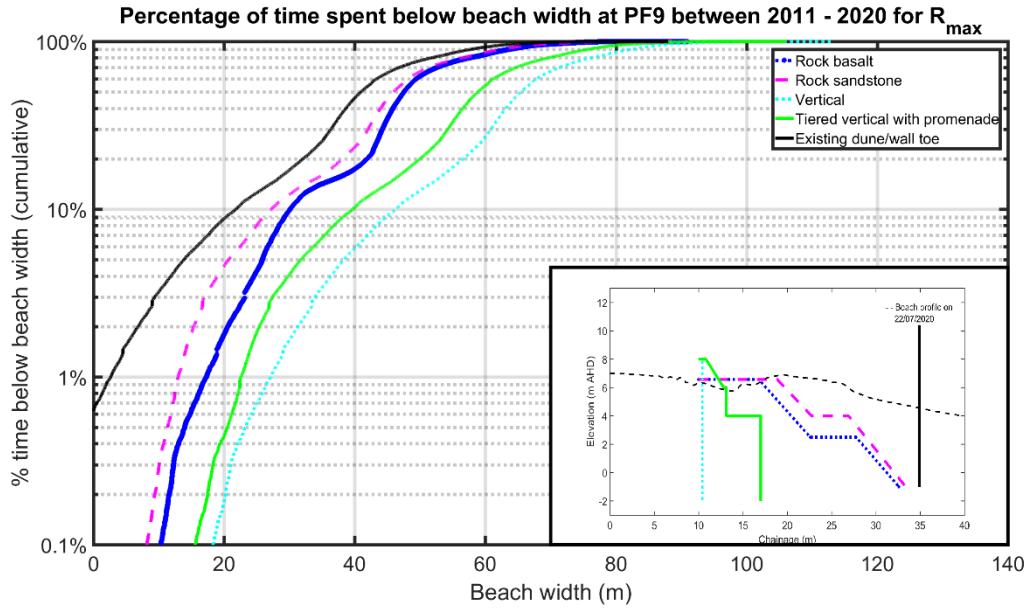
Figure A.1: Performance of the Mase equation at Collaroy-Narrabeen Beach

(source: Tucker et al., 2019)
