Environmental Assessment Form – Level 2

Geotechnical Investigation - Avoca Lagoon Crossing Transfer Main

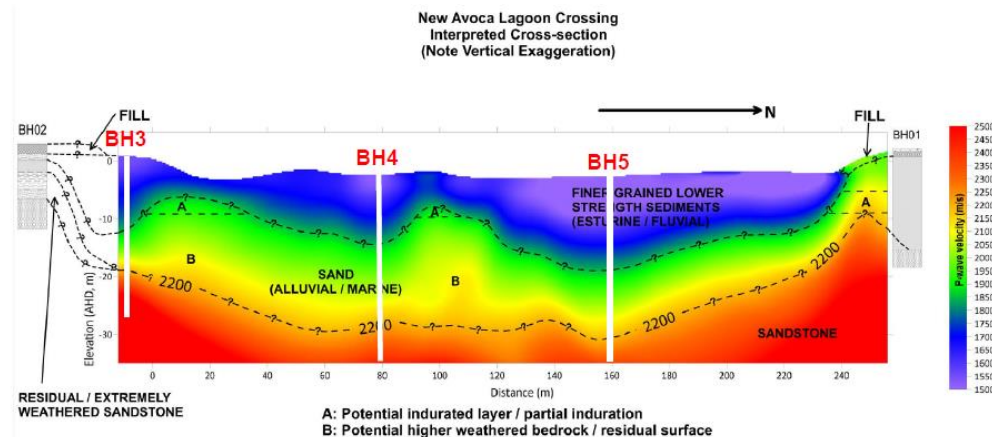
Figure 2: Proposed borehole location along alignment shown in Figure 1 (GHD, 2020).

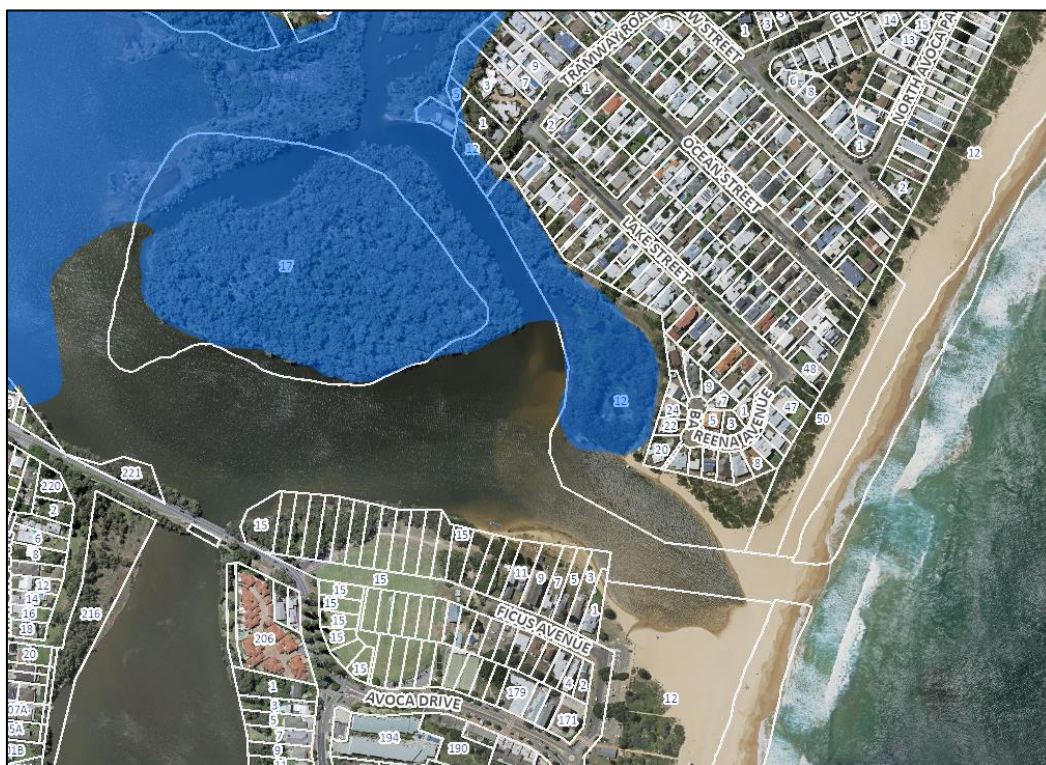
Figure 3: Coastal Wetland mapping (blue polygon) at Avoca Lagoon (Geocortex, 2023).

The vegetated island (Lot 100 DP 60217 – Crown Land) and large portions of remnant vegetation surrounding Avoca Lagoon has been mapped as a Coastal Wetland under Chapter 2 of the the NSW *State Environmental Planning Policy (Resilience and Hazards) 2021* (Resilience and Hazards SEPP) (see **Figure 3**).

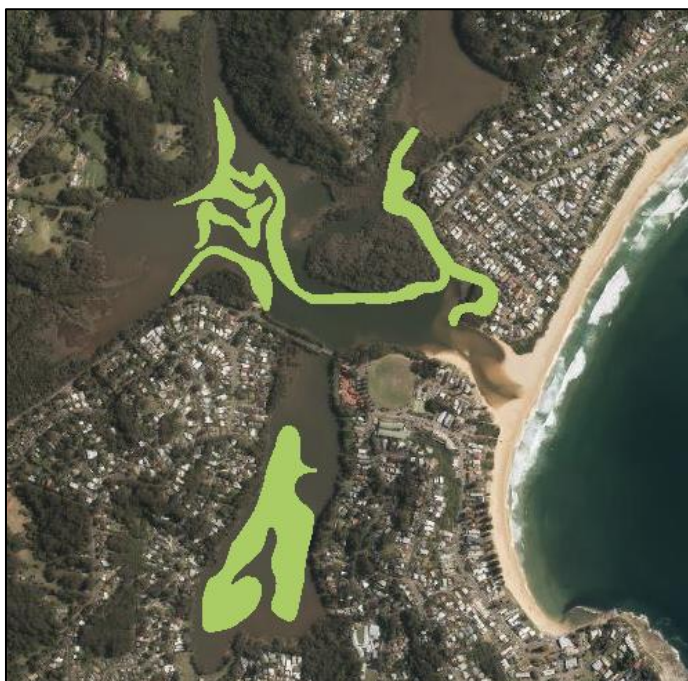
Figure 4: *Ruppia sp.* mapping within Avoca Lagoon (DPI Fisheries, 2023)

The proposed activity includes the use of a barge and geotechnical investigation within the Avoca Lagoon, with proposed BH5 occurring immediately adjacent to mapping for *Ruppia sp.* (Sea Tassel), often found in brackish (salt diluted) waters. The extent of *Ruppia sp.* mapping for the Avoca Lagoon is shown in **Figure 4**. The NSW Department of Primary Industries – Fisheries (DPI Fisheries) *Fisheries NSW Spatial Data Portal* (2023) maps the Avoca Lagoon as Key Fish Habitat, while Avoca Lagoon (noting brakish environment) is not mapped within the extent of indicative occurrence for Threatened Freshwater Fish Species.

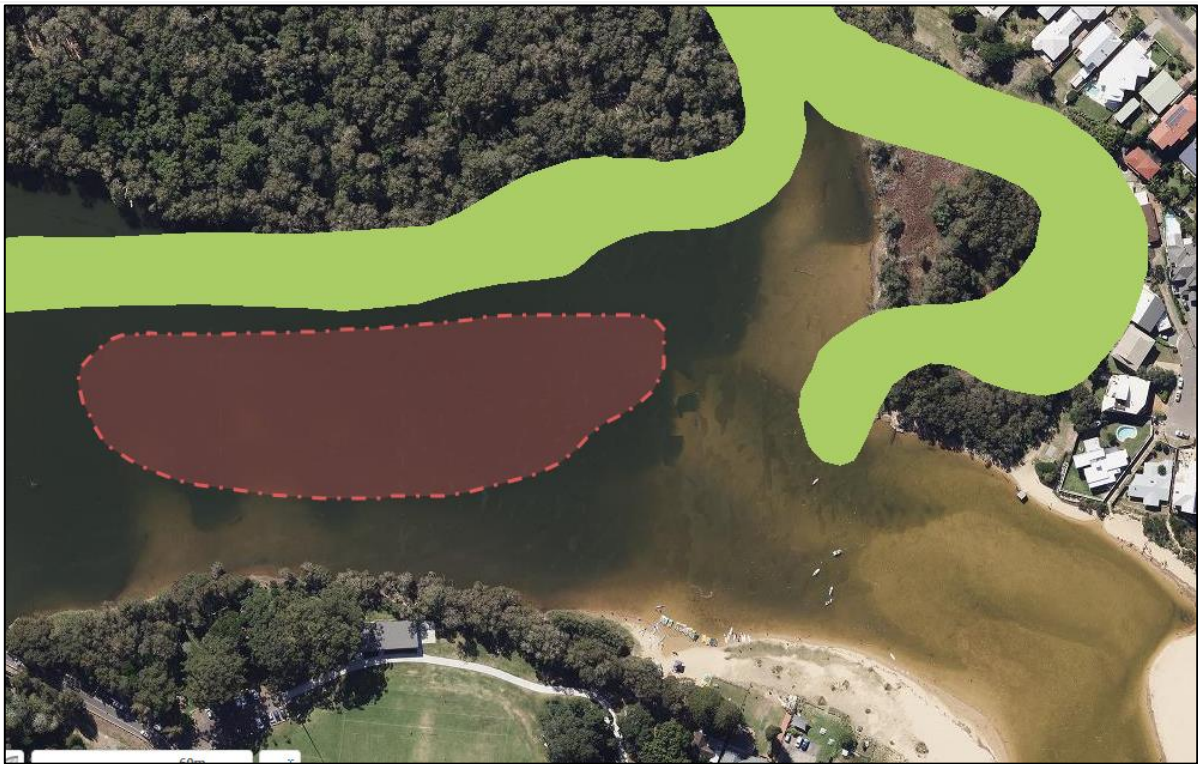
Figure 5: Possible anchoring location (red) and Ruppia mapping (green) (DPI Fisheries, 2023).

- 1) Controls as listed in other sections of this REF.
- 2) The area of works will be kept to the minimum to safely complete the proposed activity.
- 3) Any anchoring or mooring structure used to secure the barge is to occur outside the mapped extent of *Ruppia* sp. and is to avoid Bareena Wetland, with suggested location provided in.

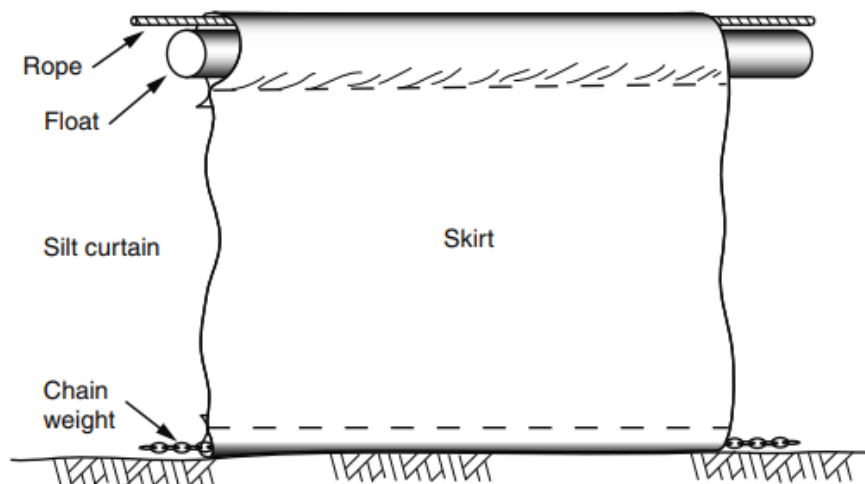
(a) Components of a floating silt curtain

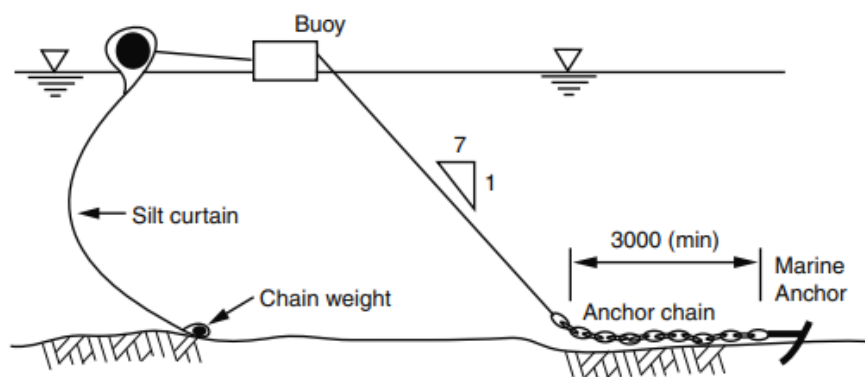
(c) Typical marine anchorage system

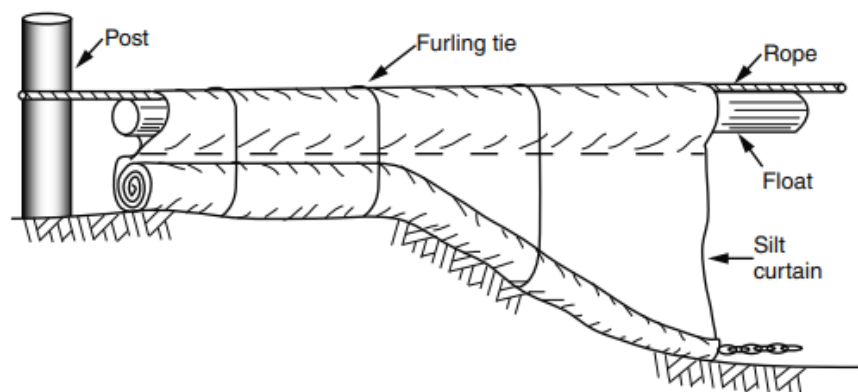
(b) Typical land anchorage system

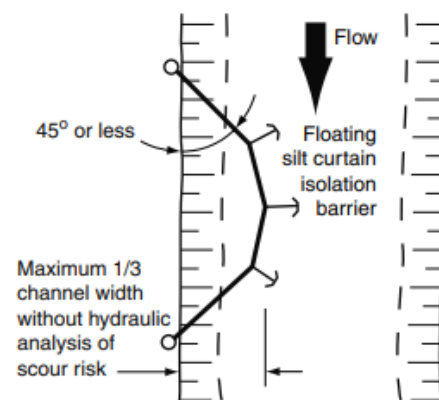
(d) Typical installation of
floating silt curtain

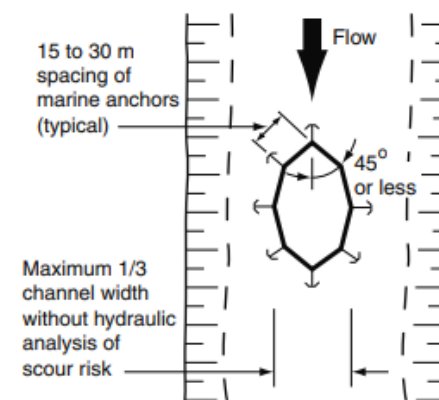
(e) Typical installation of
floating silt curtain
