## DAVISTOWN CATCHMENT FLOOD STUDY VOLUME 2 - FIGURES

Davistown Catchment Flood Study

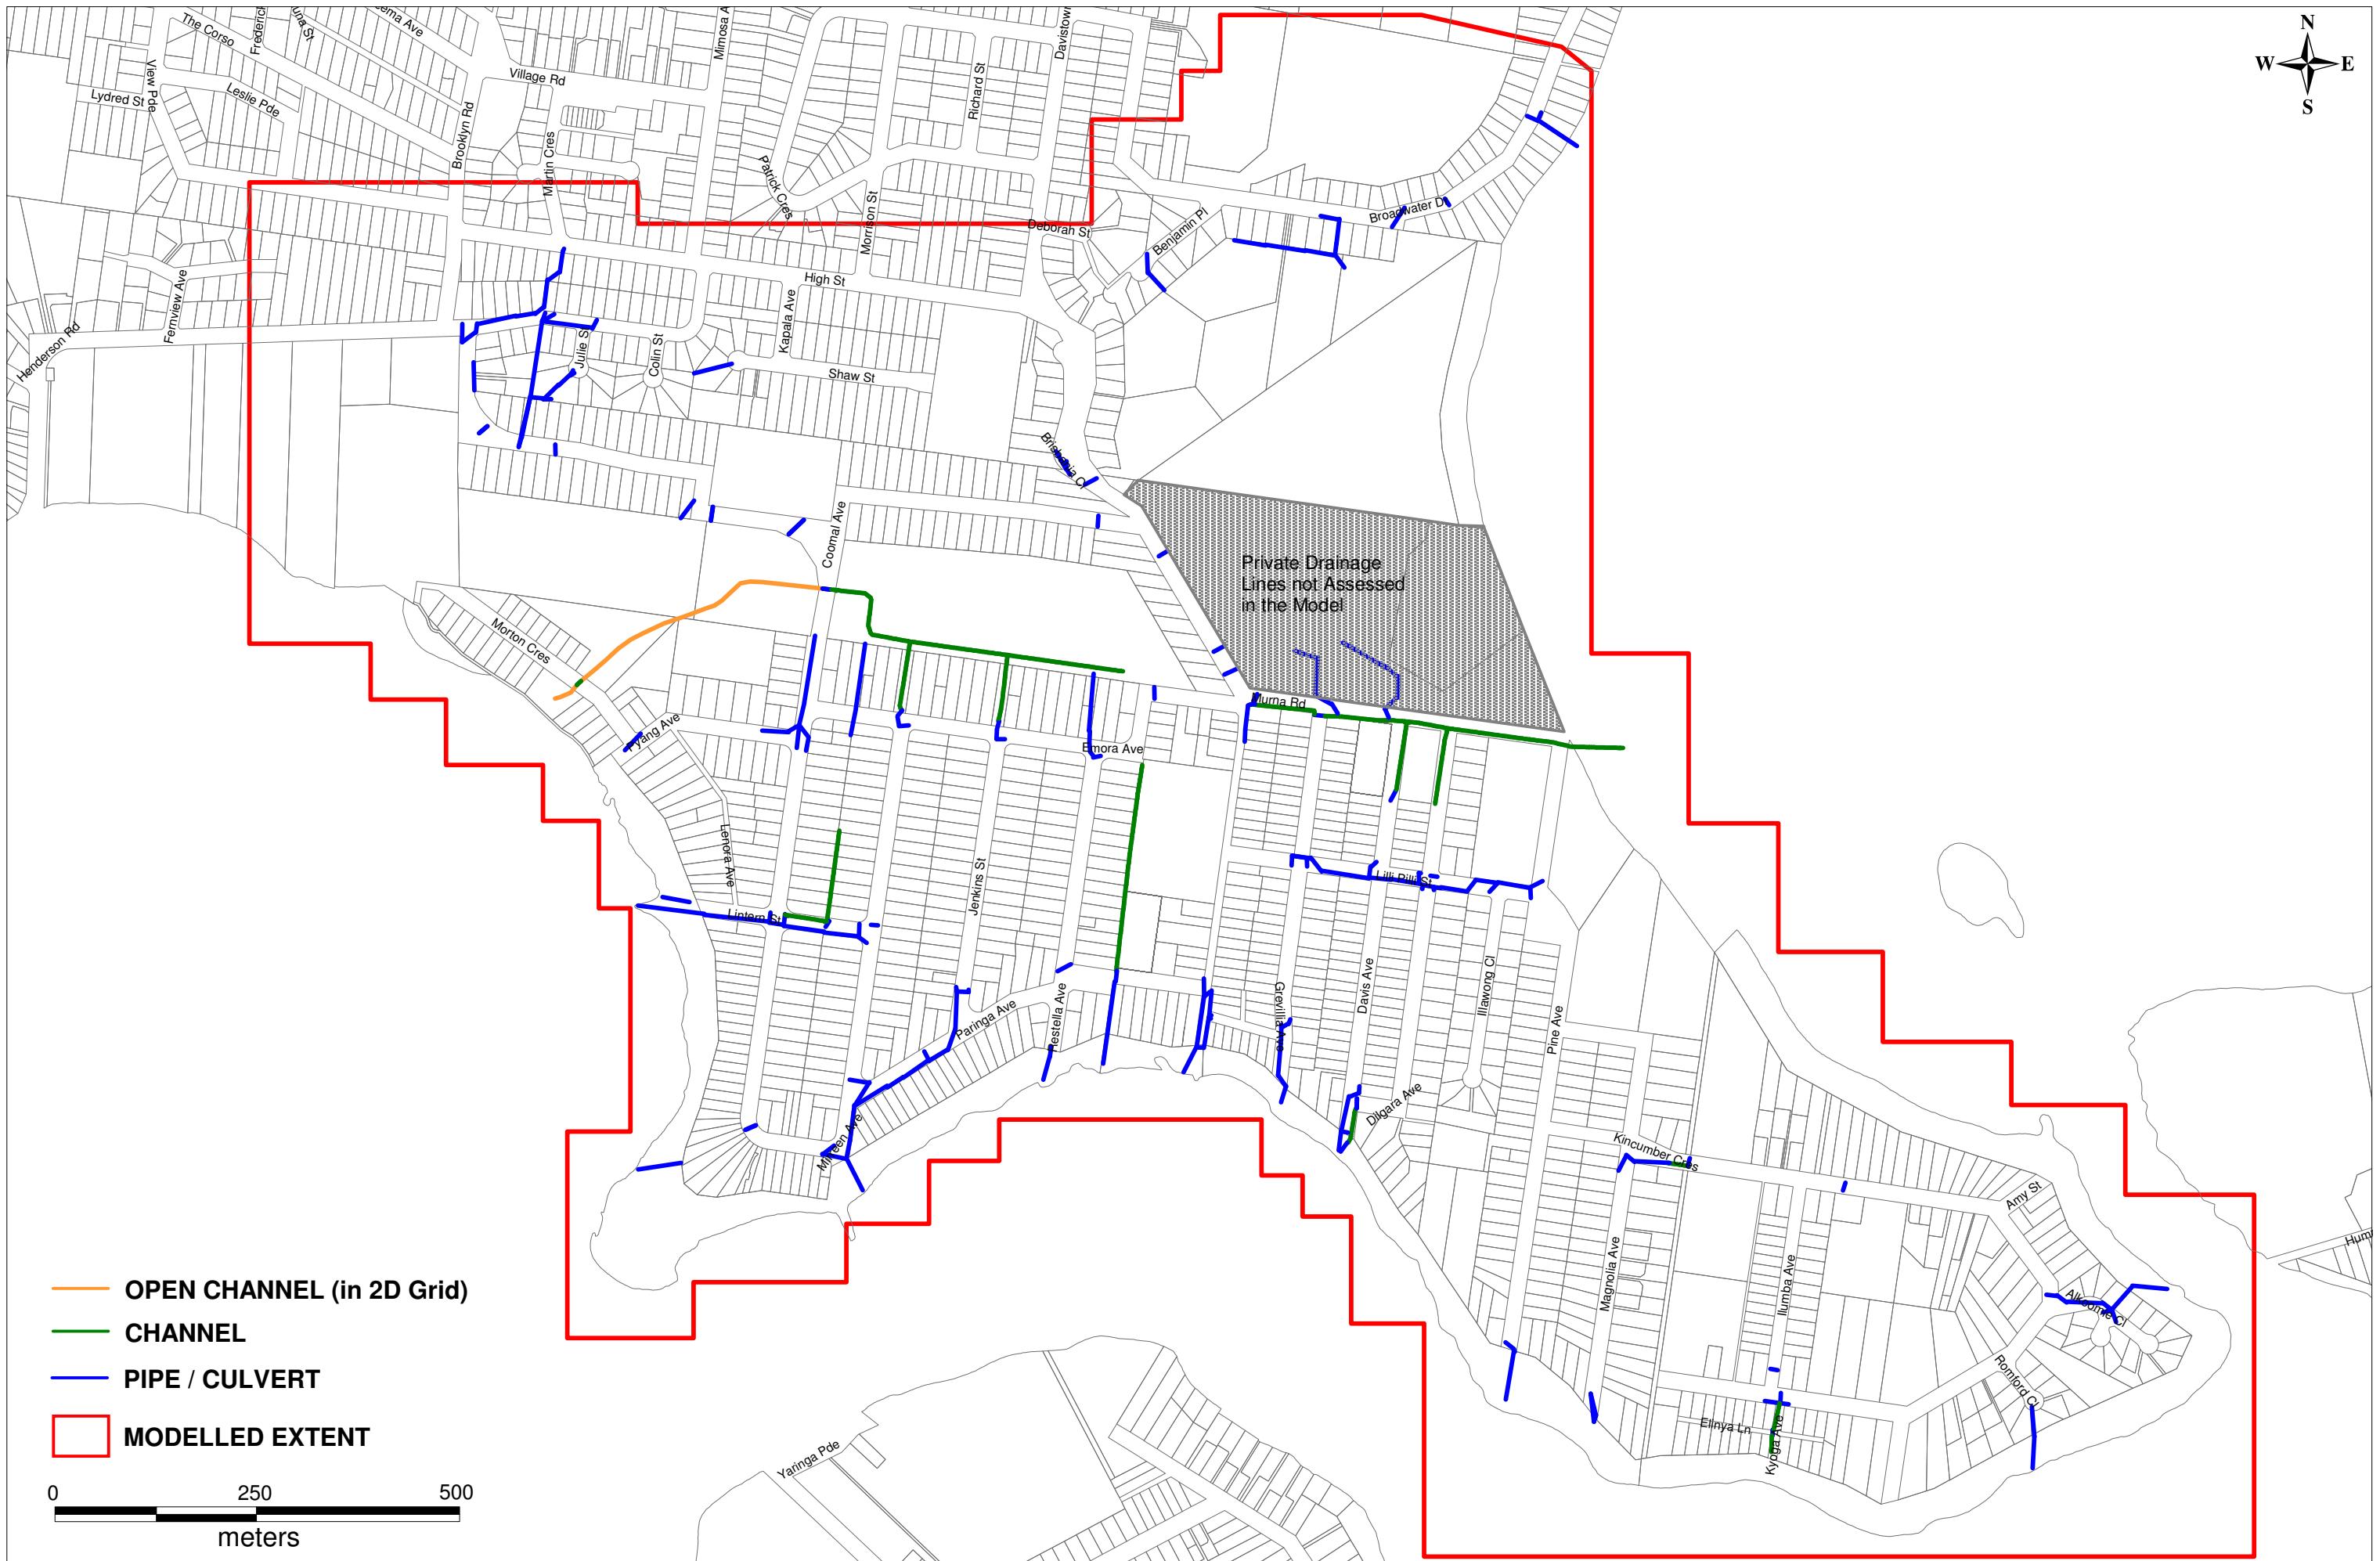
FIGURE 5.2

SOBEK MODEL - 1D DRAINAGE SYSTEMS

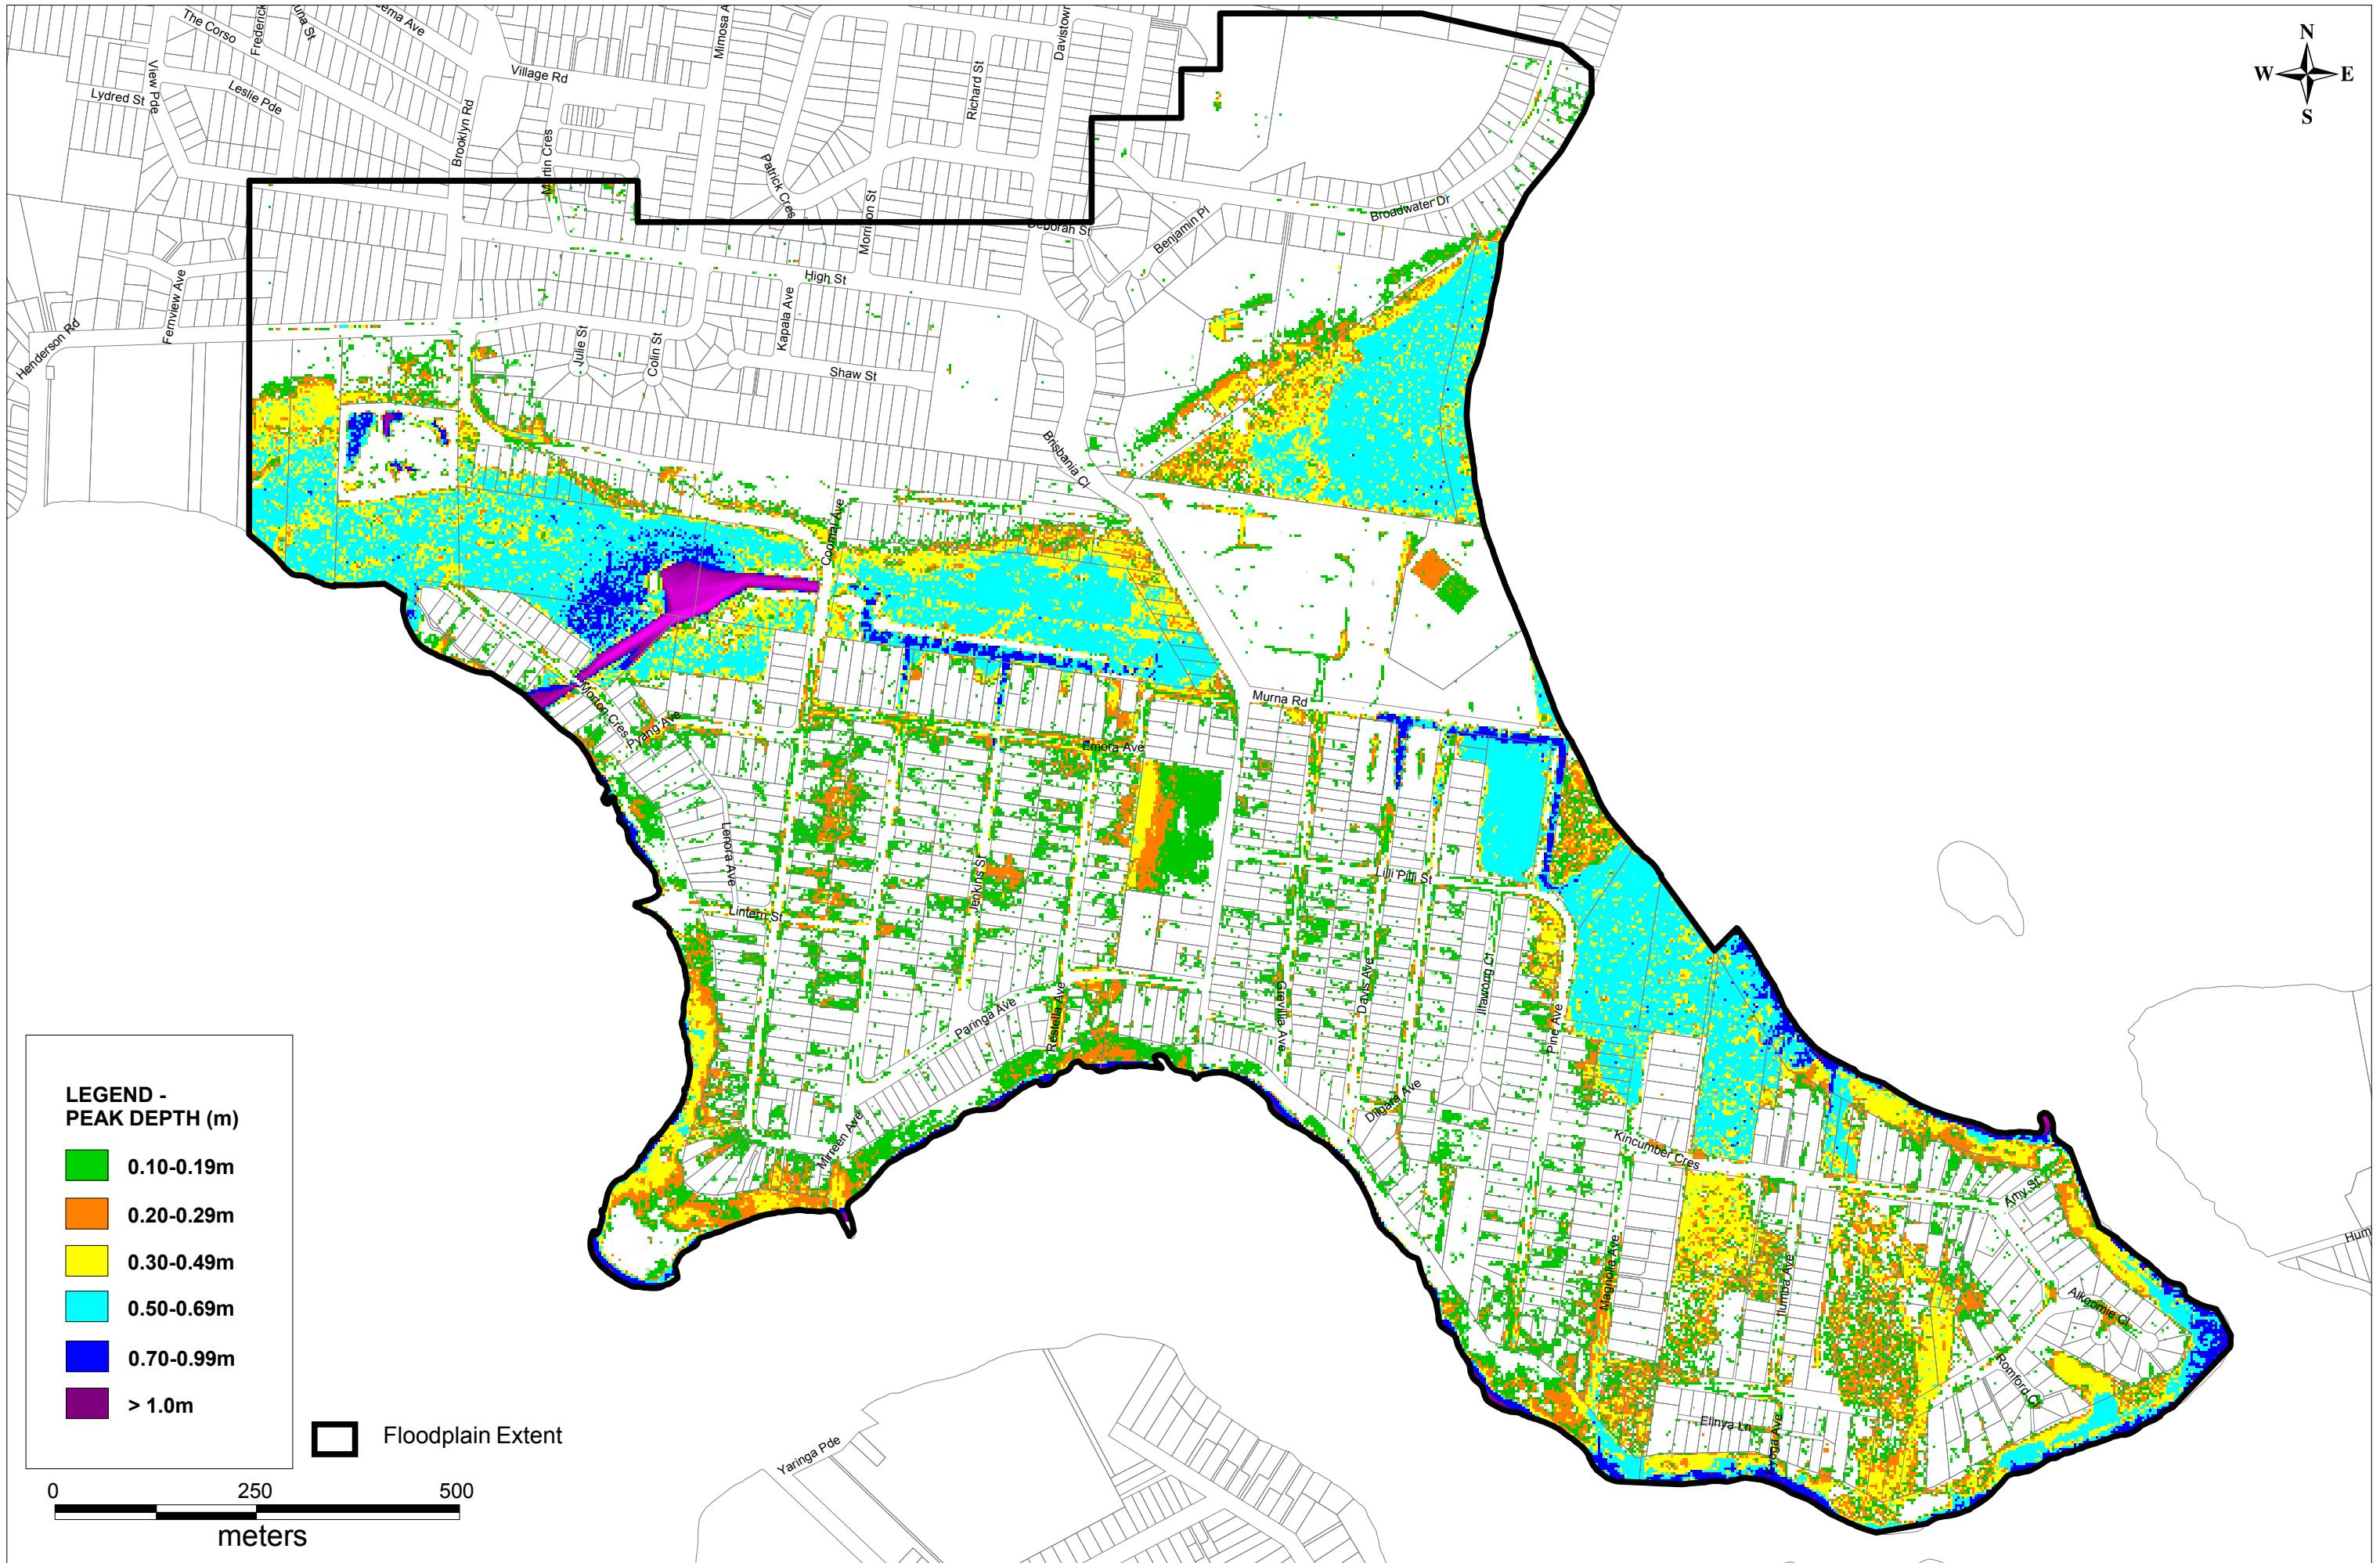
**FIGURE 5.8**  
PEAK DEPTH - 7 to 10 June 2007

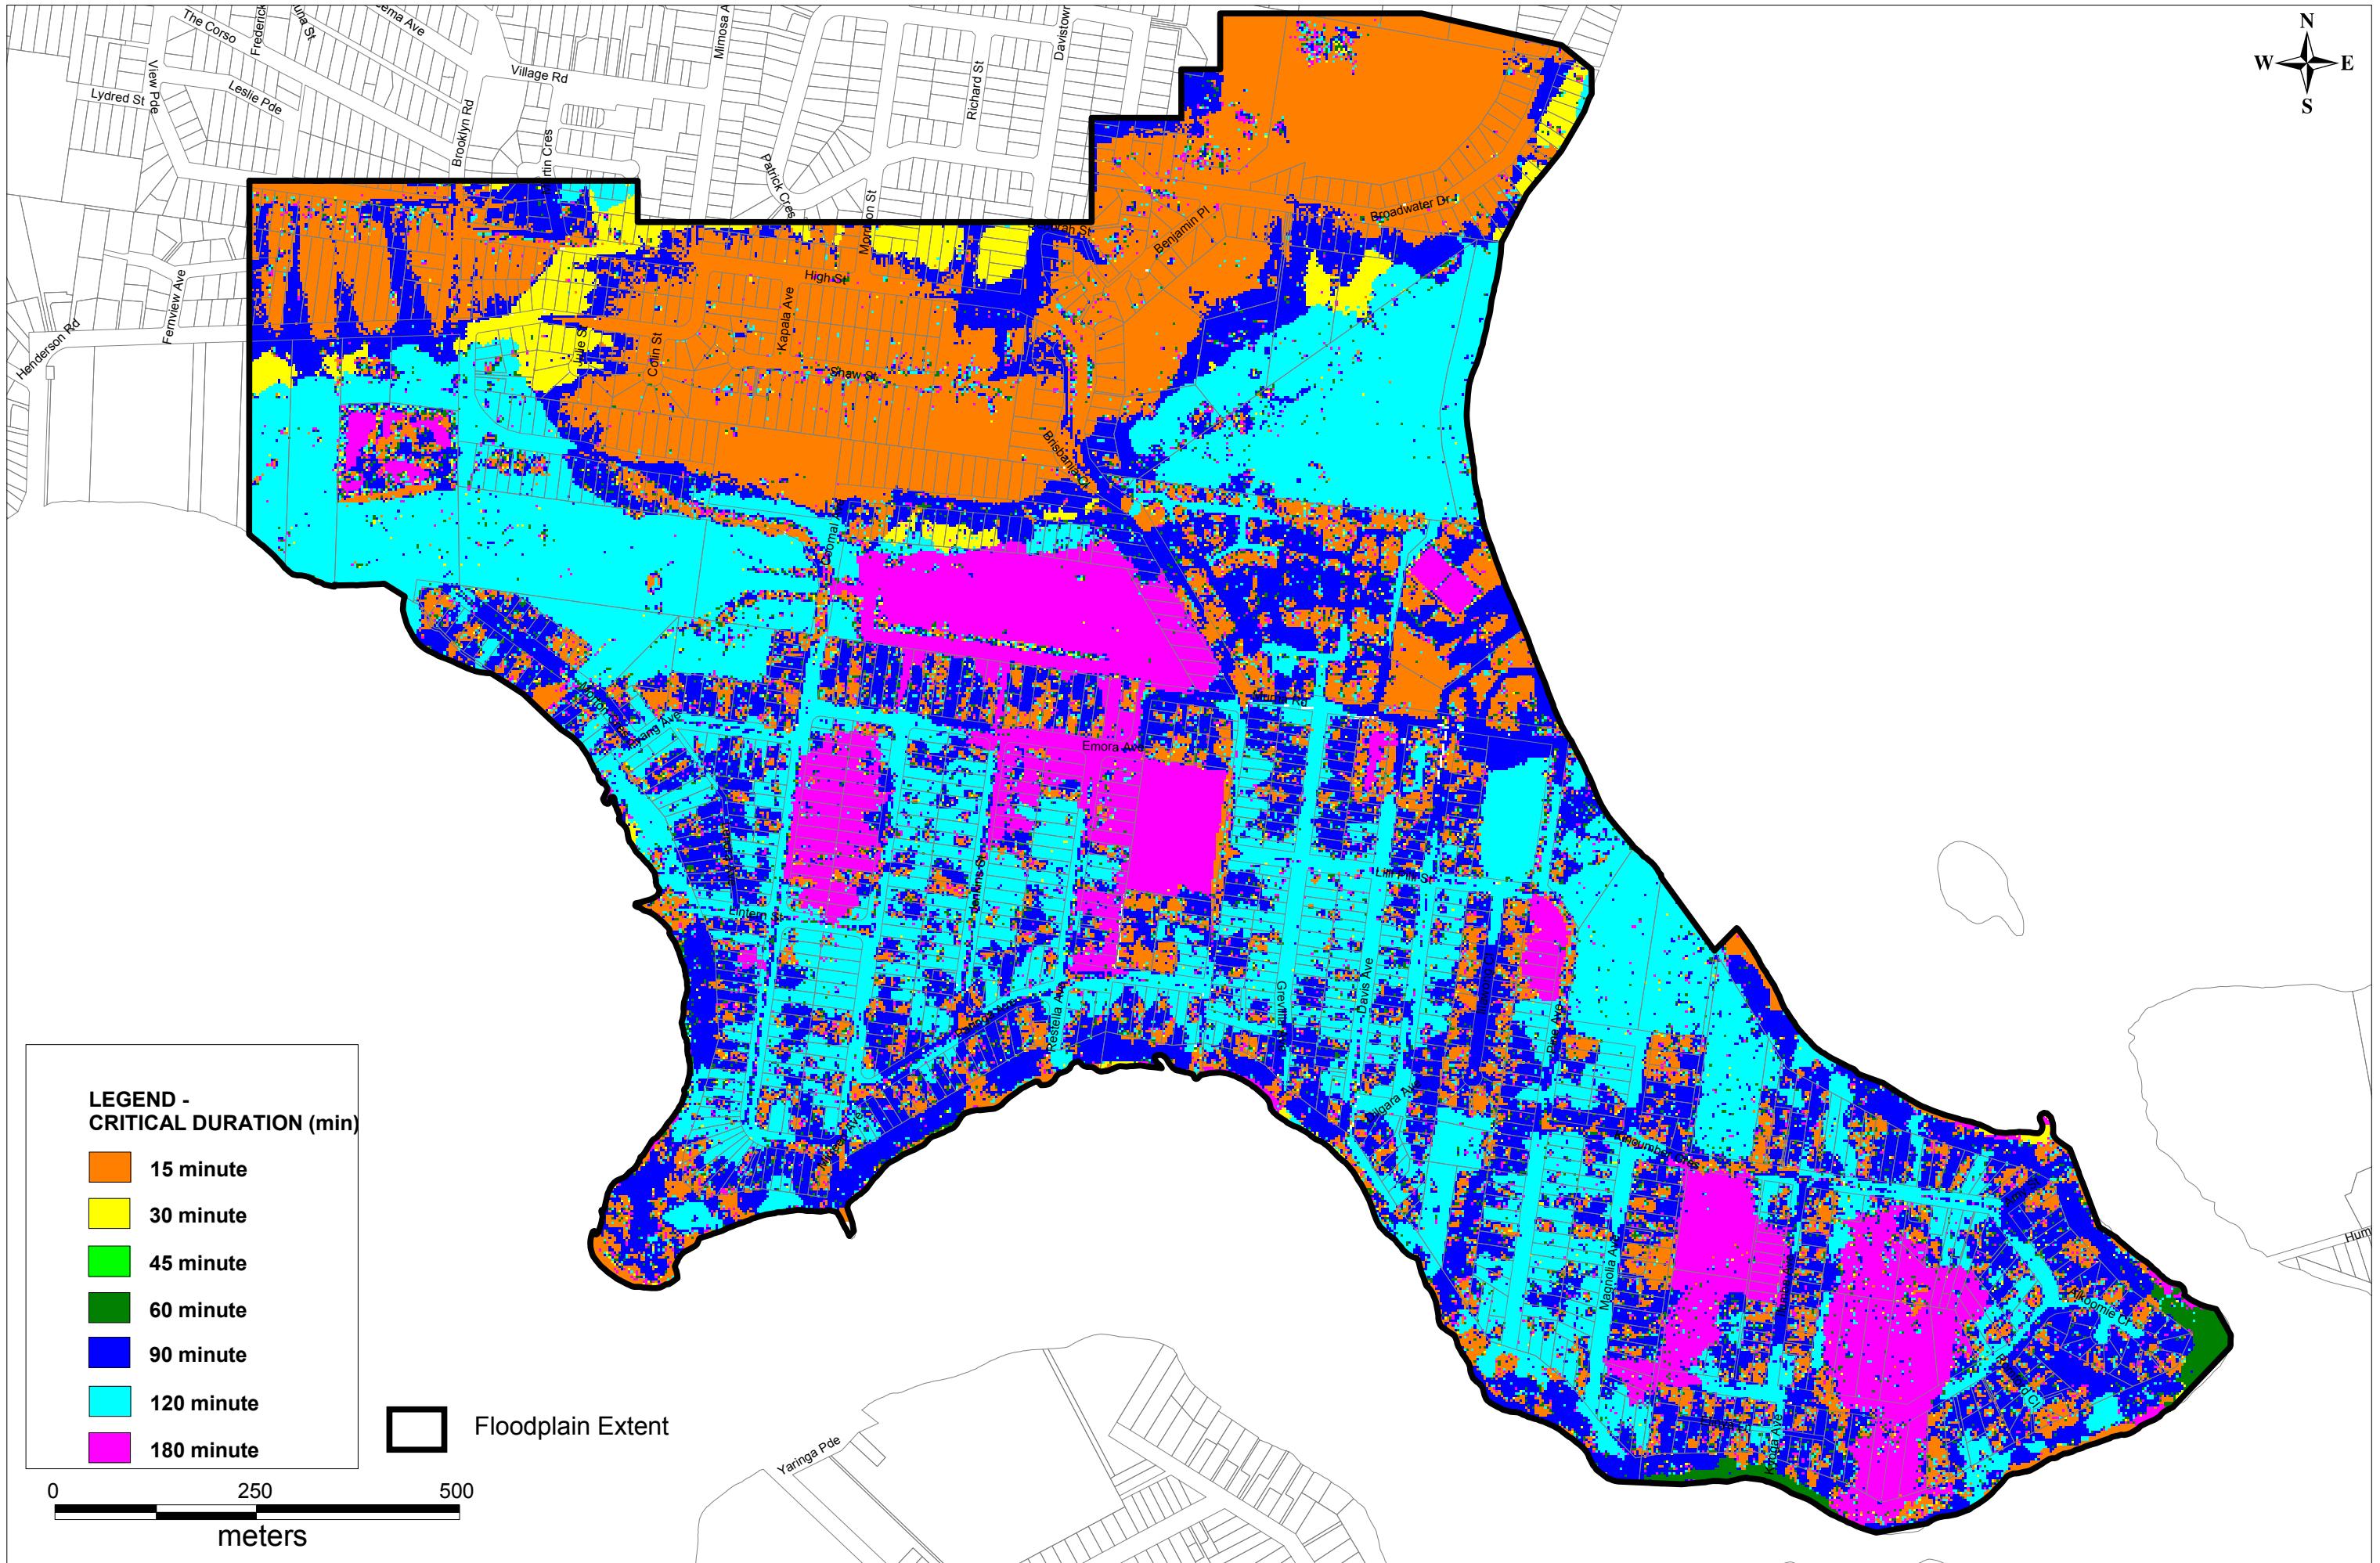
FIGURE 6.3  
1% AEP CRITICAL DURATION

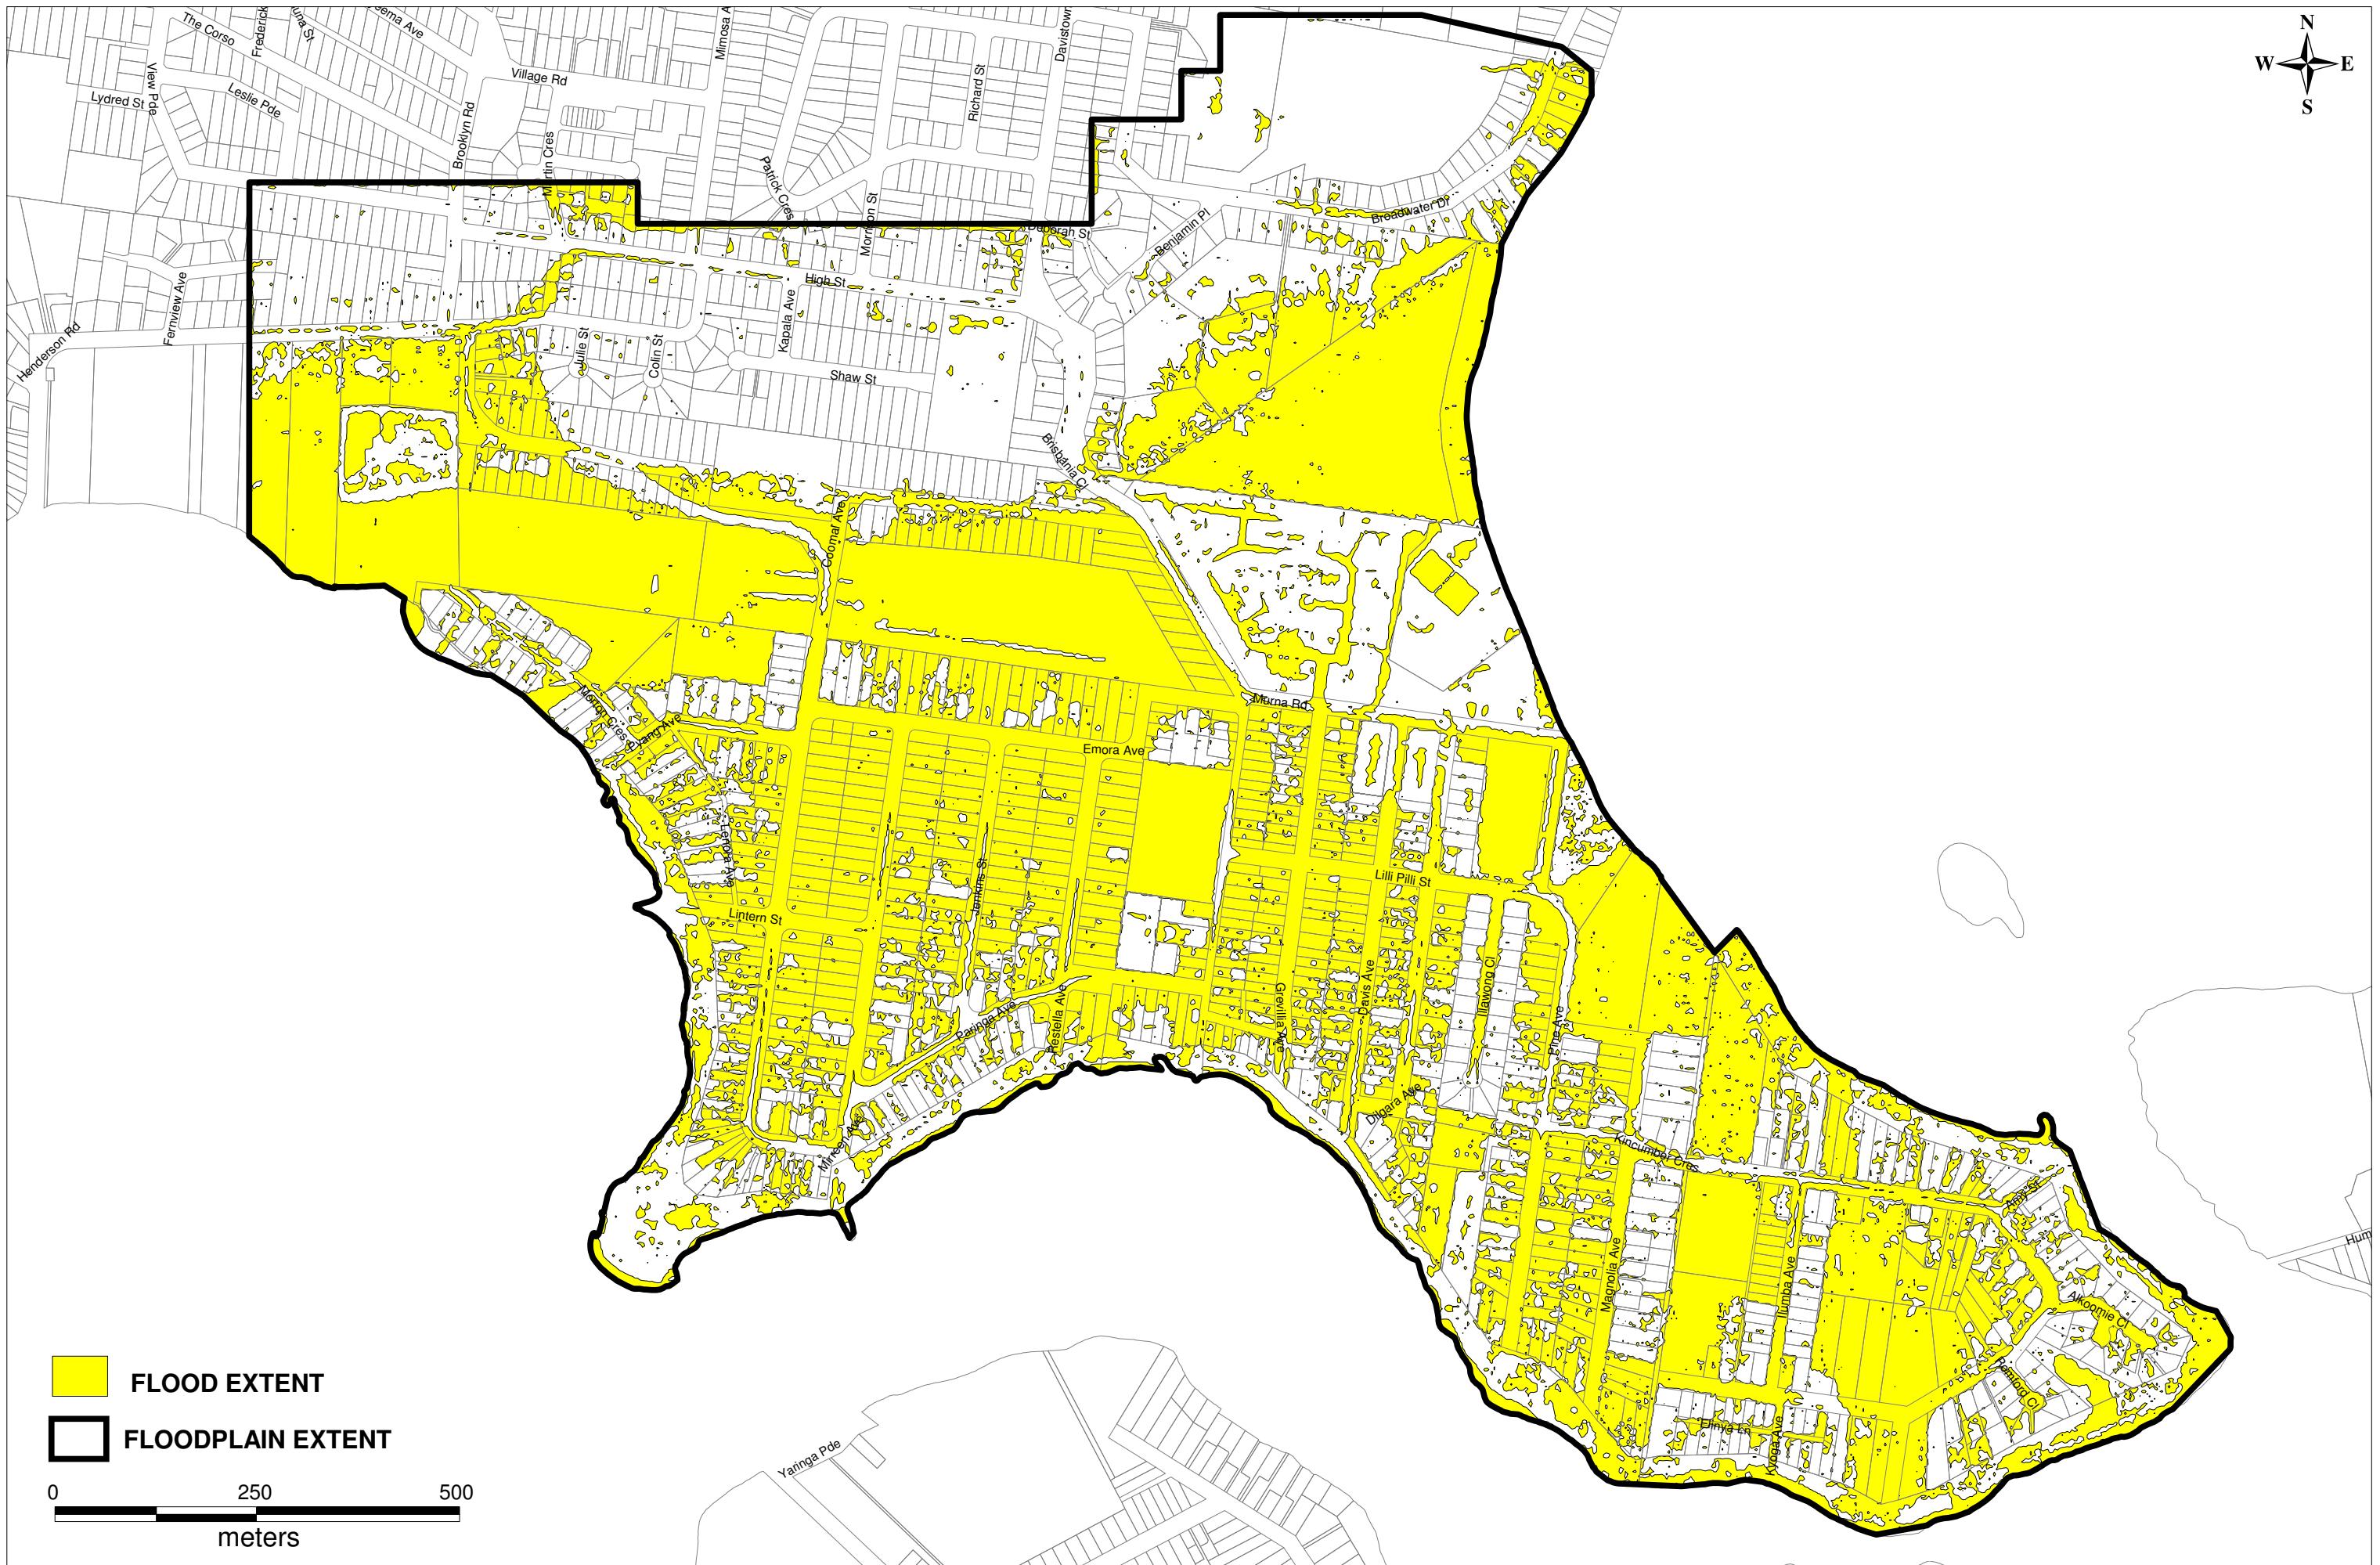
FIGURE 6.5  
FLOOD EXTENT - PMF

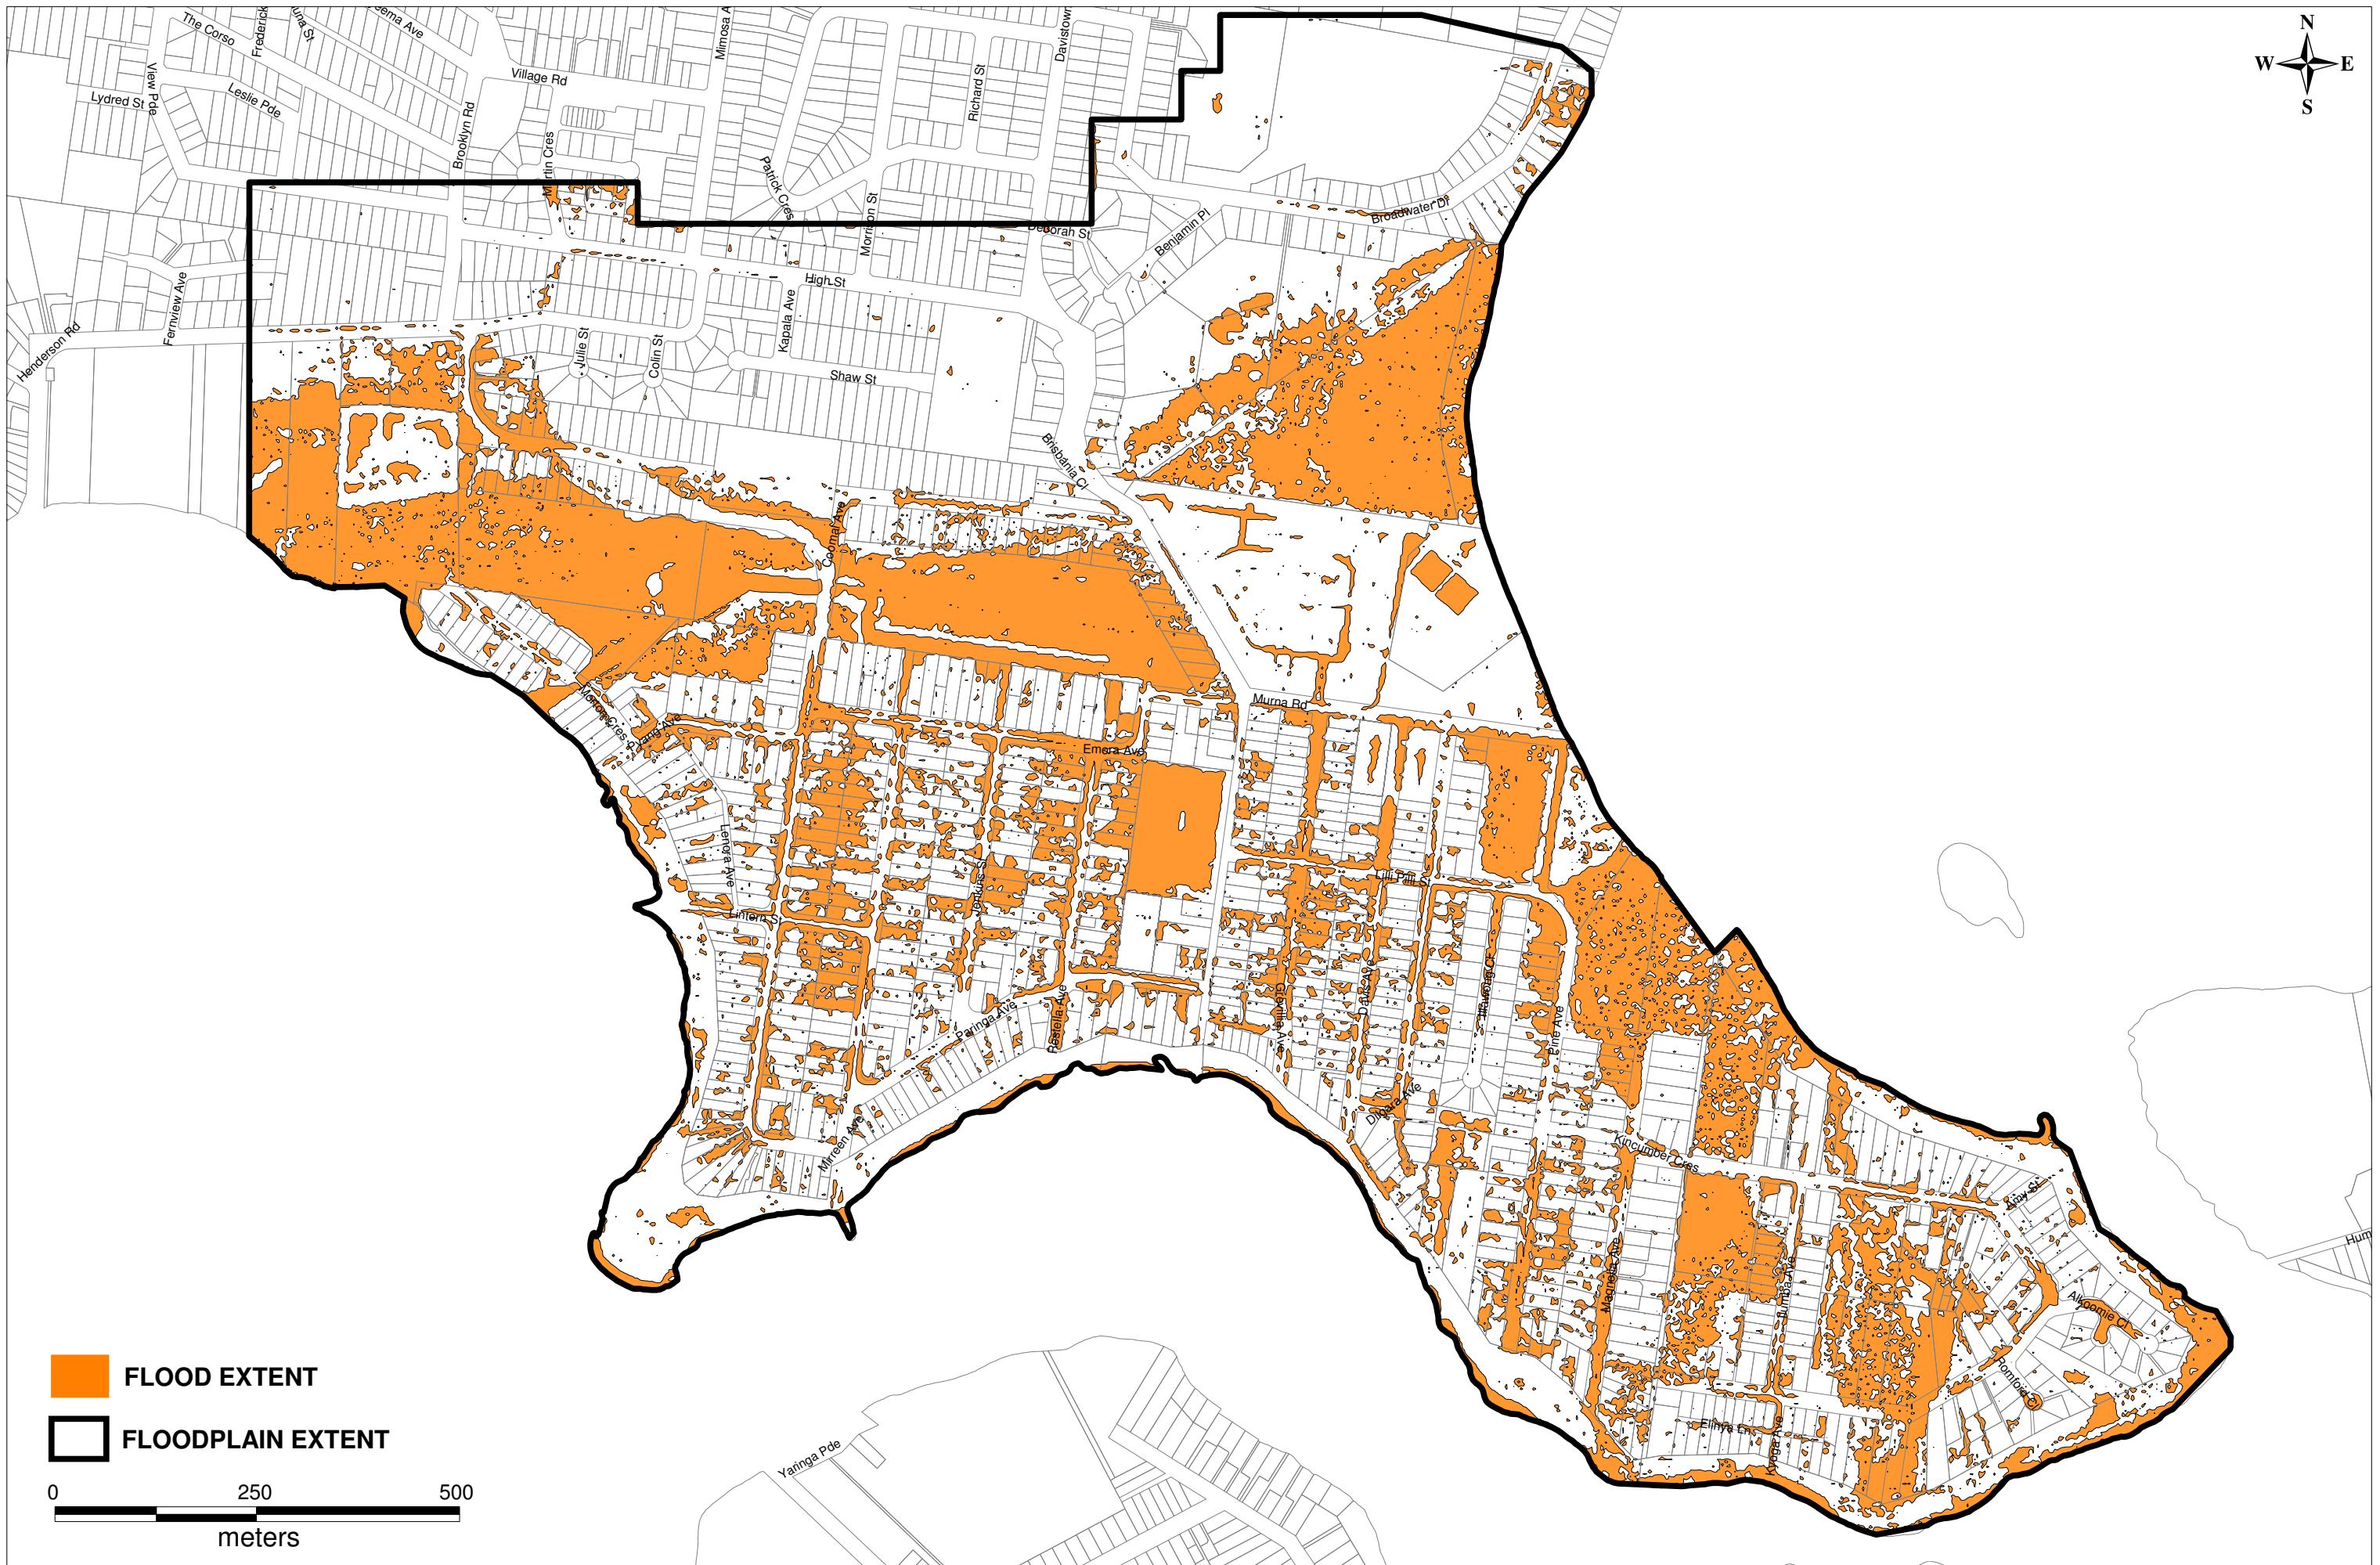
FIGURE 6.6  
FLOOD EXTENT - 0.5% AEP

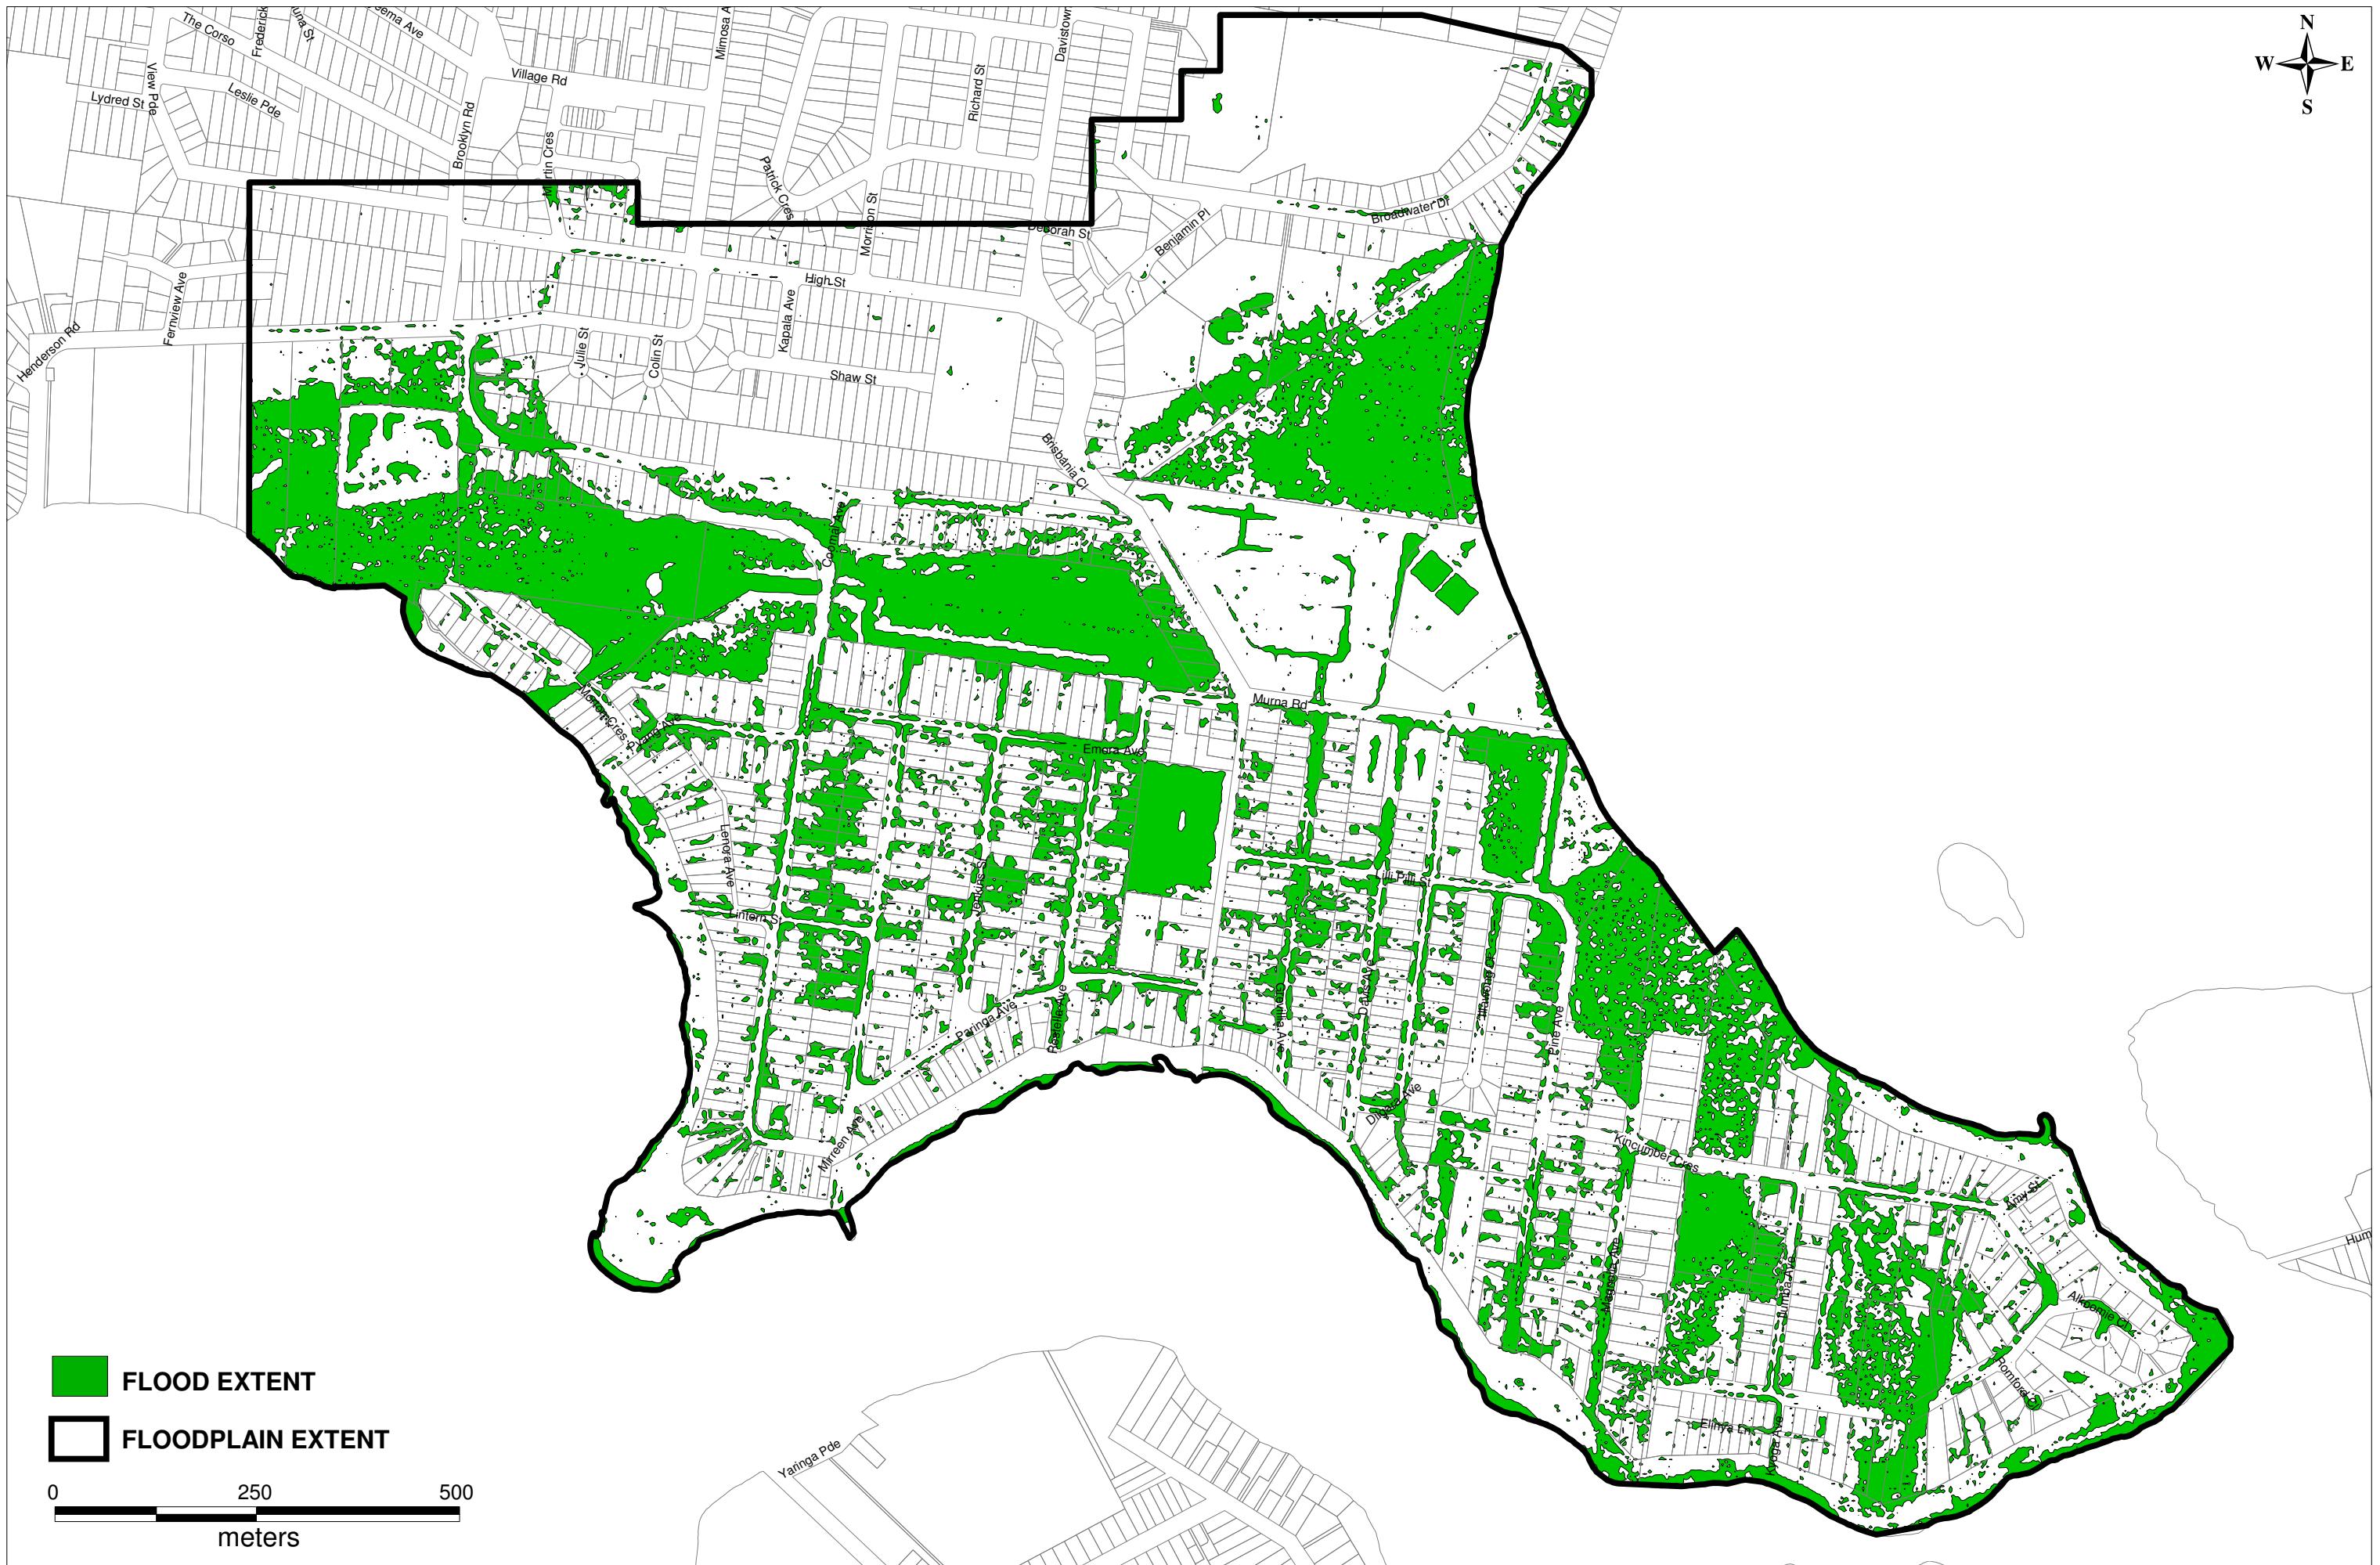
FIGURE 6.7  
FLOOD EXTENT - 1% AEP
