## DAVISTOWN CATCHMENT FLOOD STUDY VOLUME 2 - FIGURES

Davistown Catchment Flood Study

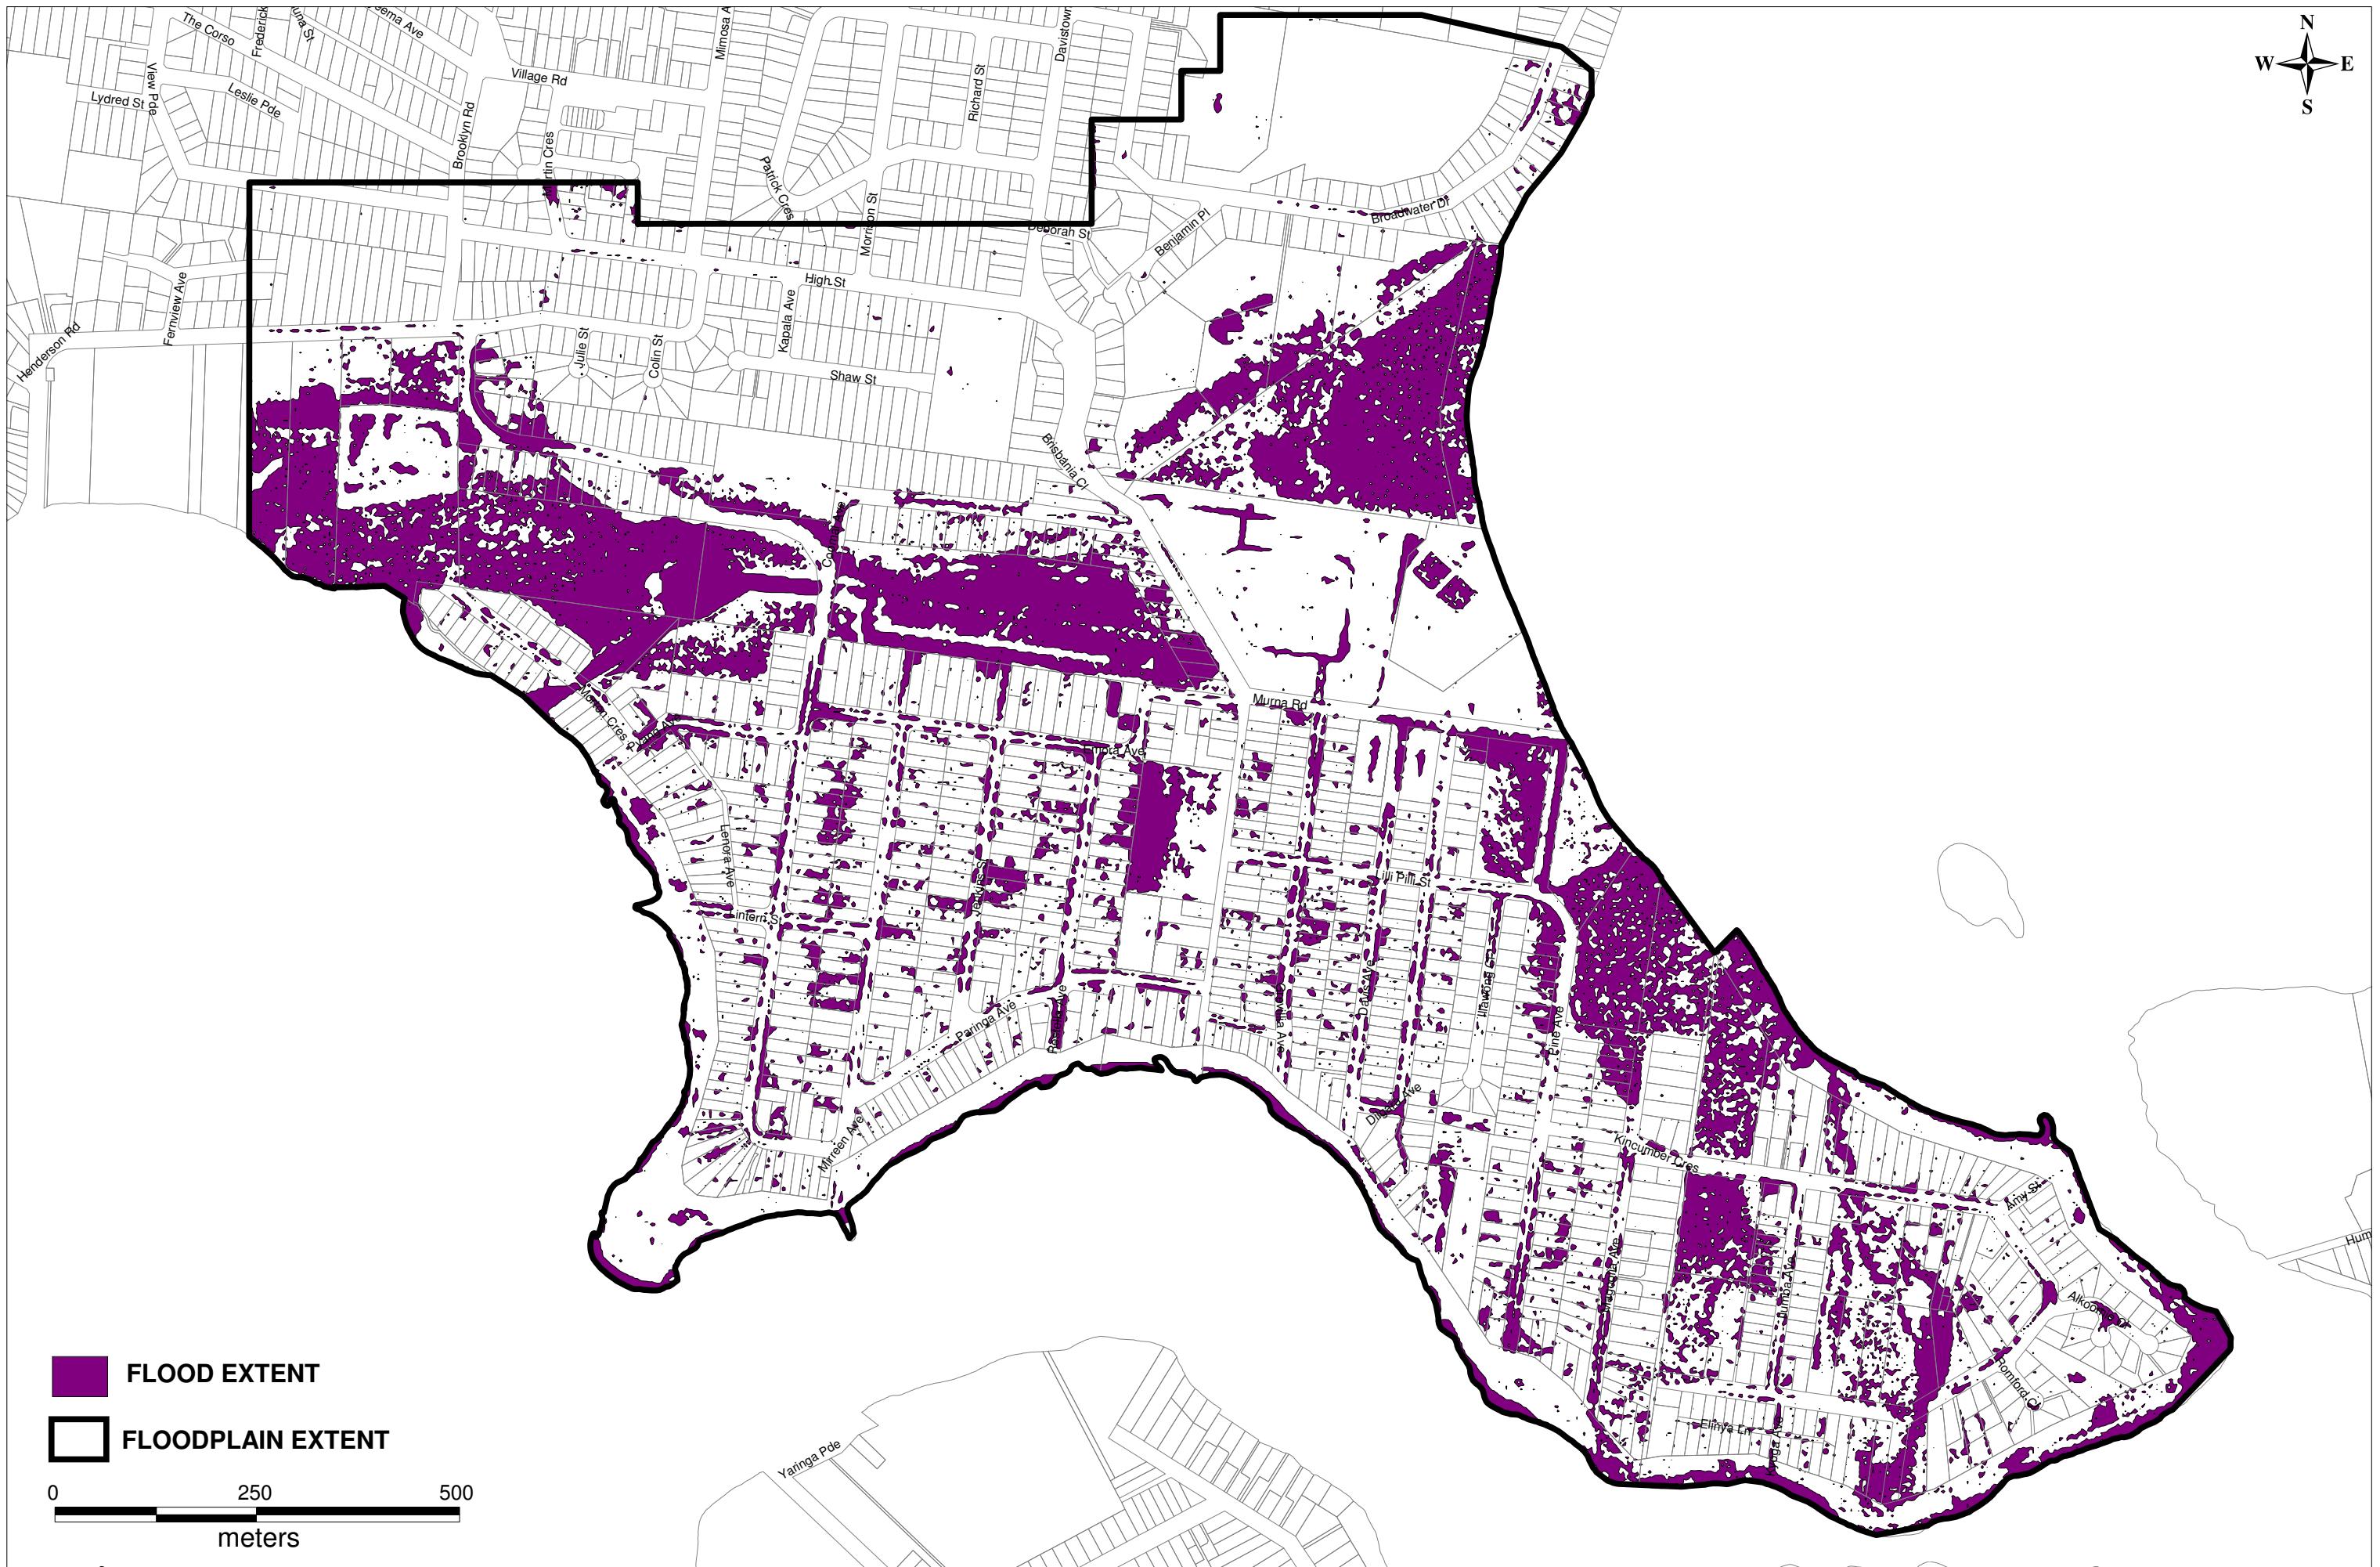
FIGURE 6.10  
FLOOD EXTENT - 10% AEP

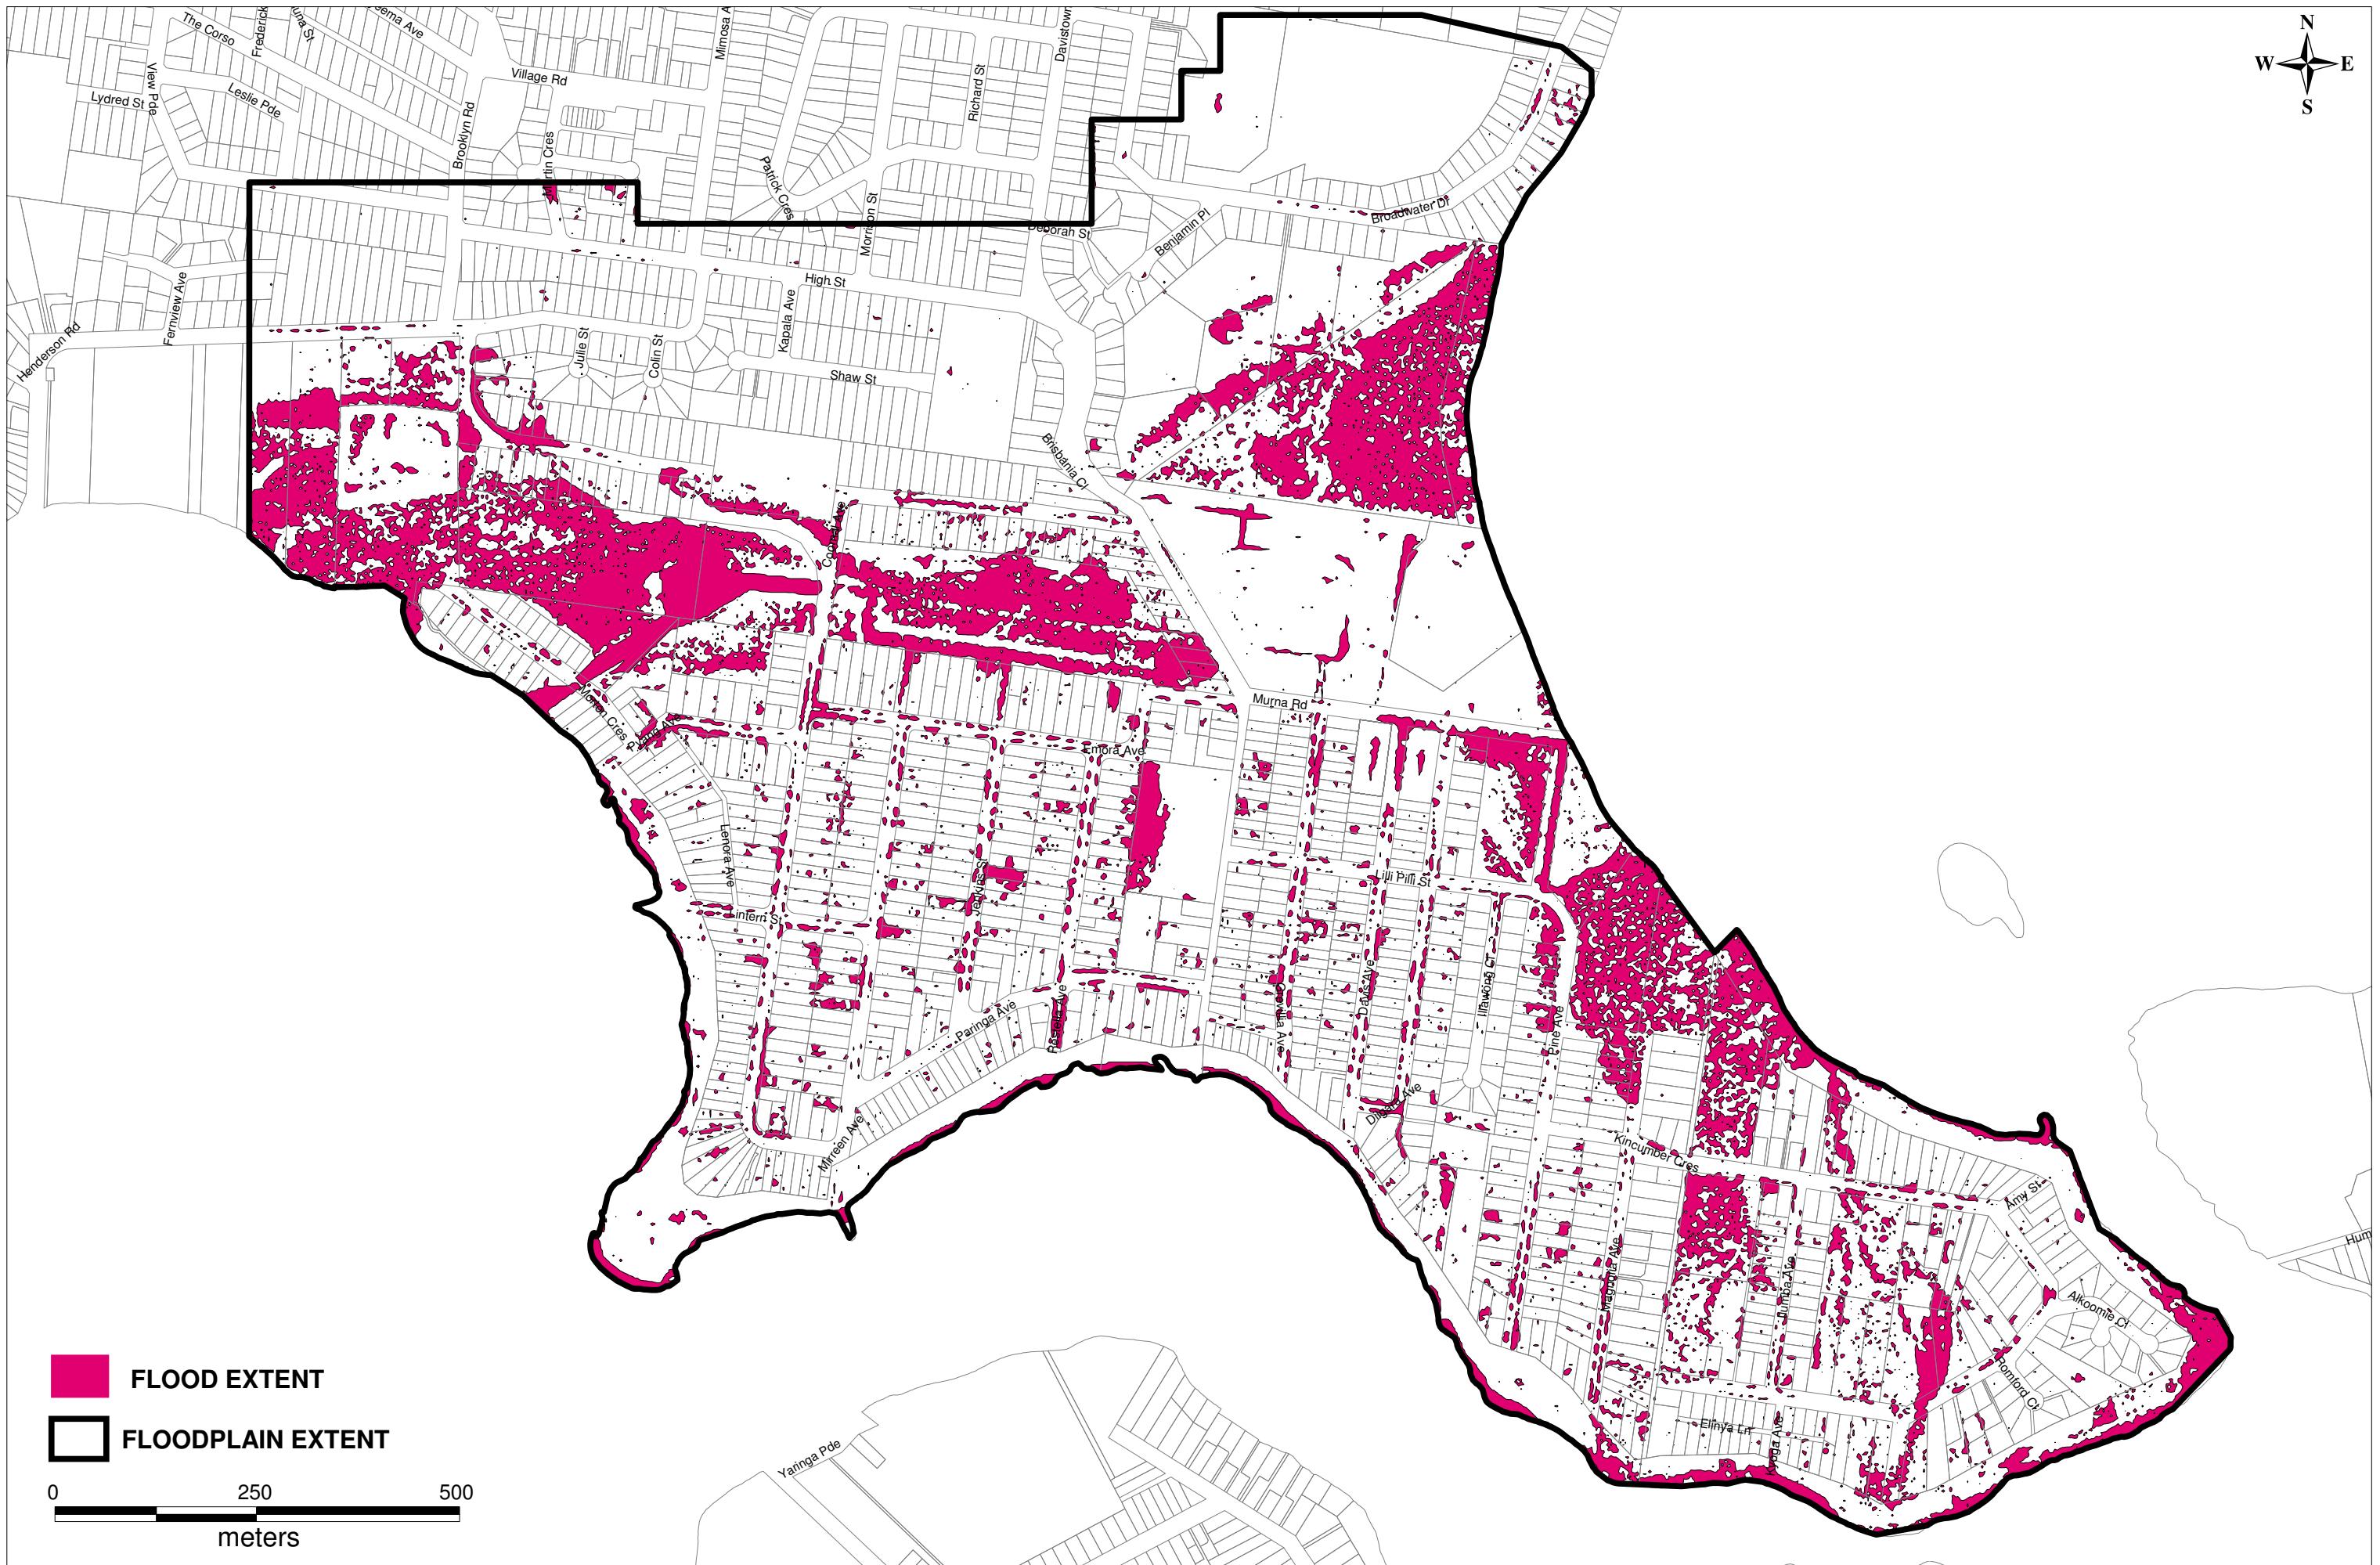
FIGURE 6.12  
FLOOD EXTENT - 50% AEP

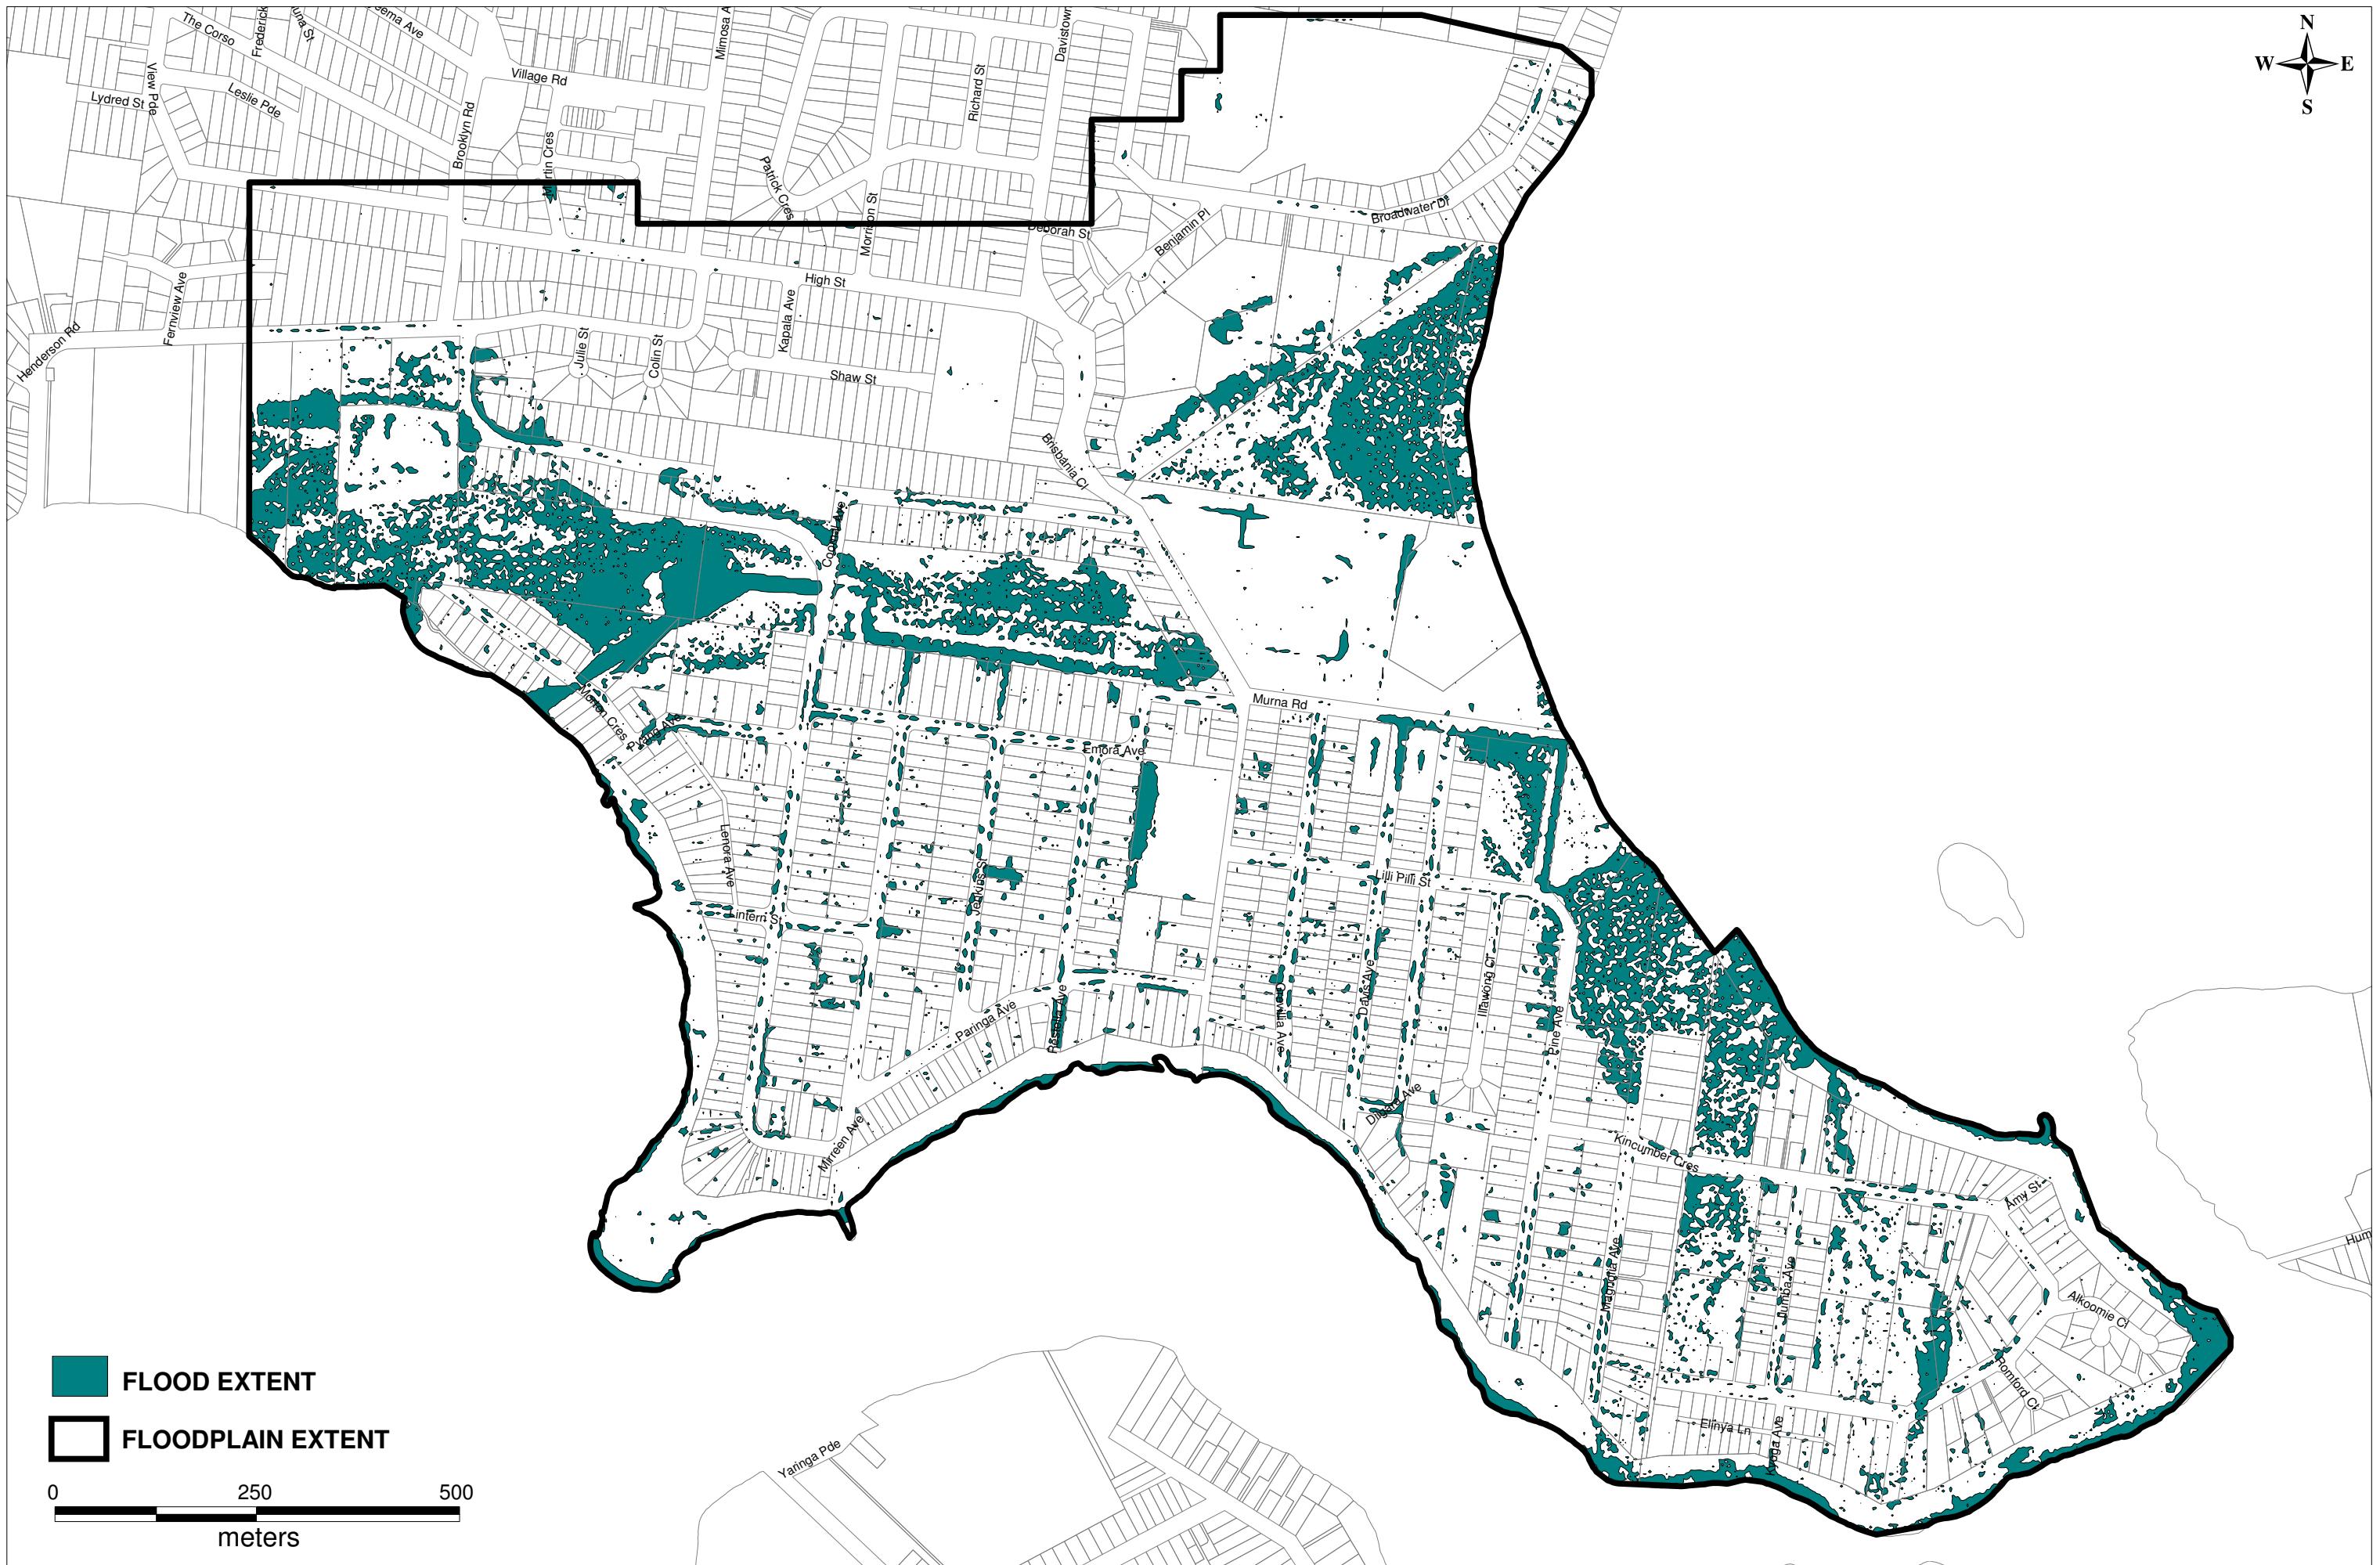
FIGURE 6.13  
FLOOD EXTENT - 100% AEP

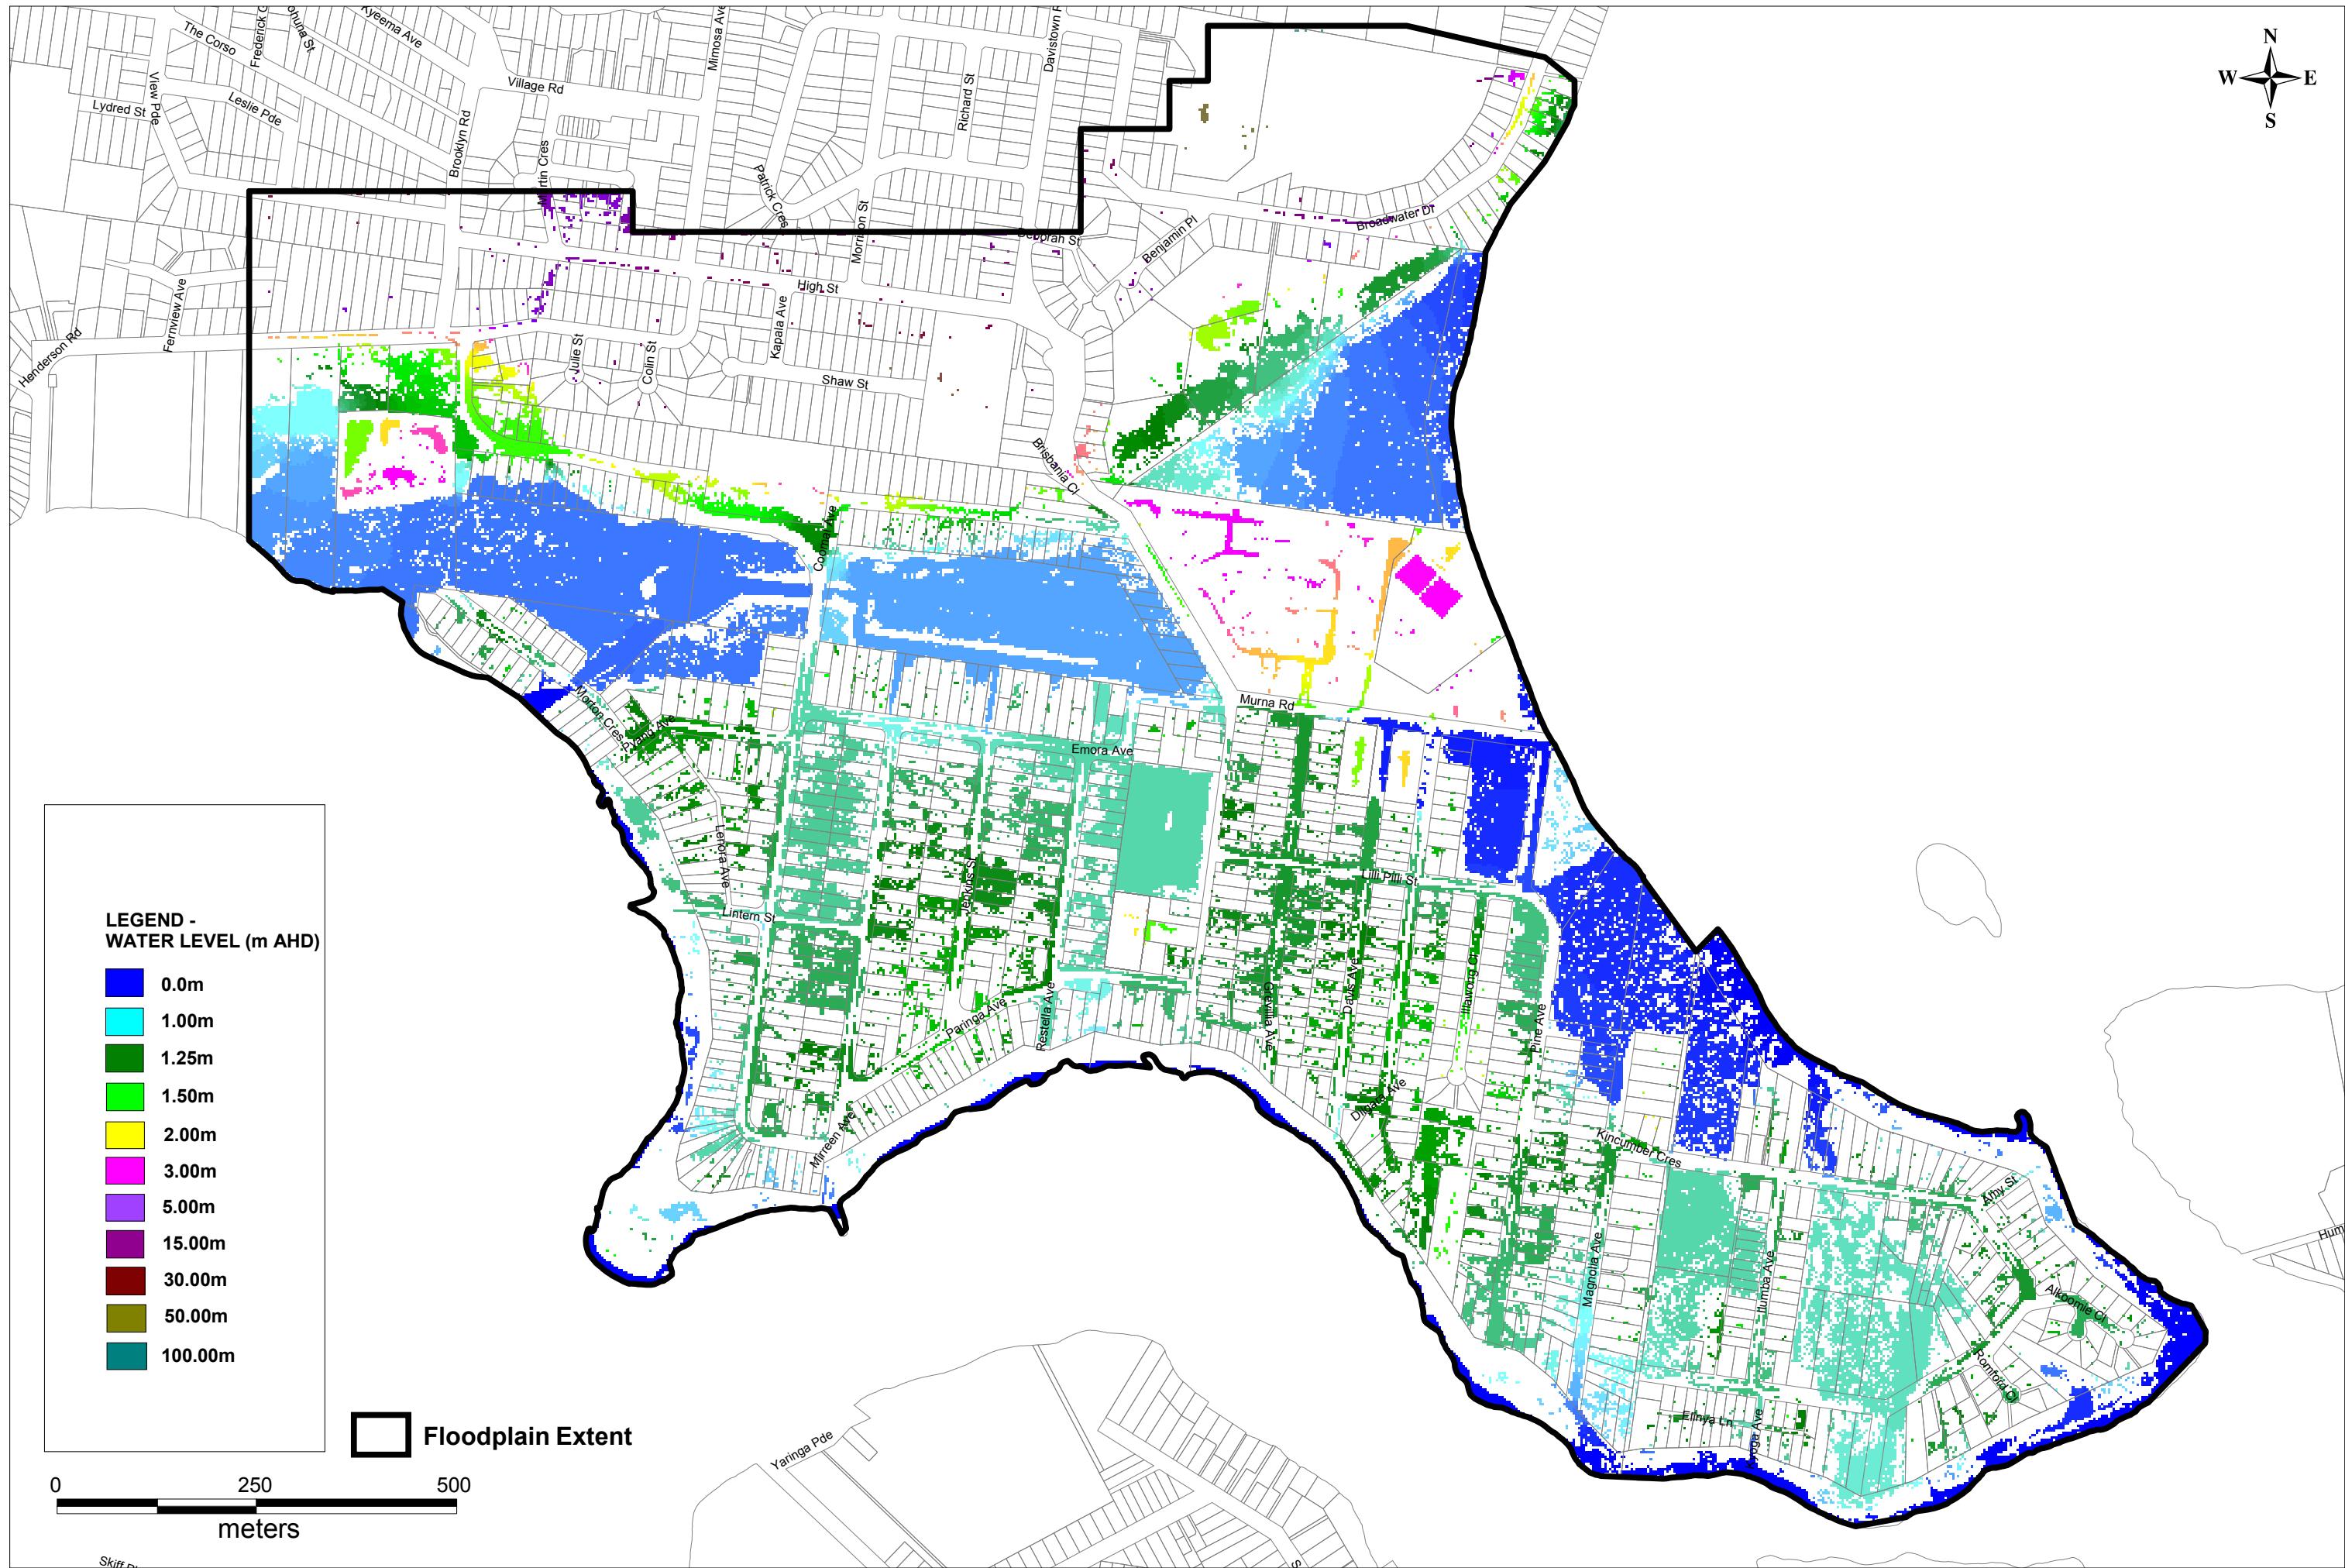
FIGURE 6.15  
PEAK WATER LEVEL - 0.5% AEP

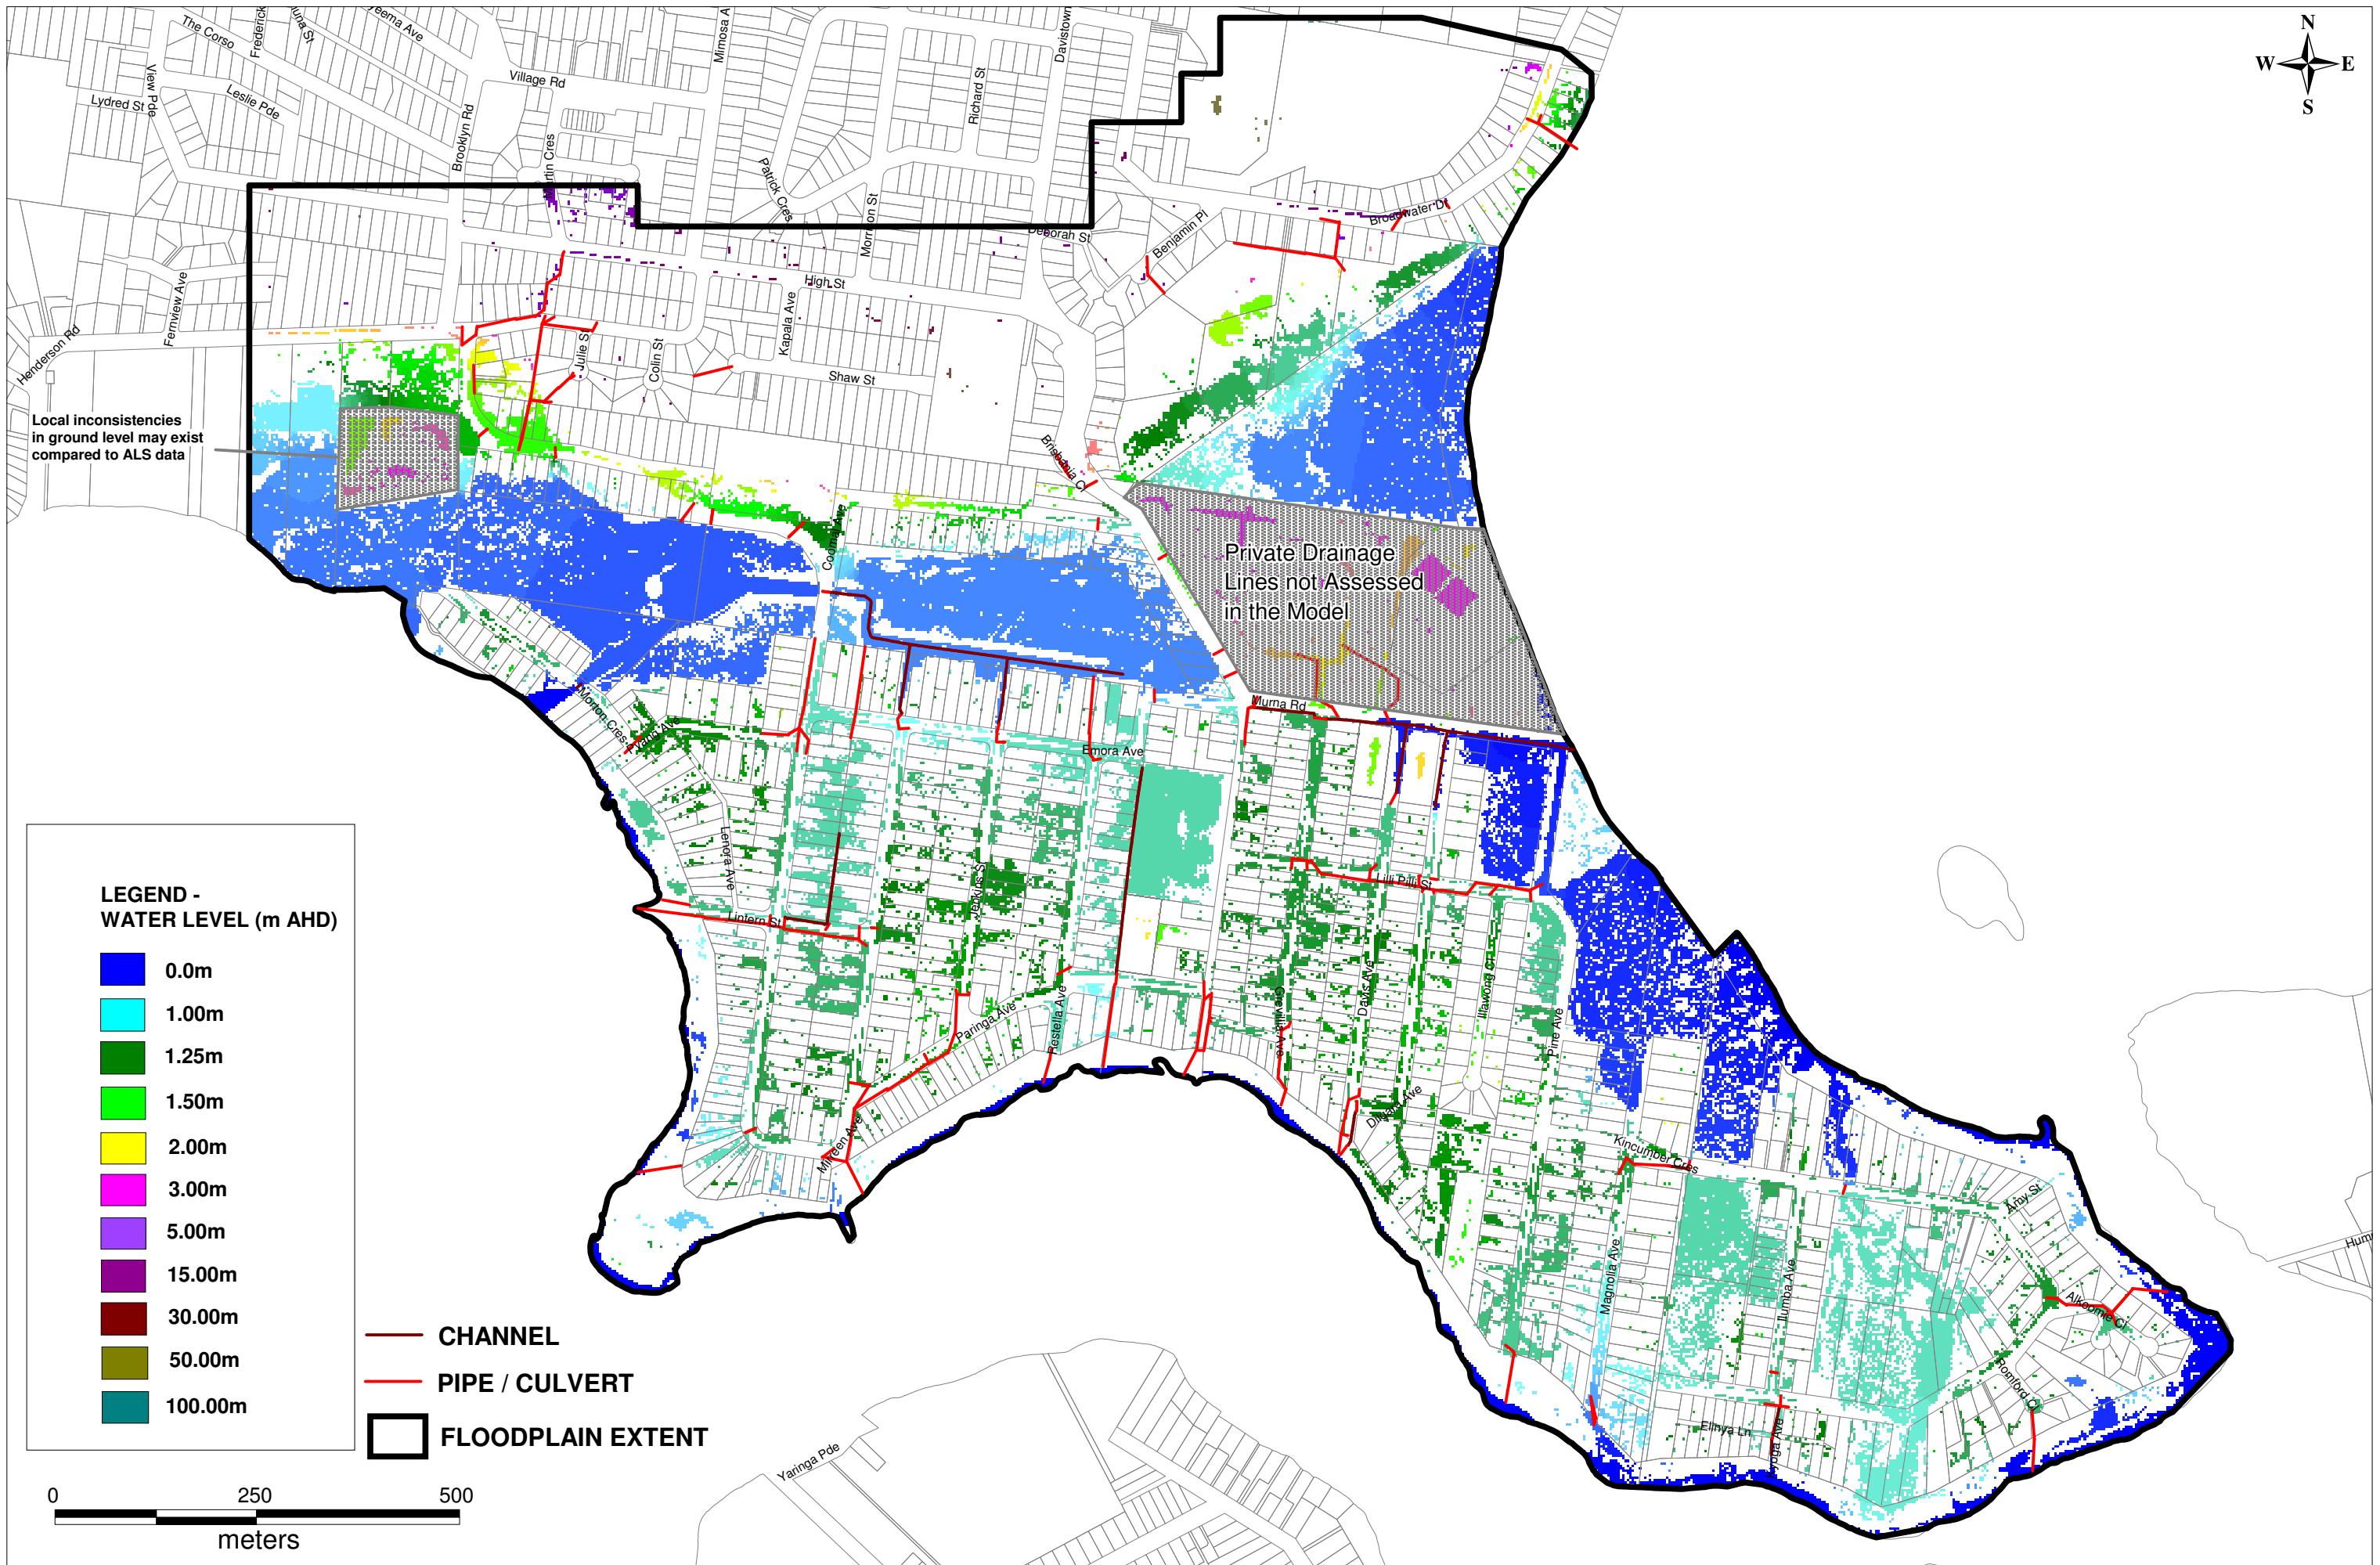
FIGURE 6.16  
PEAK WATER LEVEL - 1% AEP

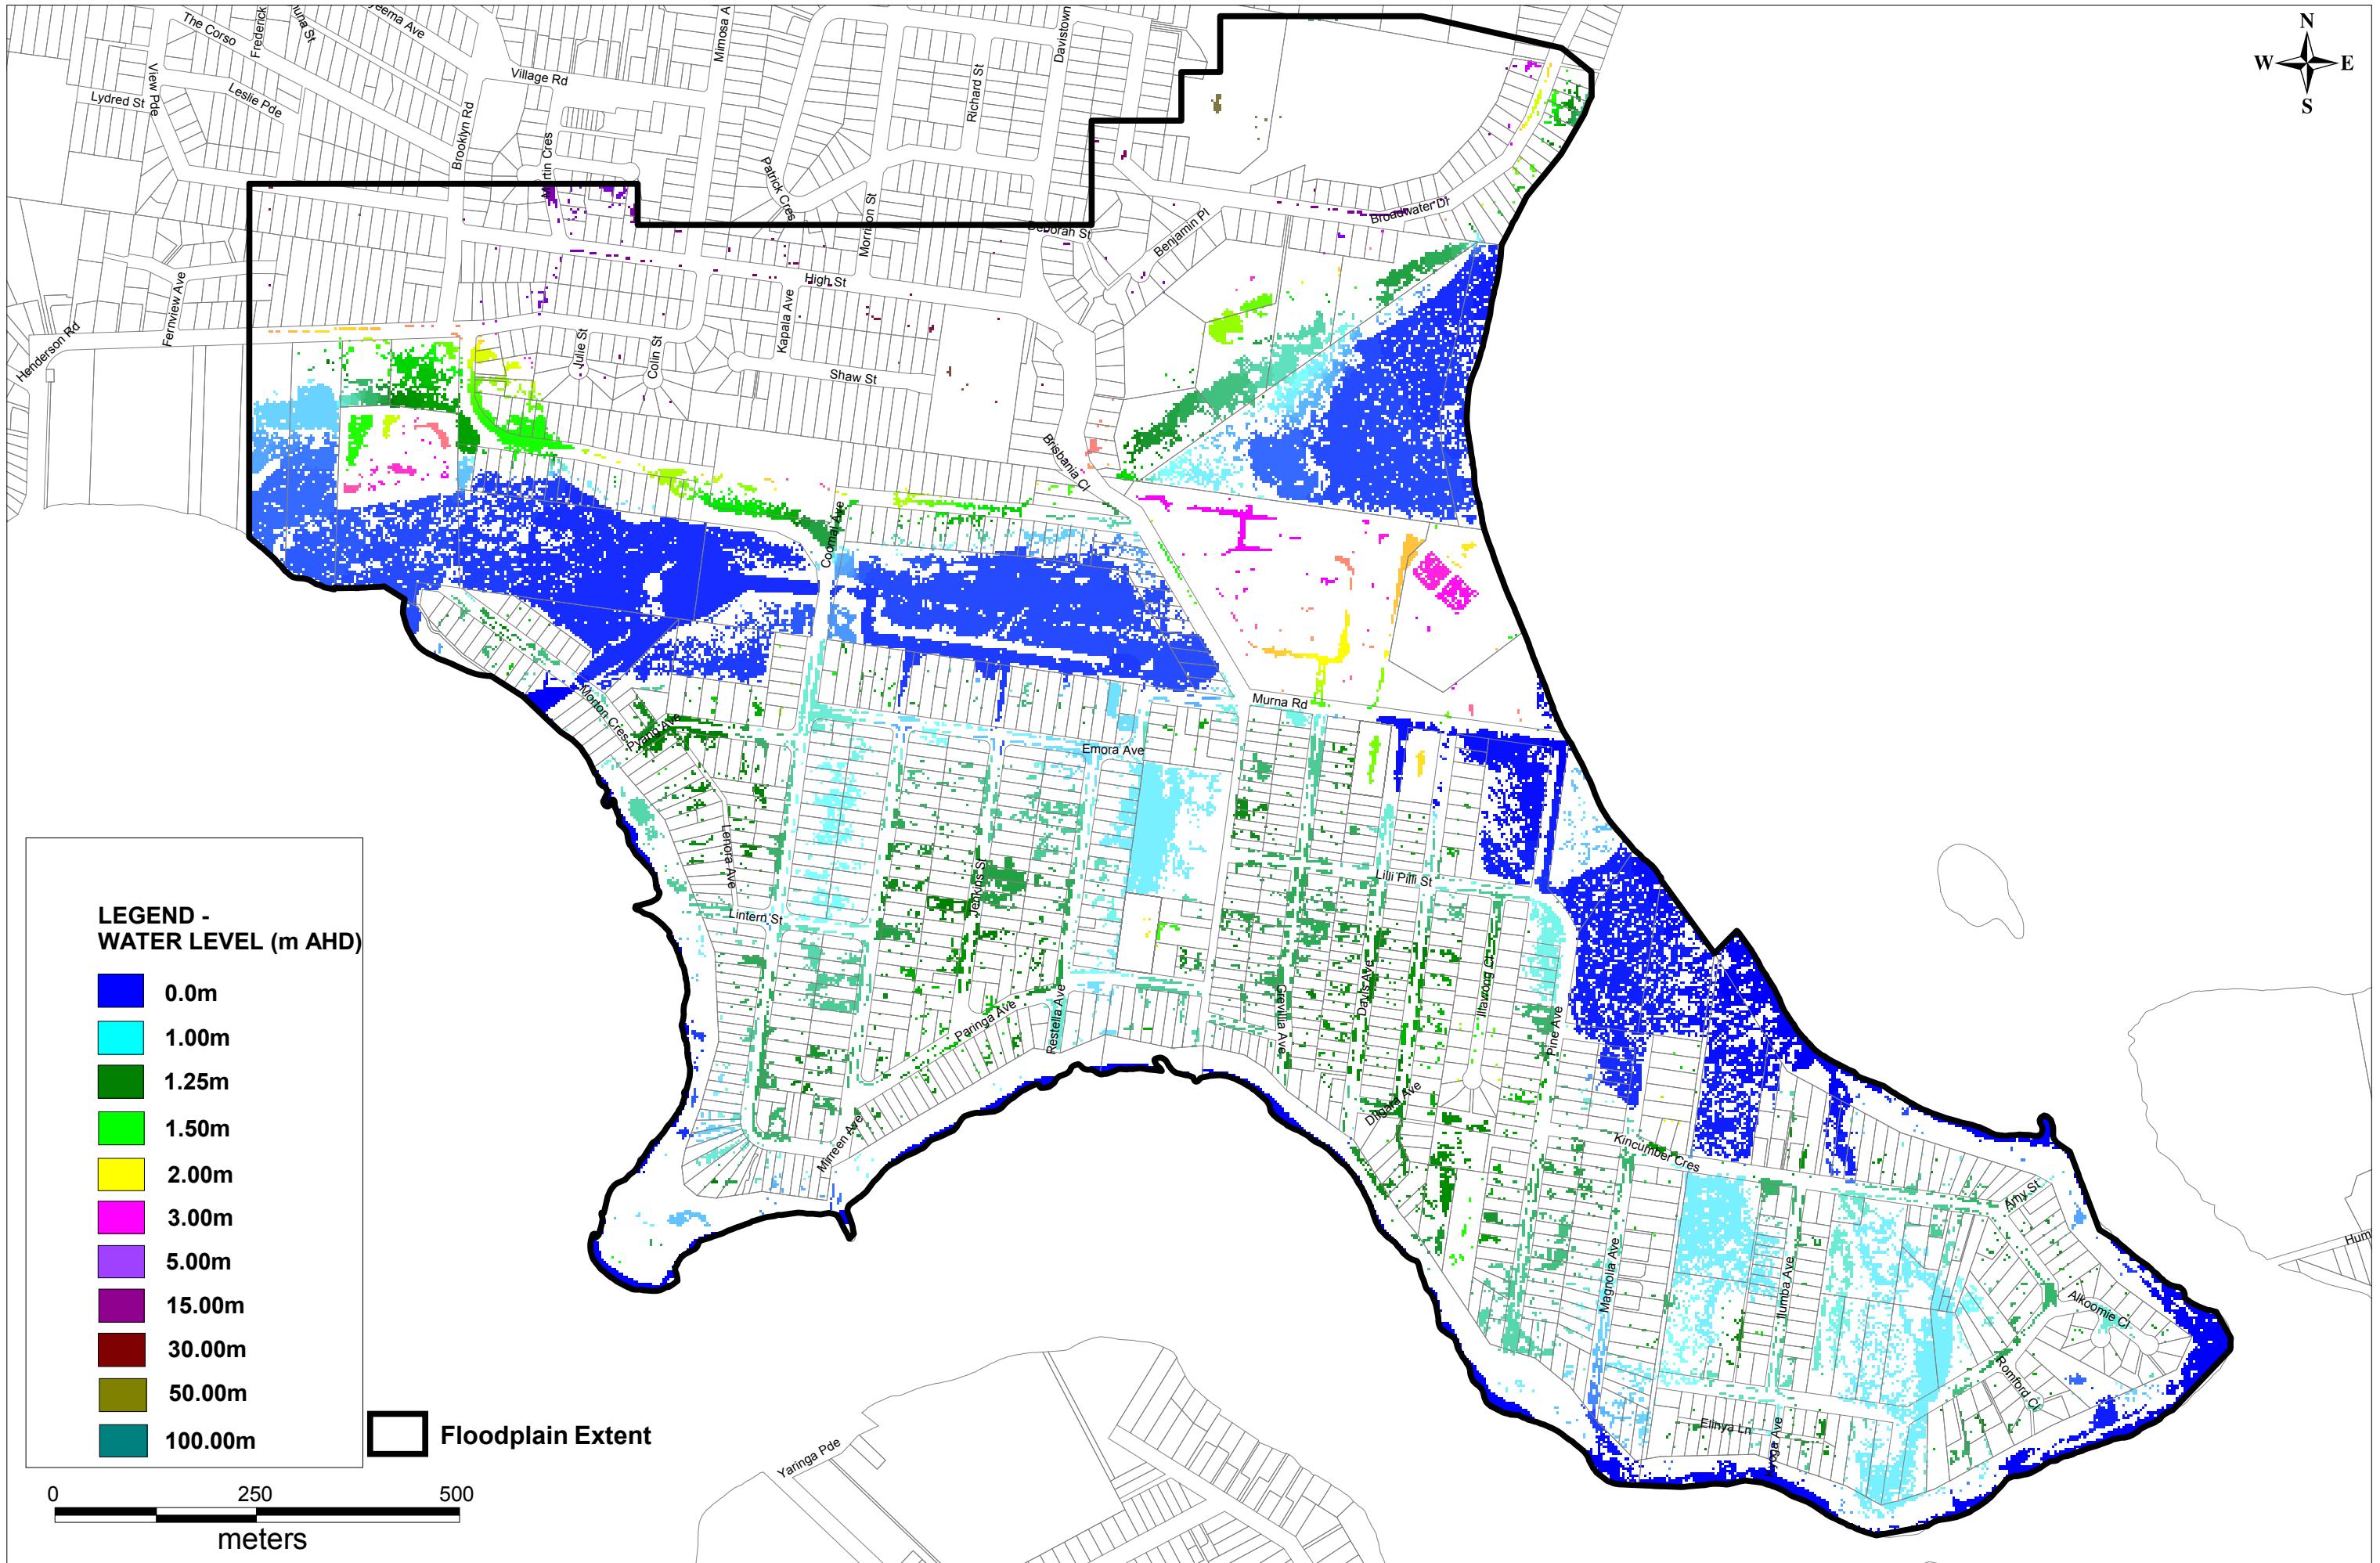
FIGURE 6.19

PEAK WATER LEVEL - 10% AEP
