## DAVISTOWN CATCHMENT FLOOD STUDY VOLUME 2 - FIGURES

Davistown Catchment Flood Study

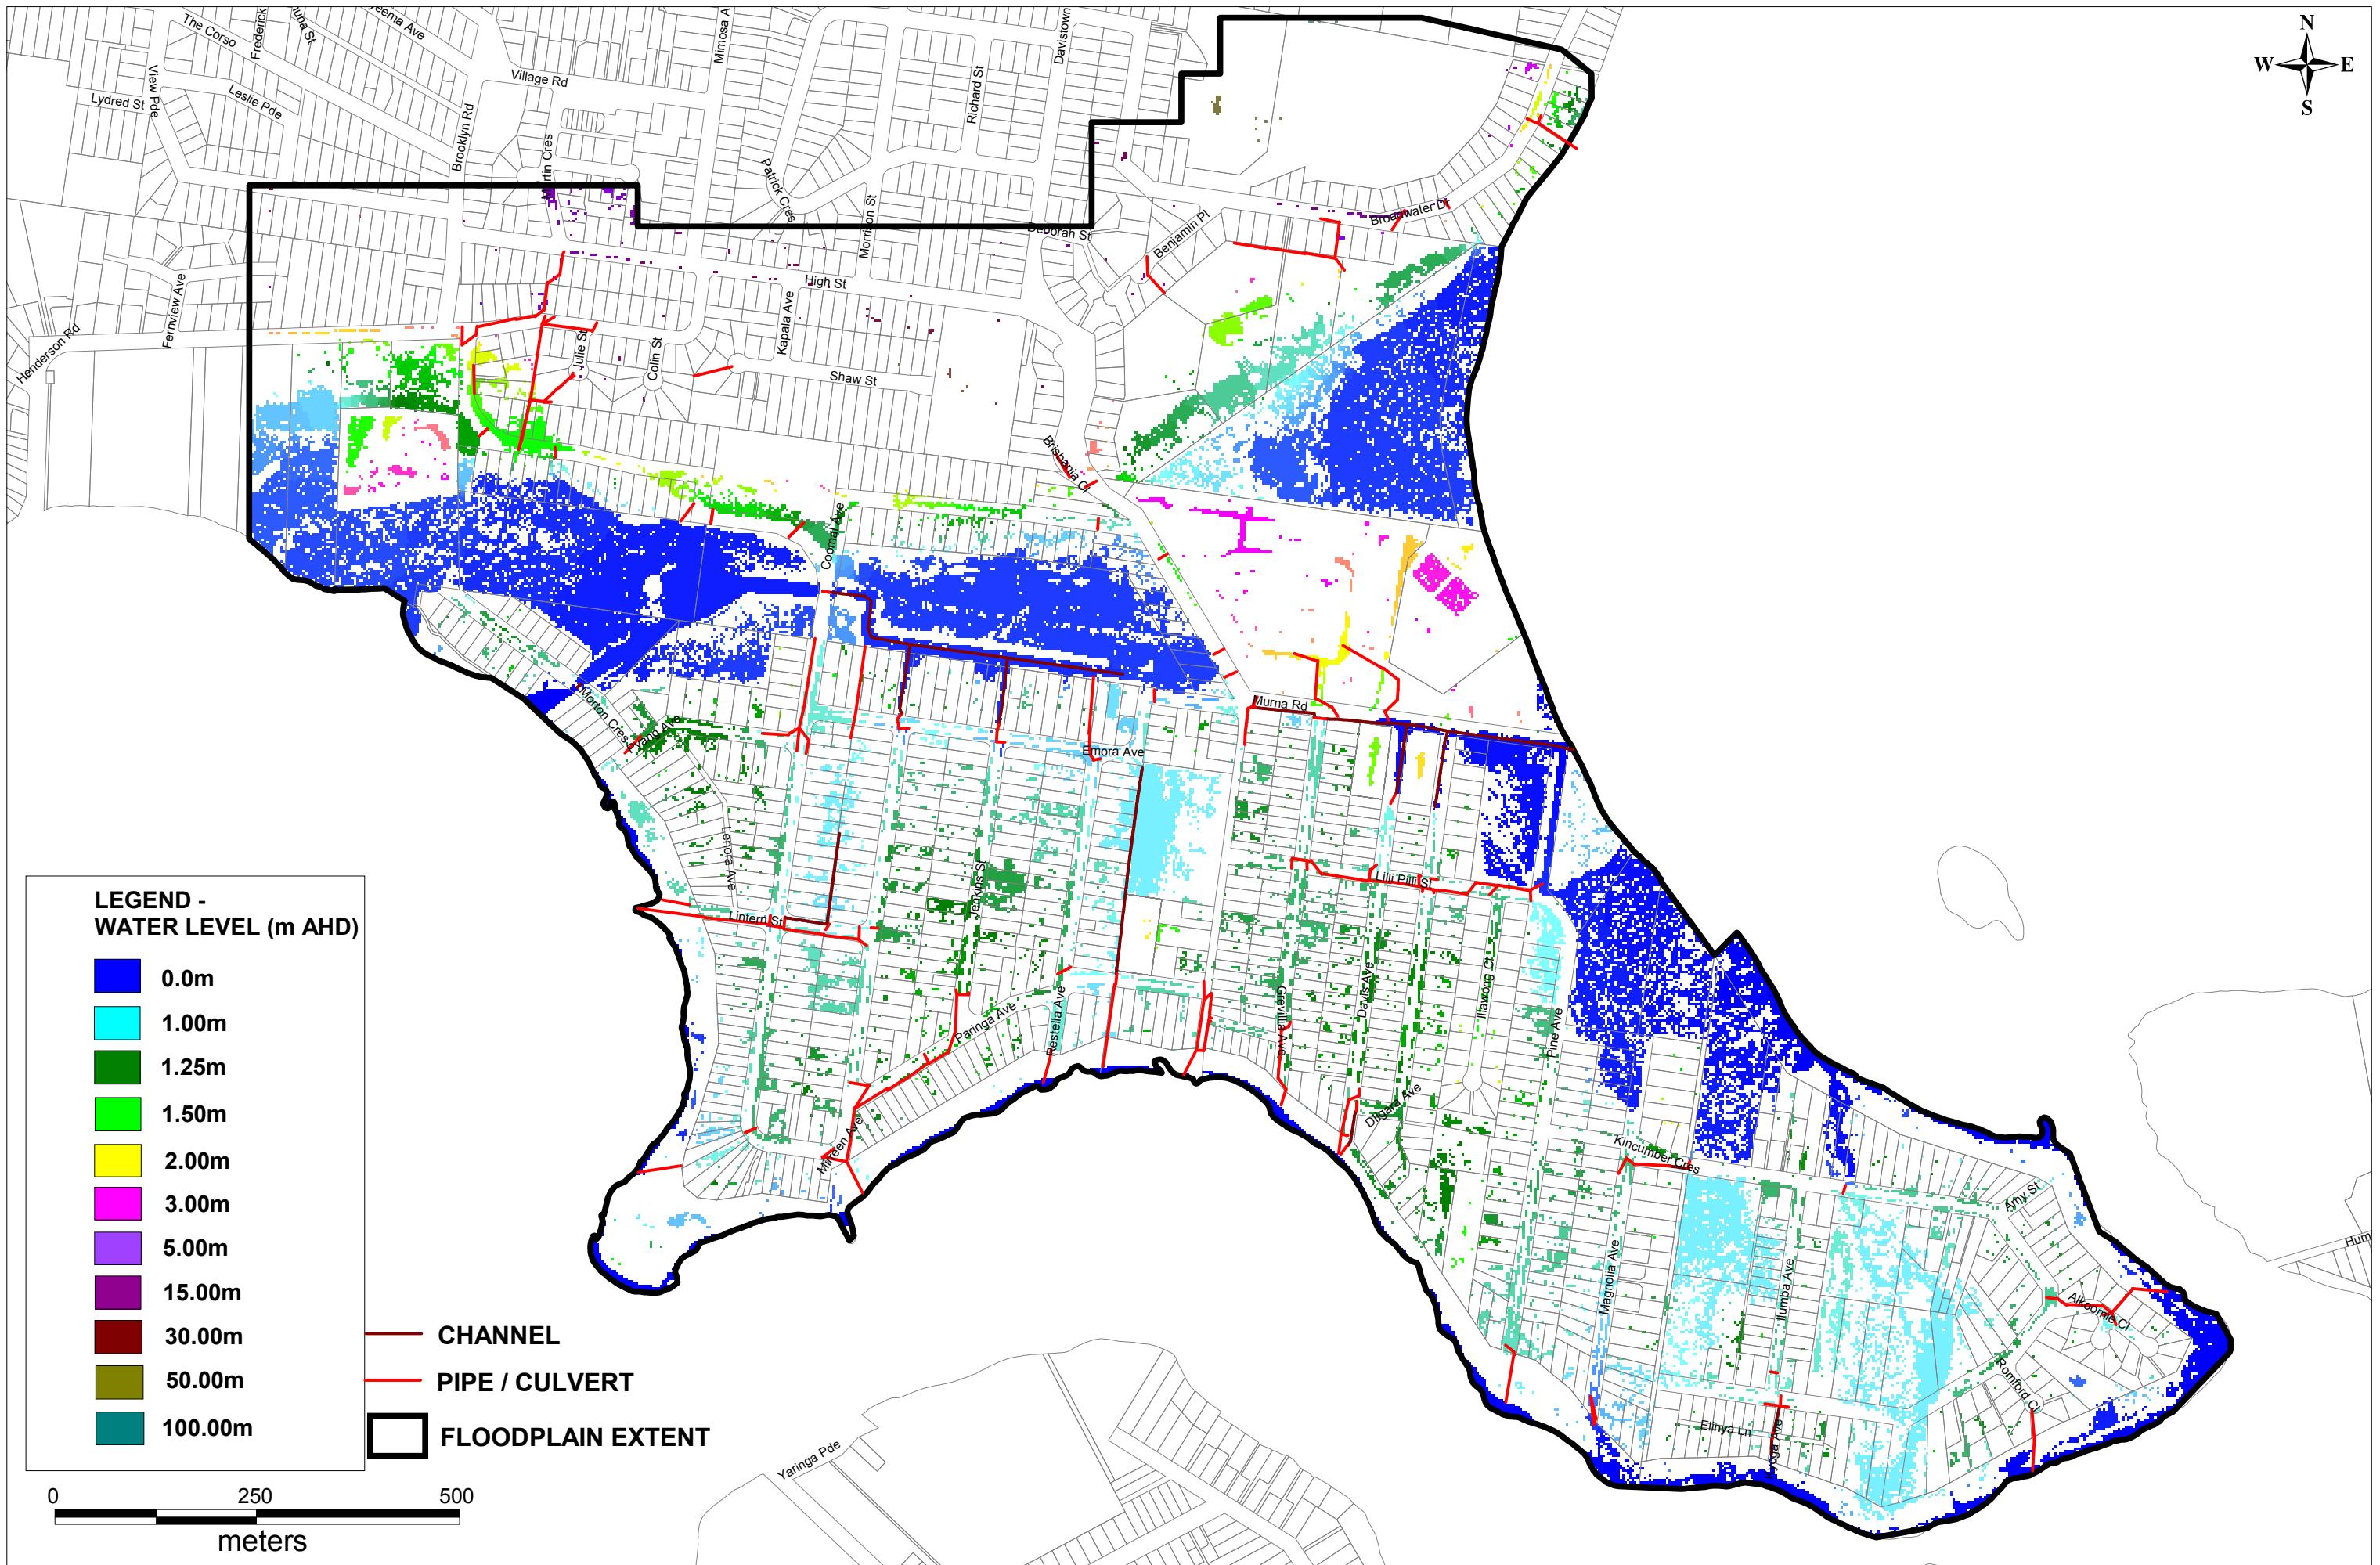
**FIGURE 6.20**  
PEAK WATER LEVEL - 20% AEP

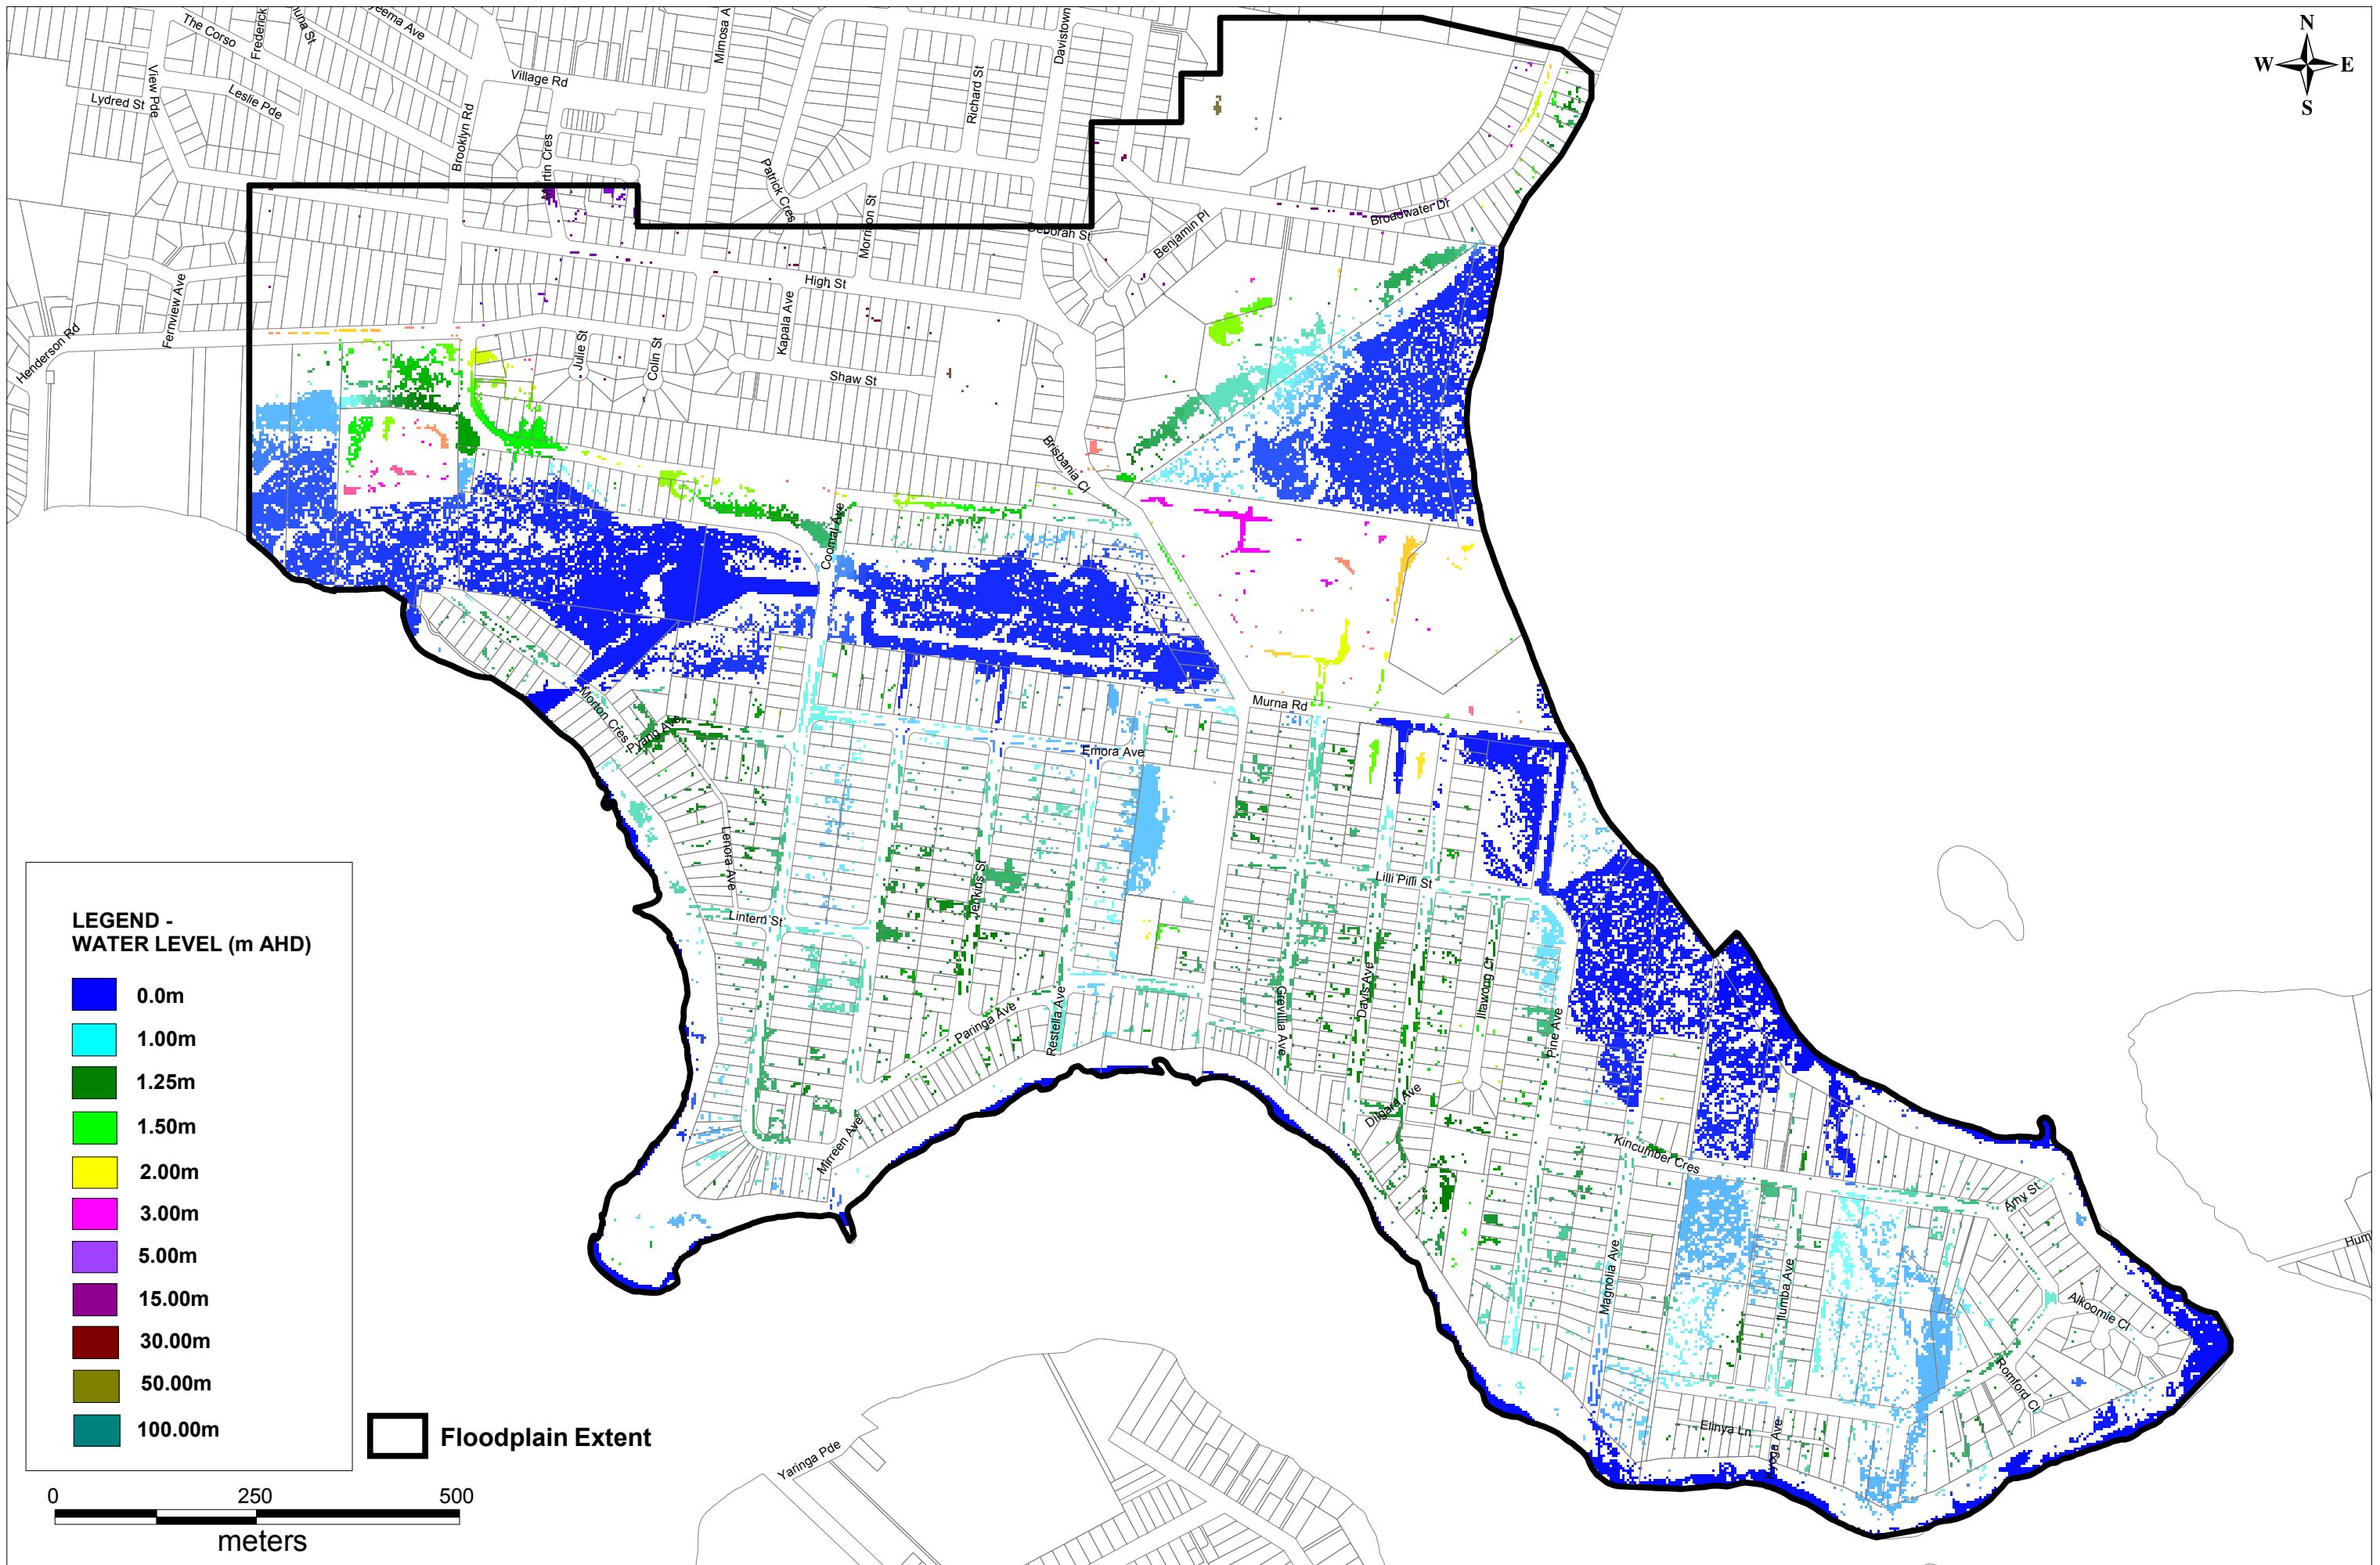
FIGURE 6.21  
PEAK WATER LEVEL - 50% AEP

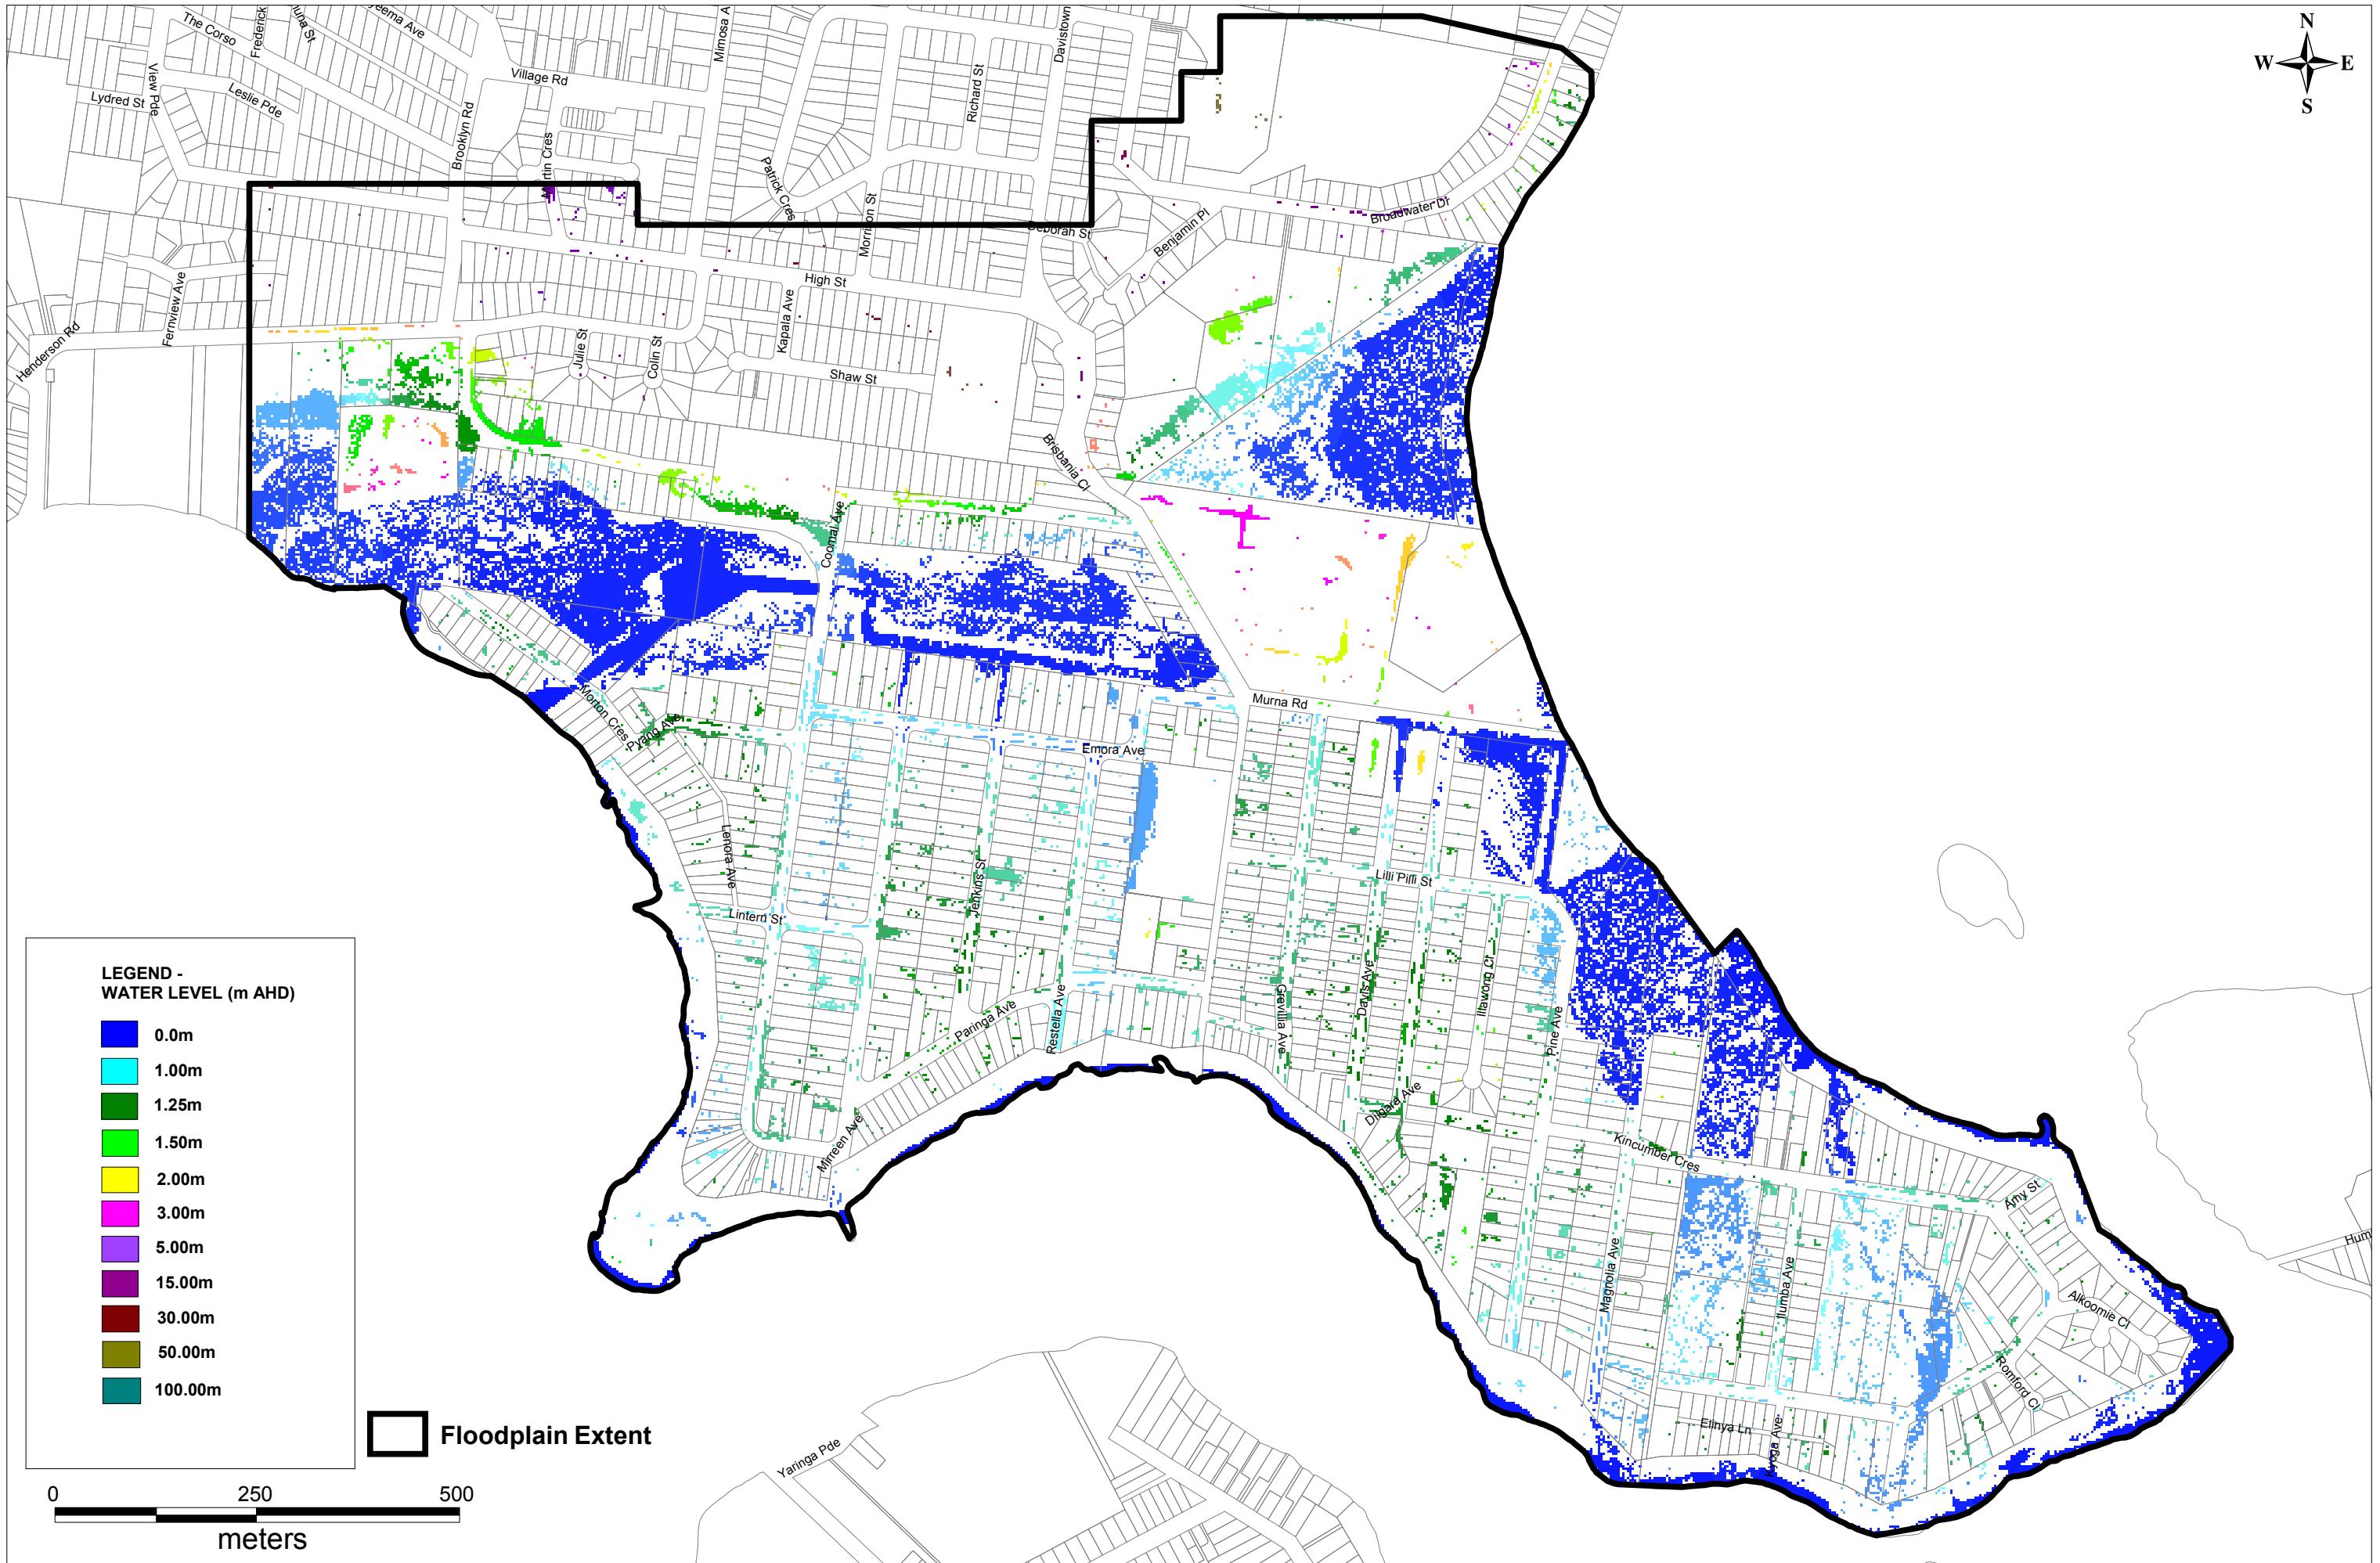
FIGURE 6.22  
PEAK WATER LEVEL - 100% AEP

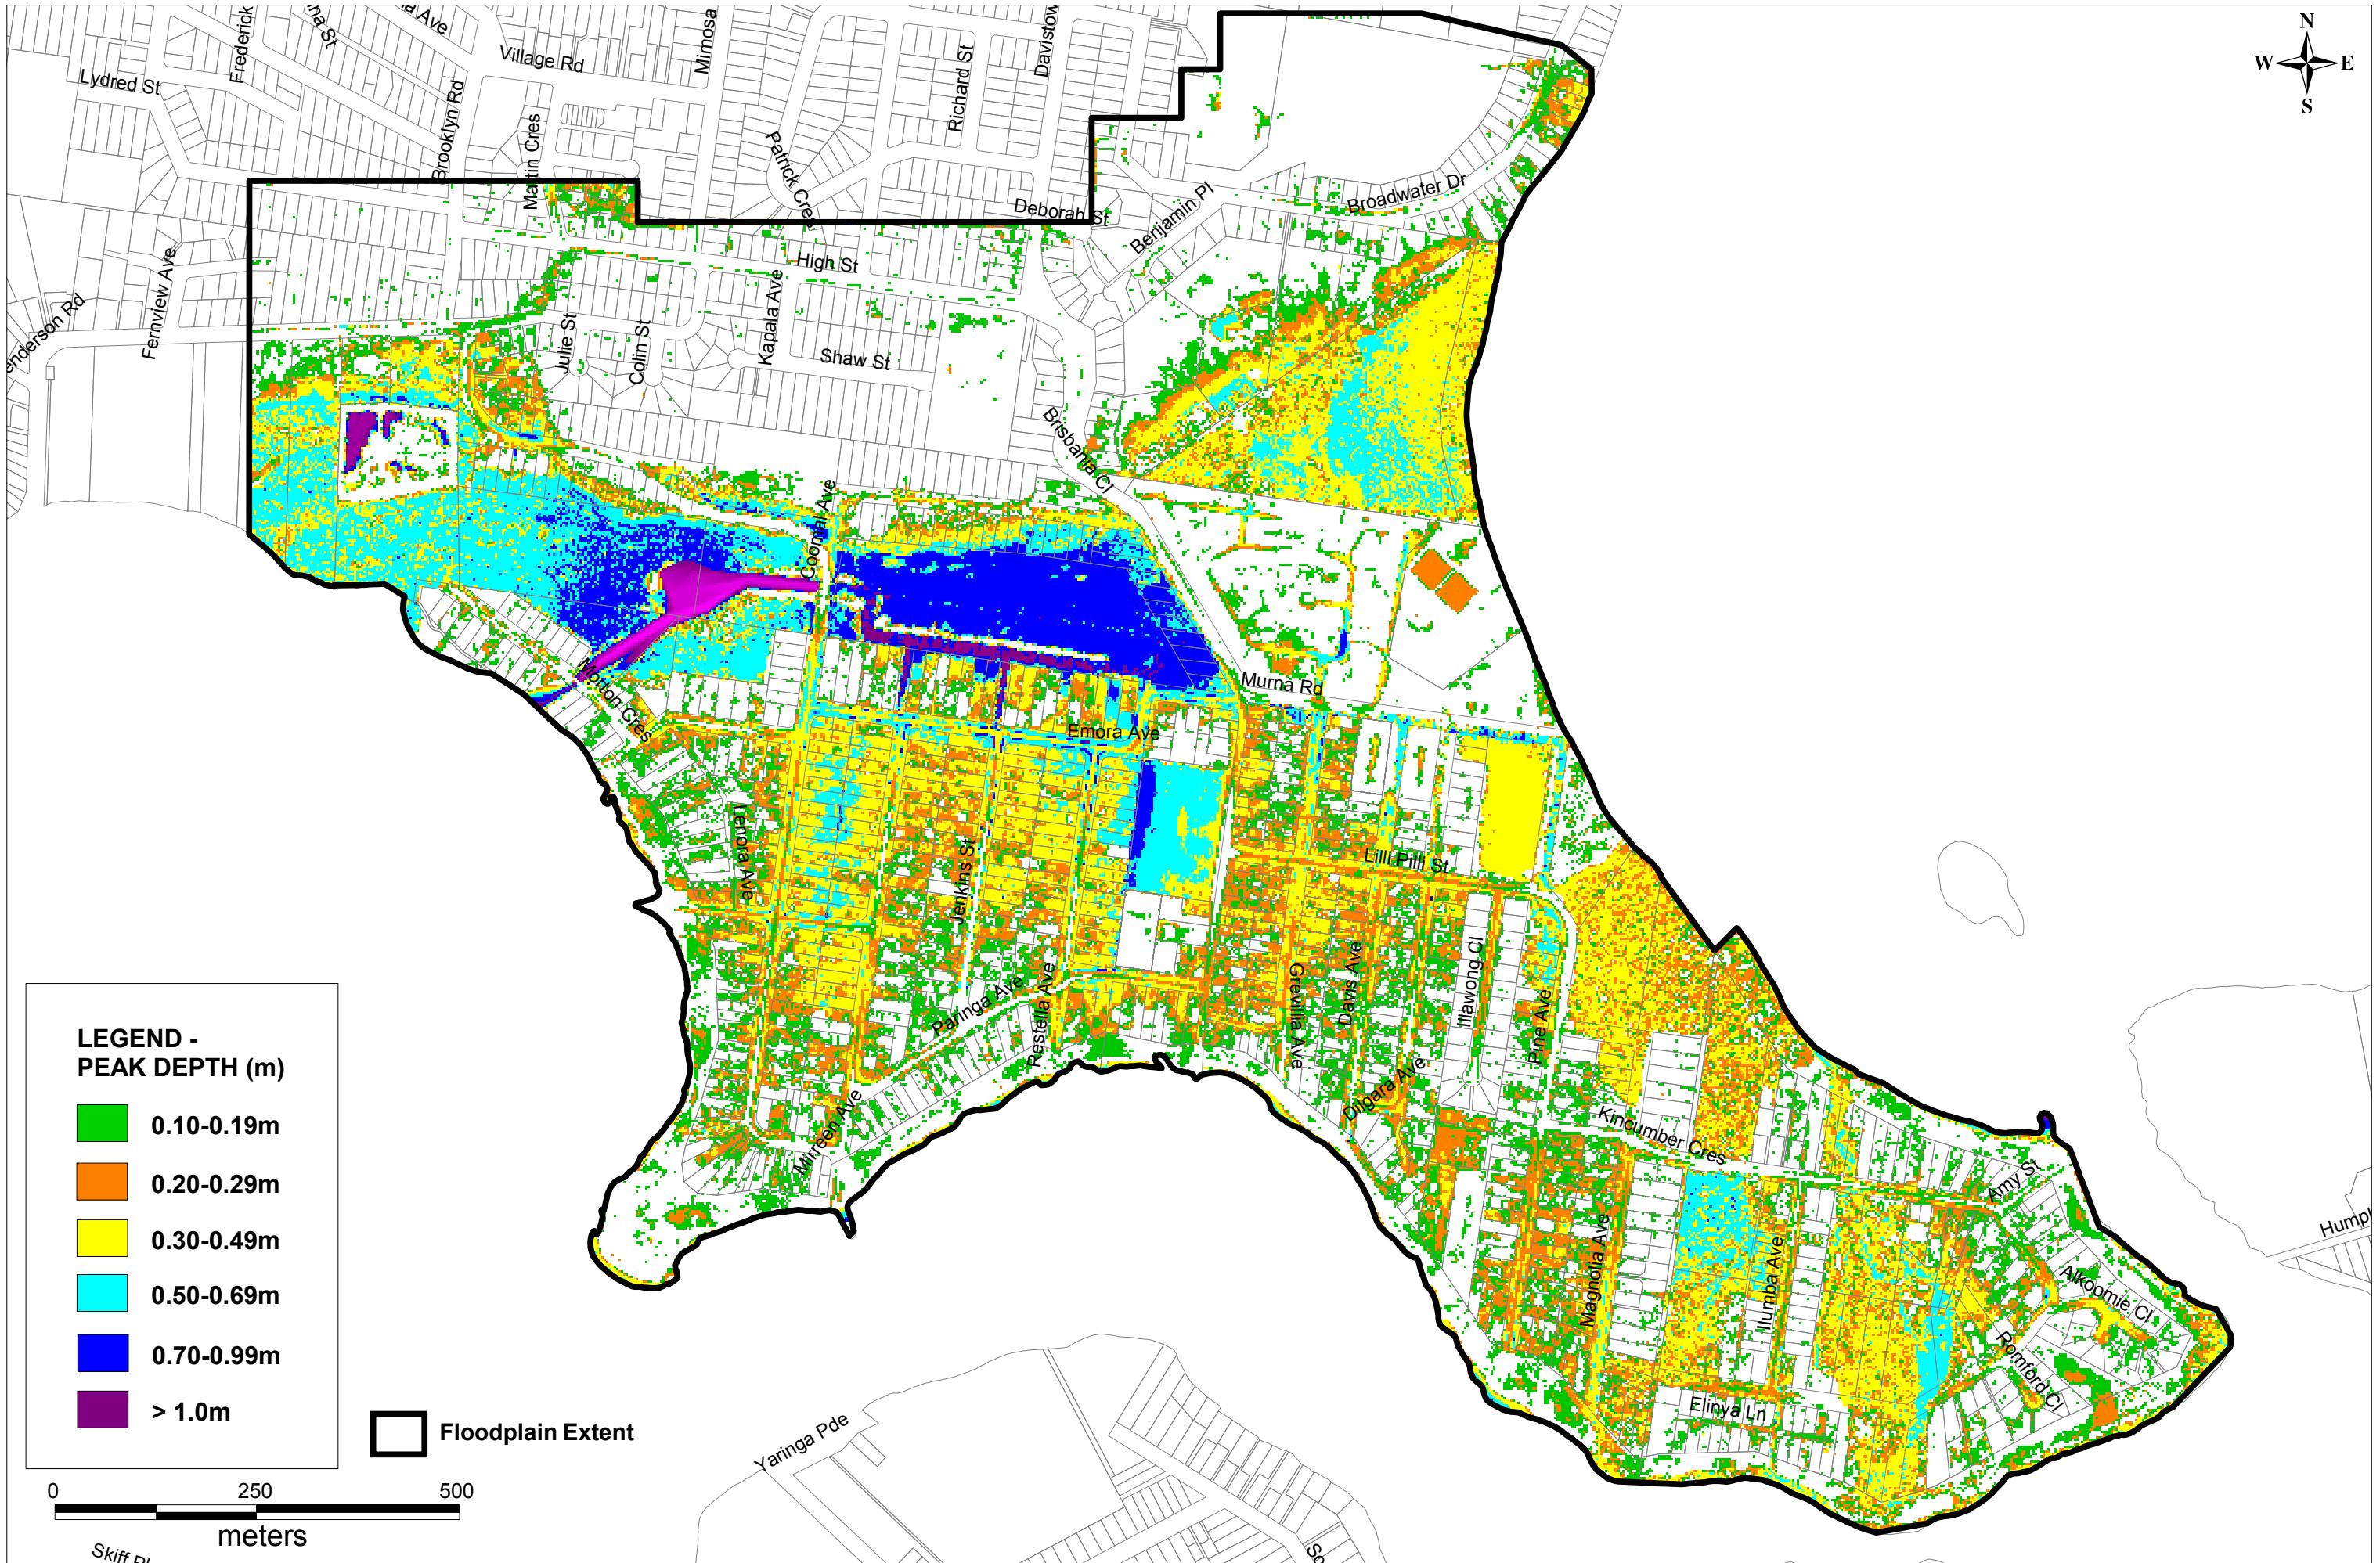
FIGURE 6.23  
PEAK DEPTH - PMF

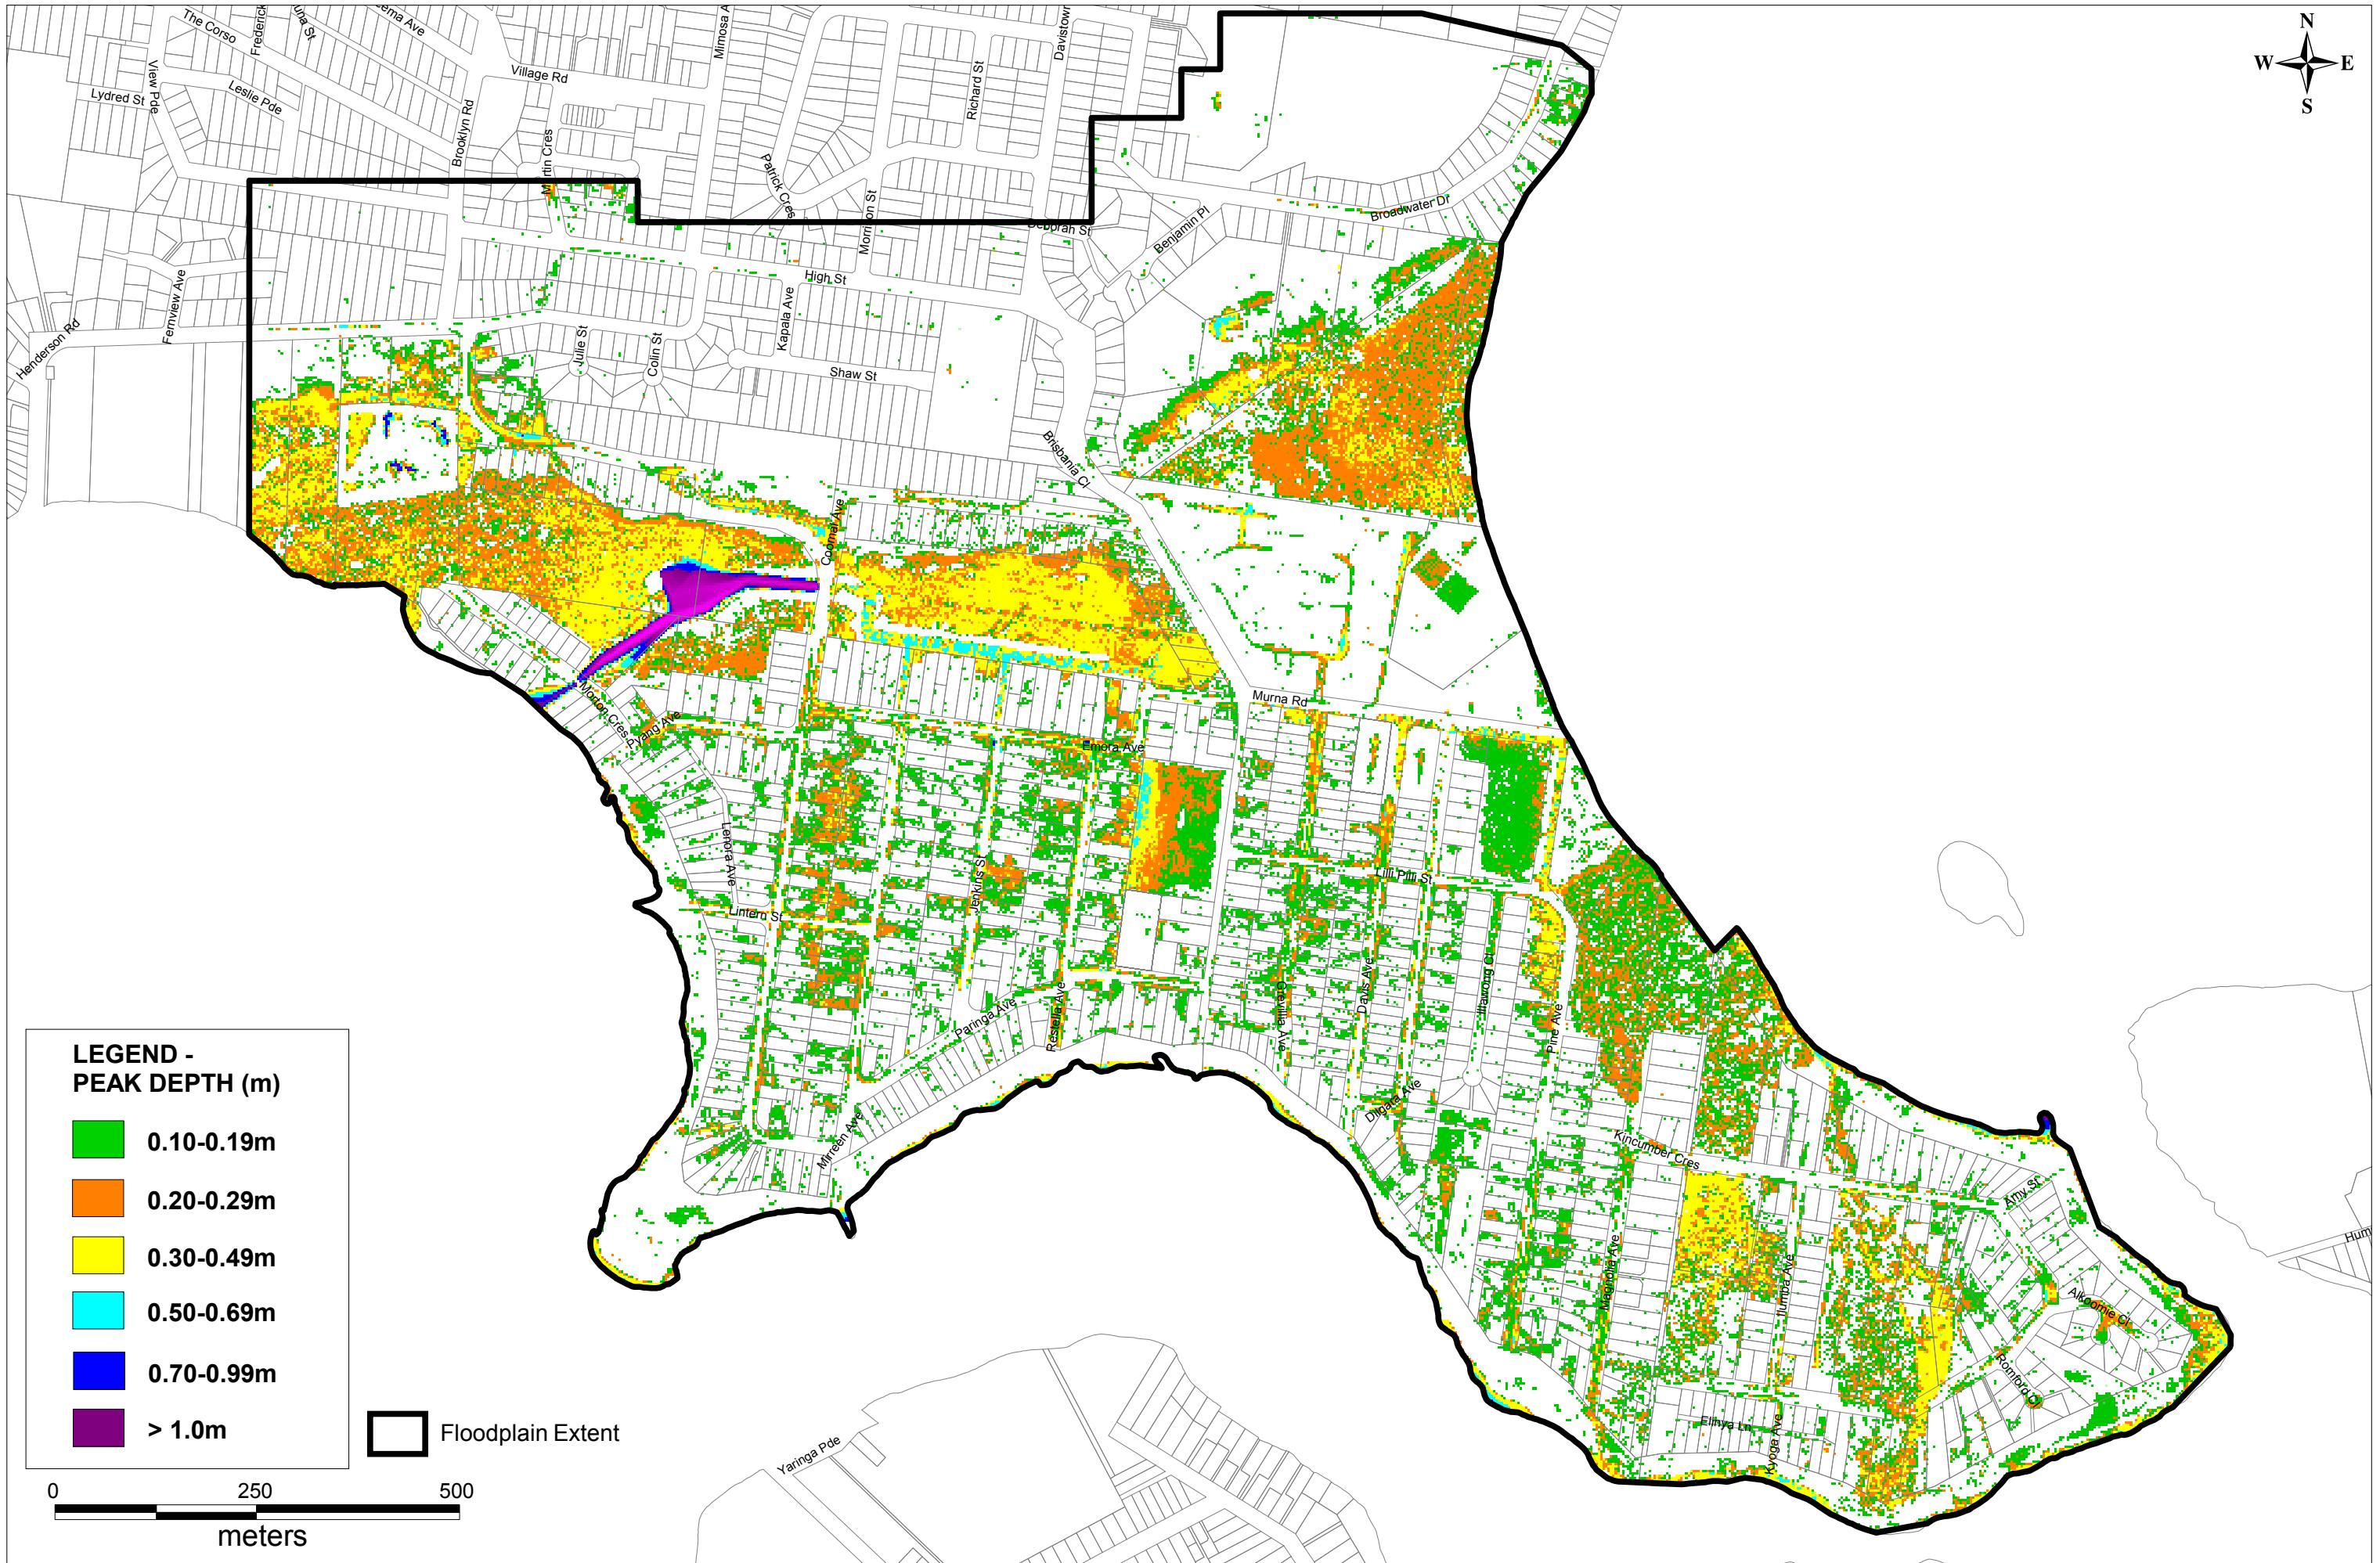
FIGURE 6.24  
PEAK DEPTH - 0.5% AEP

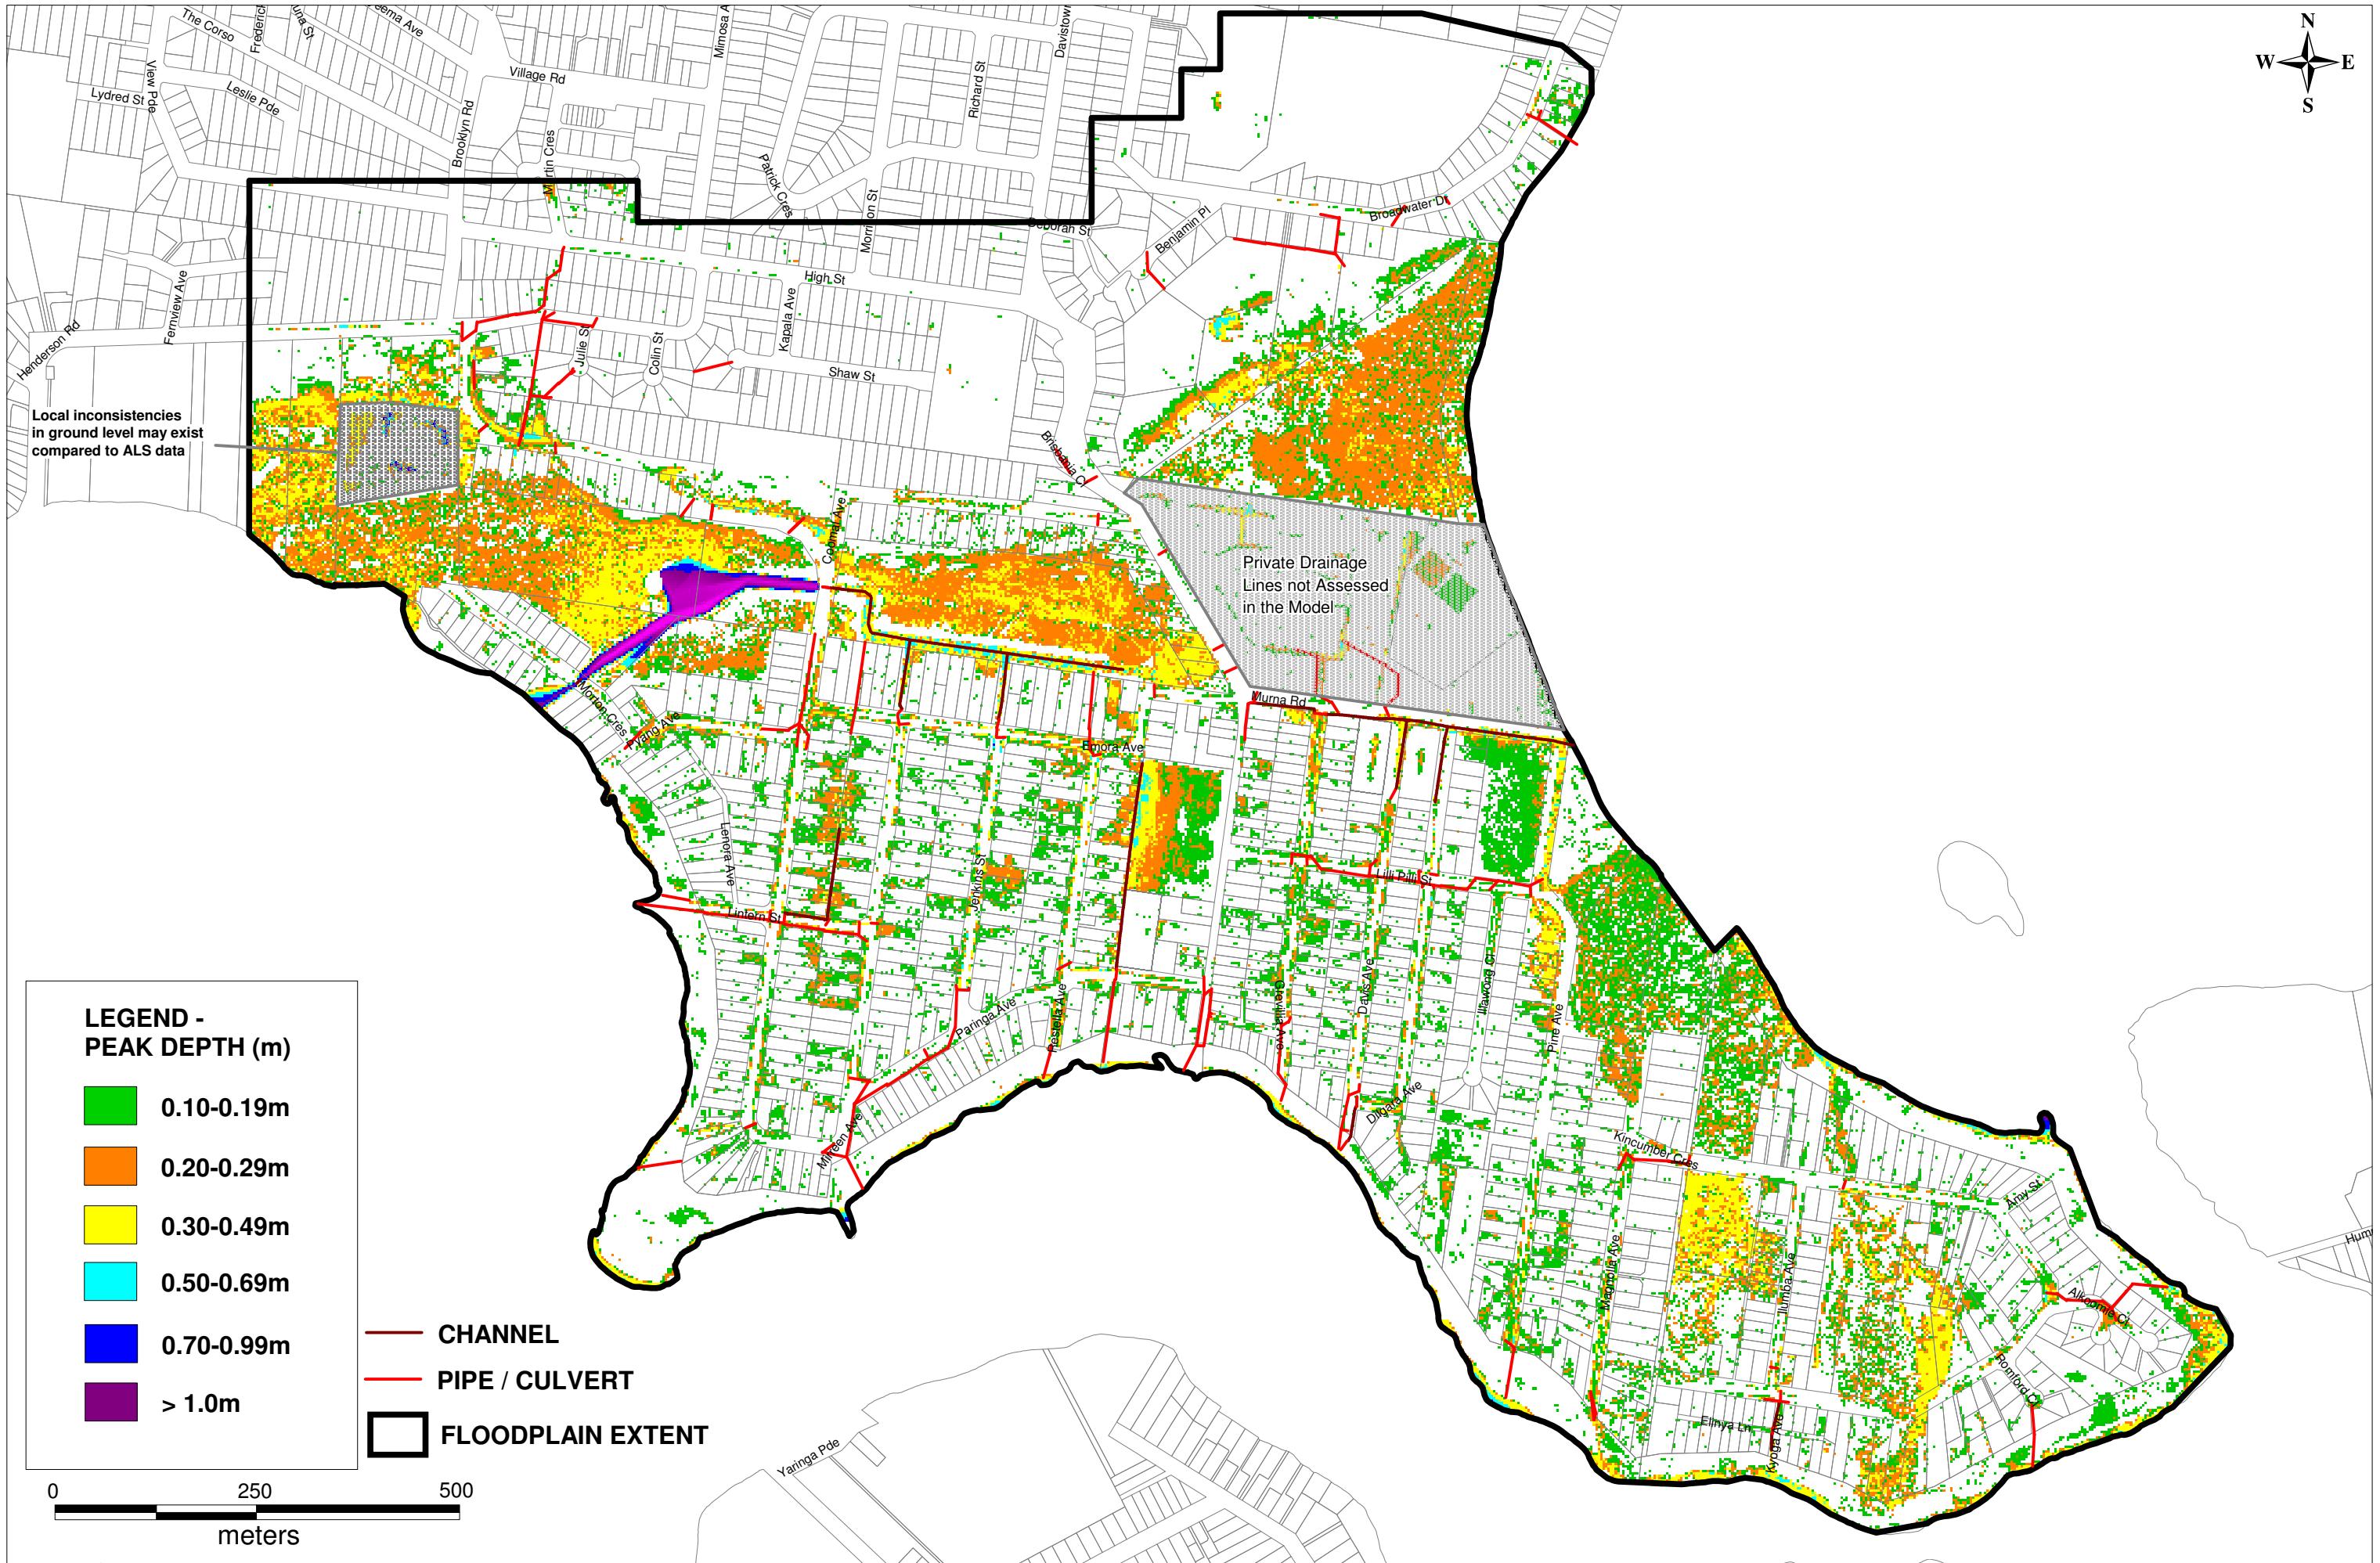
FIGURE 6.25  
PEAK DEPTH - 1% AEP
