## DAVISTOWN CATCHMENT FLOOD STUDY VOLUME 2 - FIGURES

Davistown Catchment Flood Study

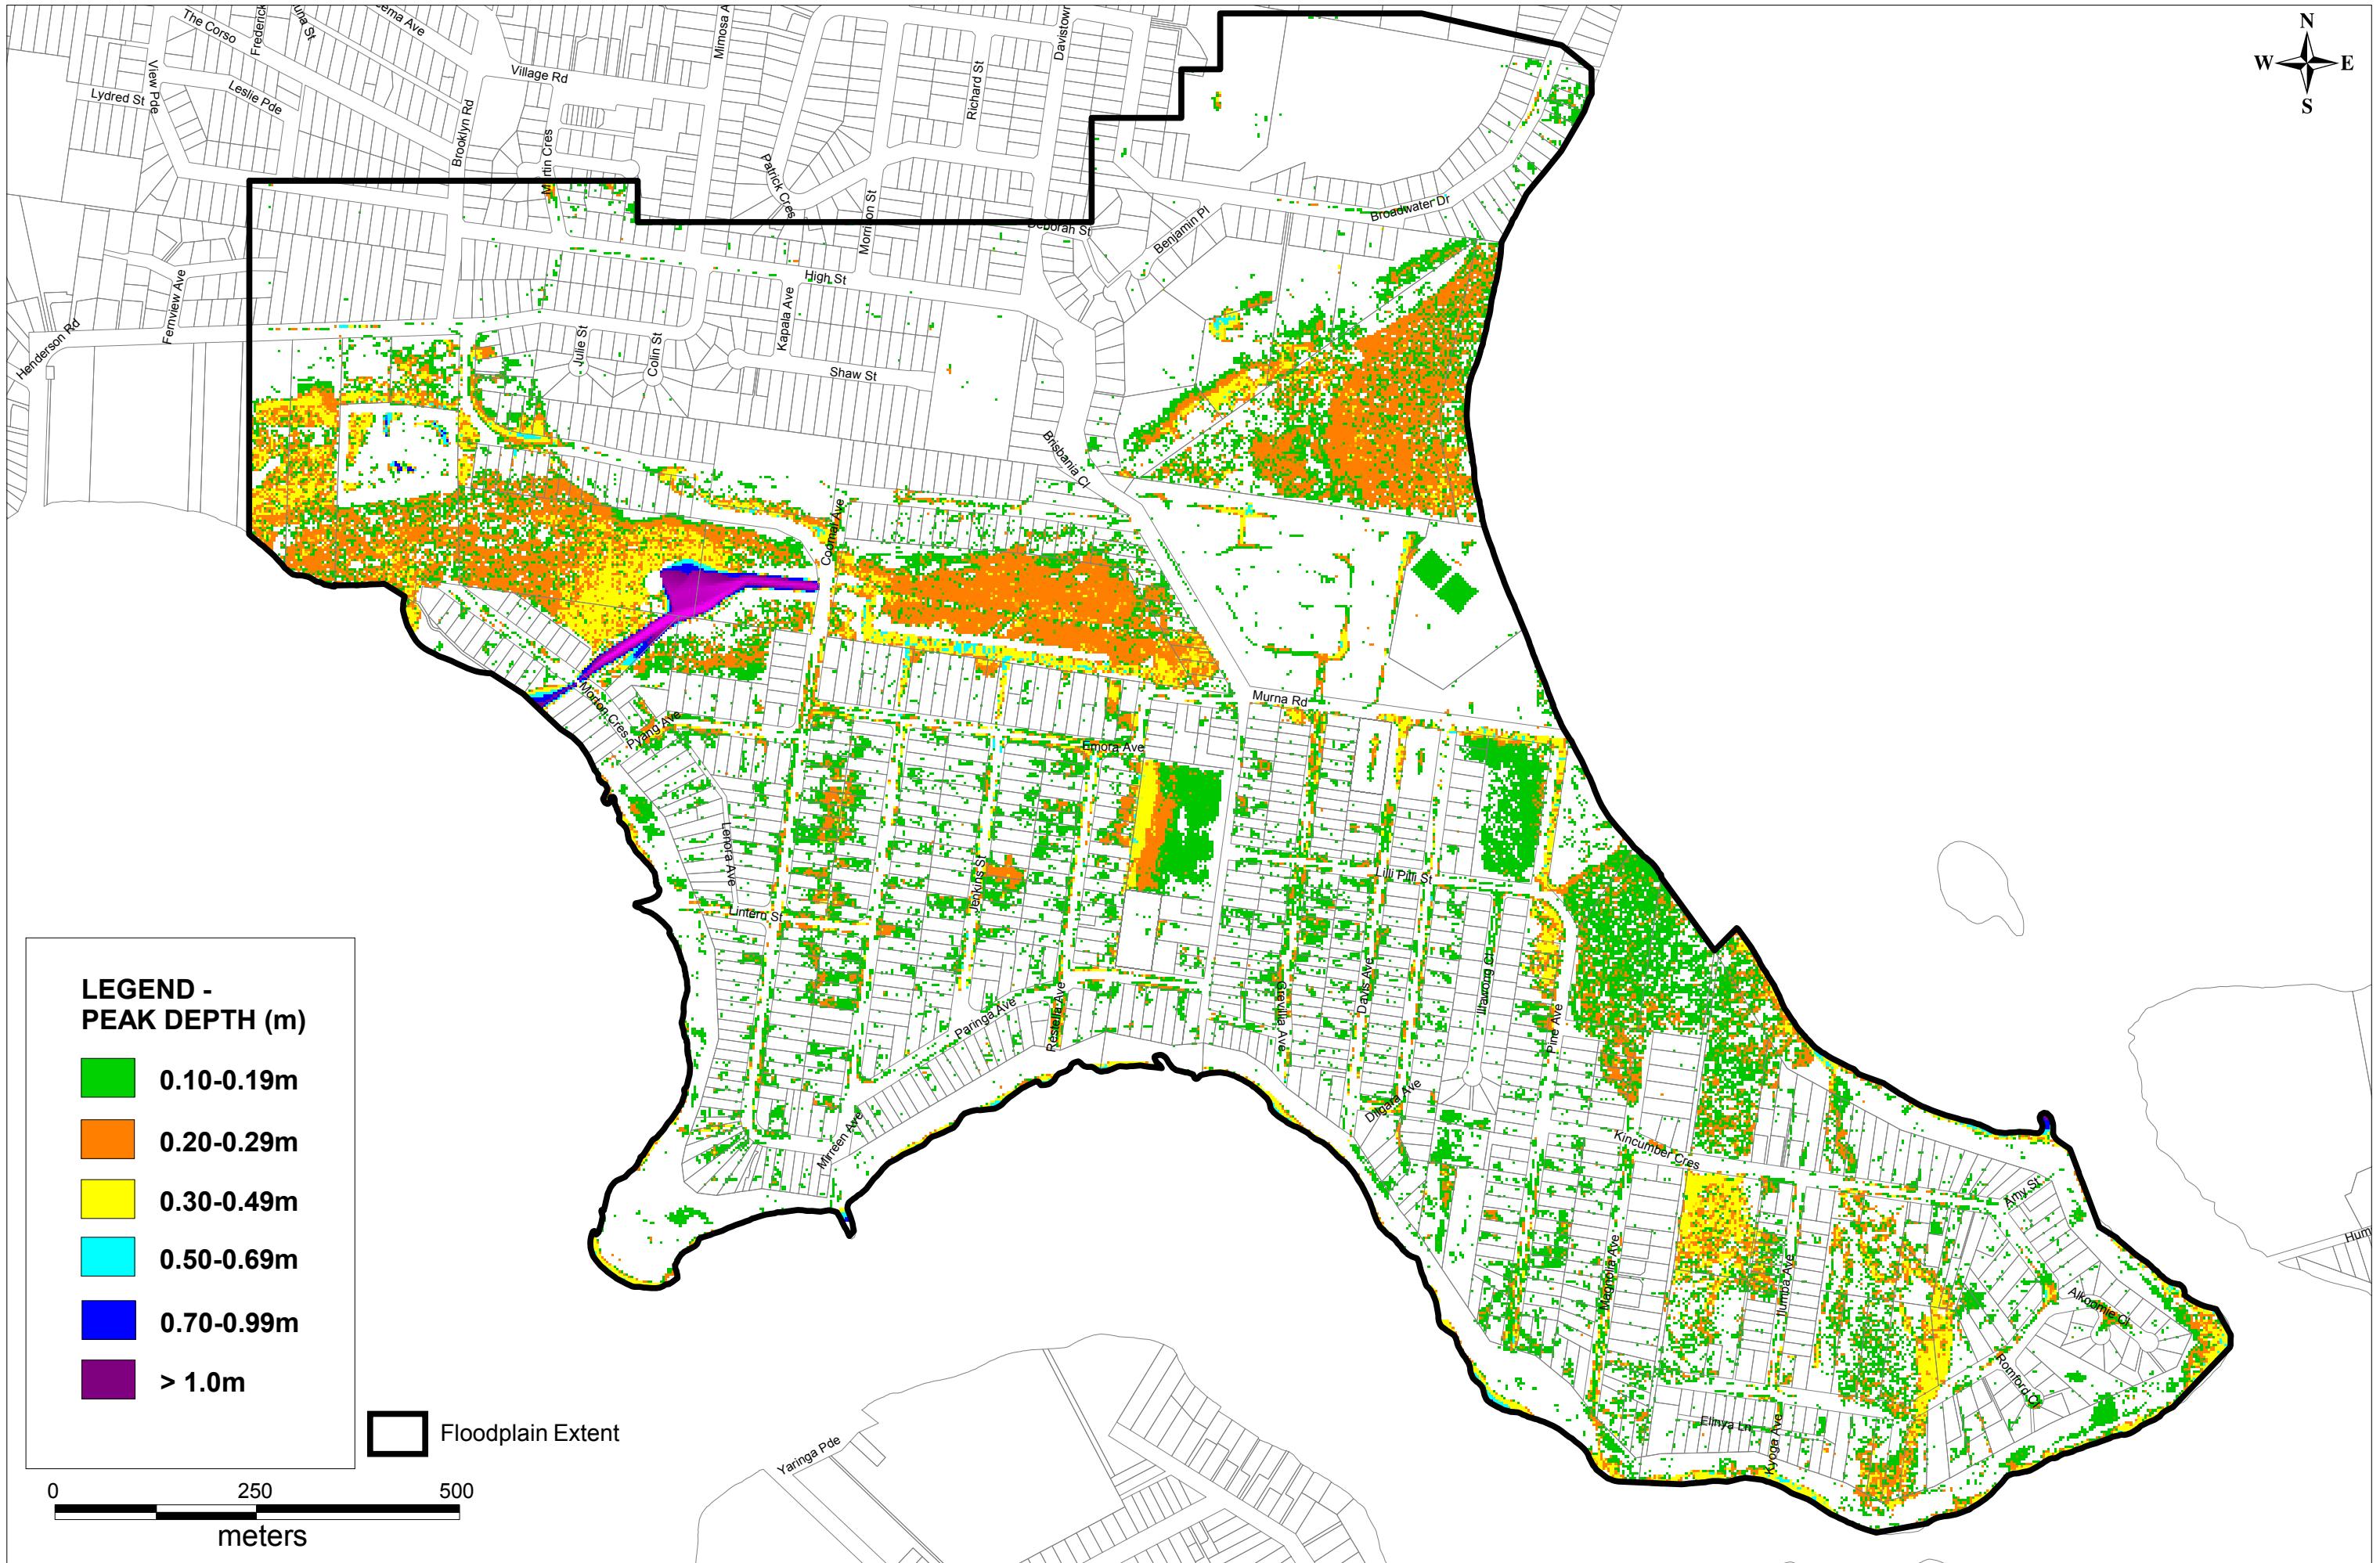
FIGURE 6.26  
PEAK DEPTH - 2% AEP

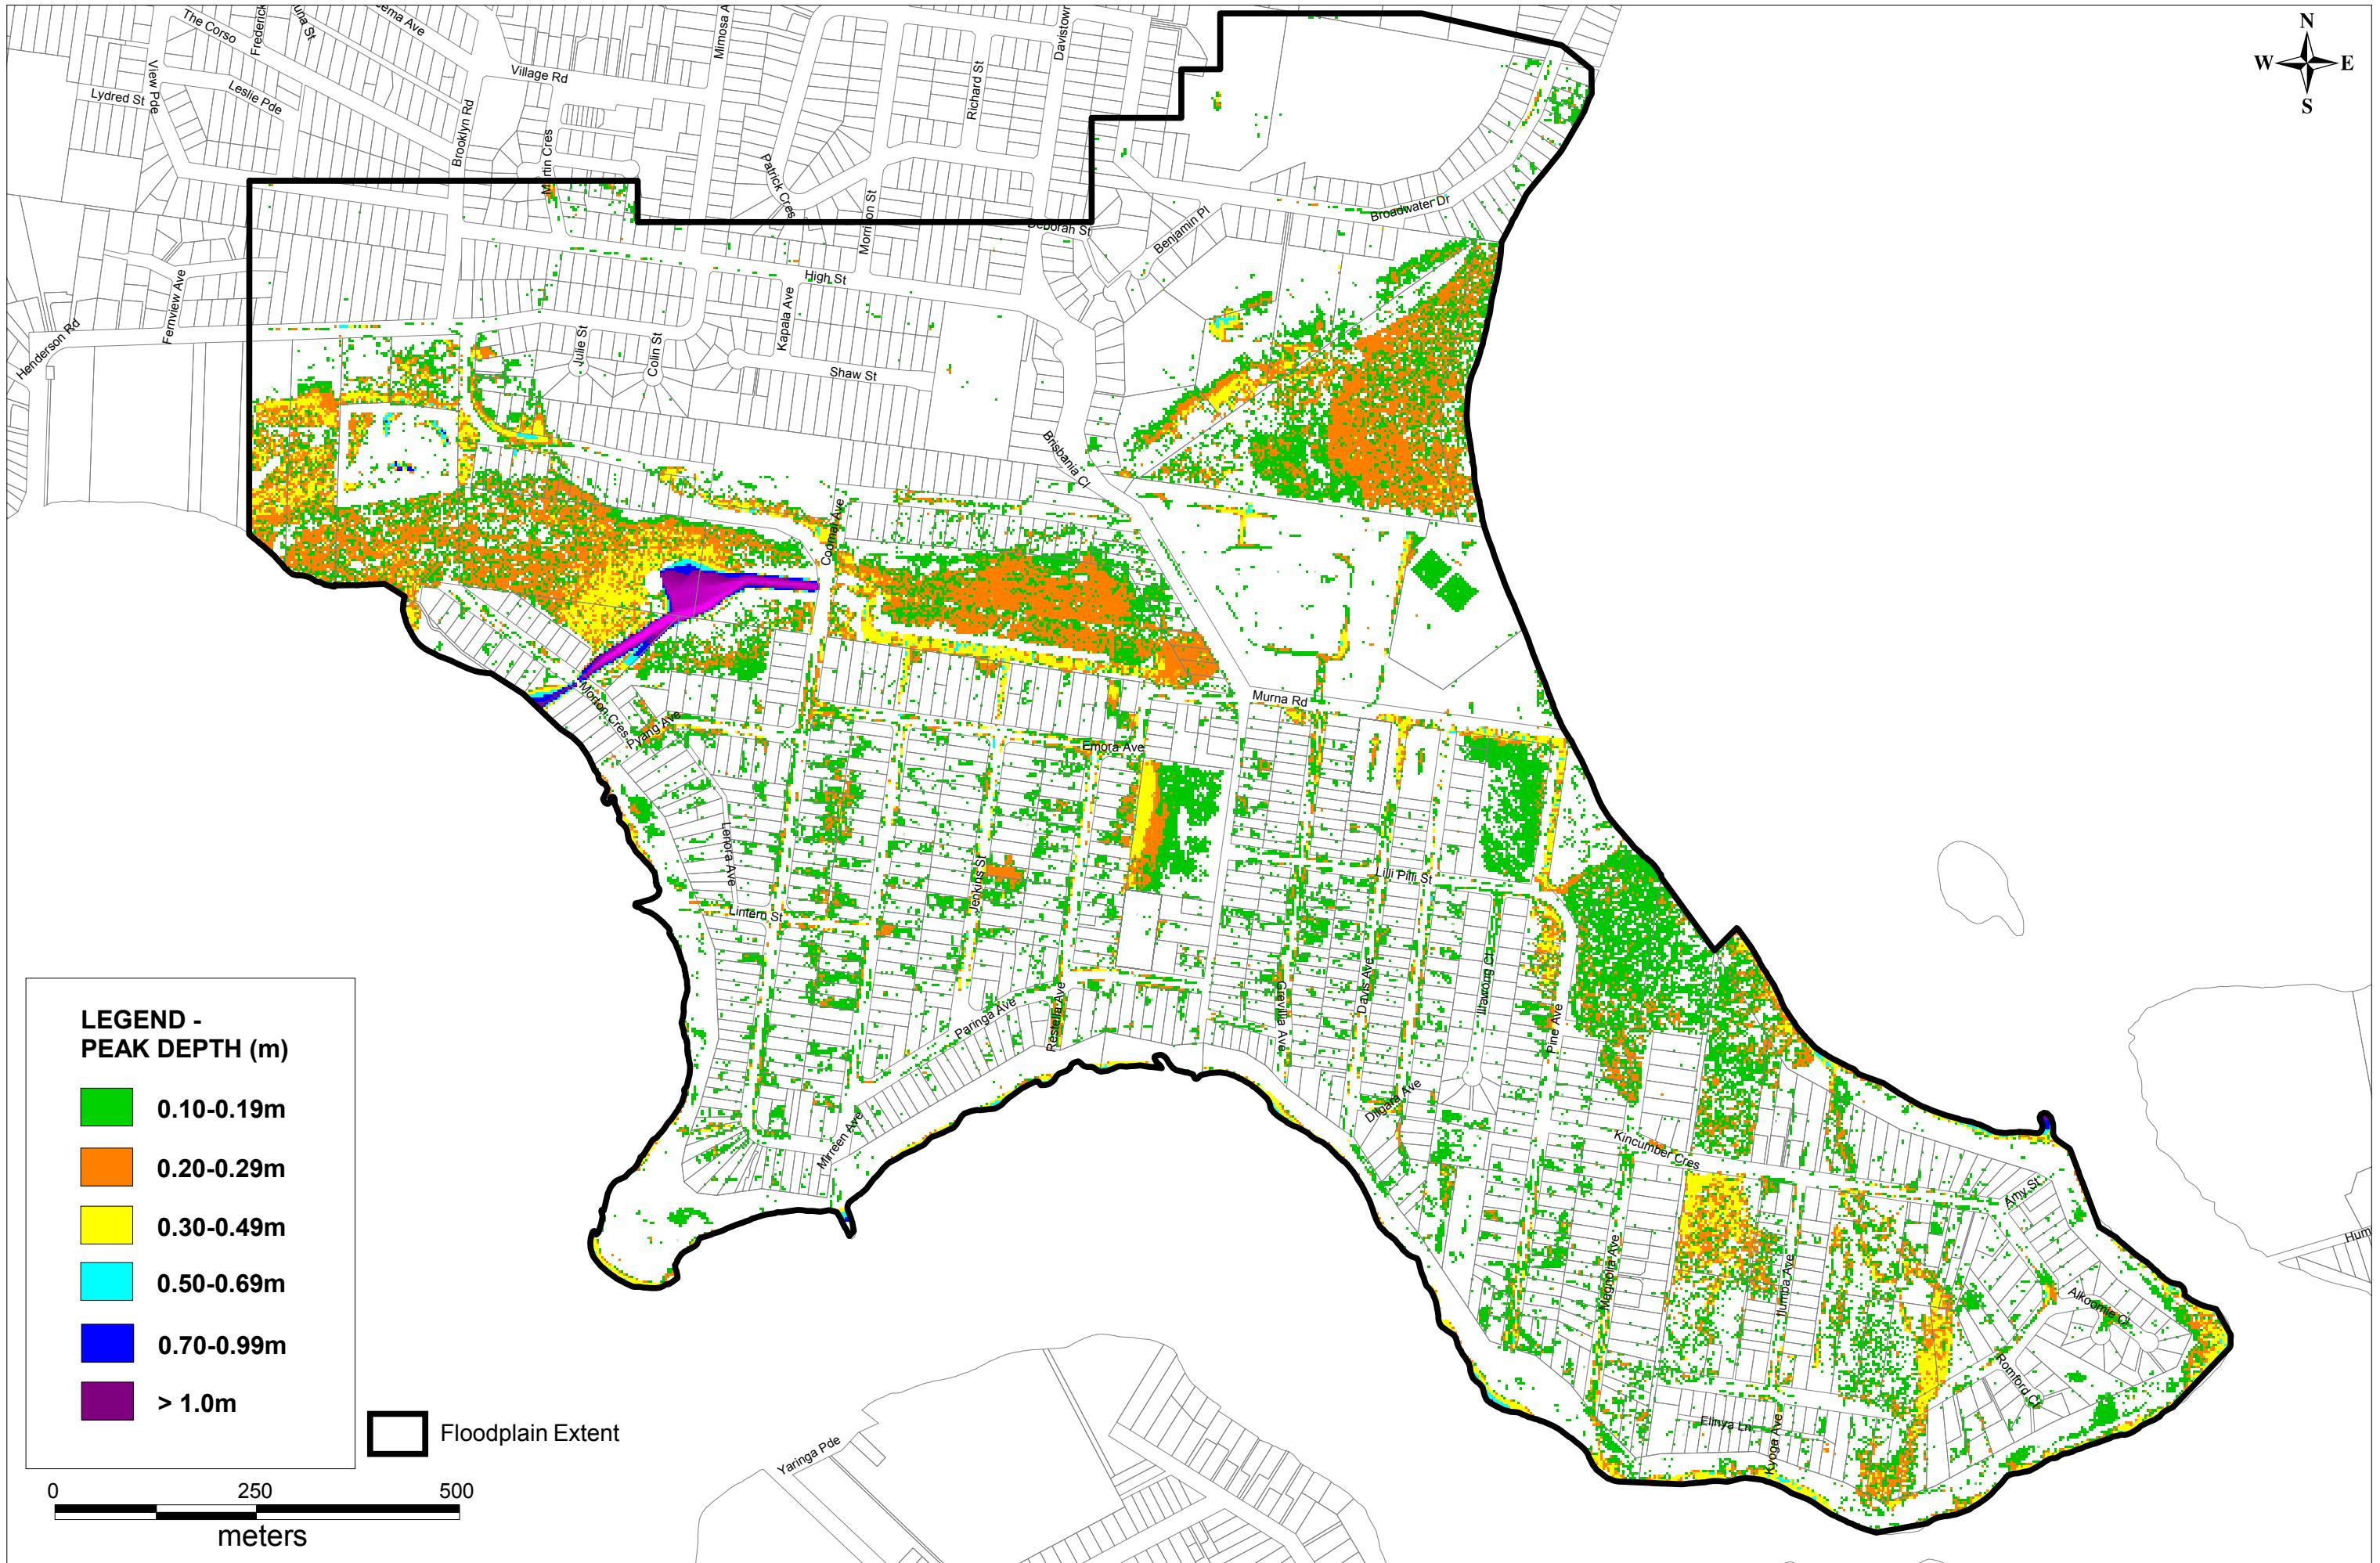
FIGURE 6.27  
PEAK DEPTH - 5% AEP

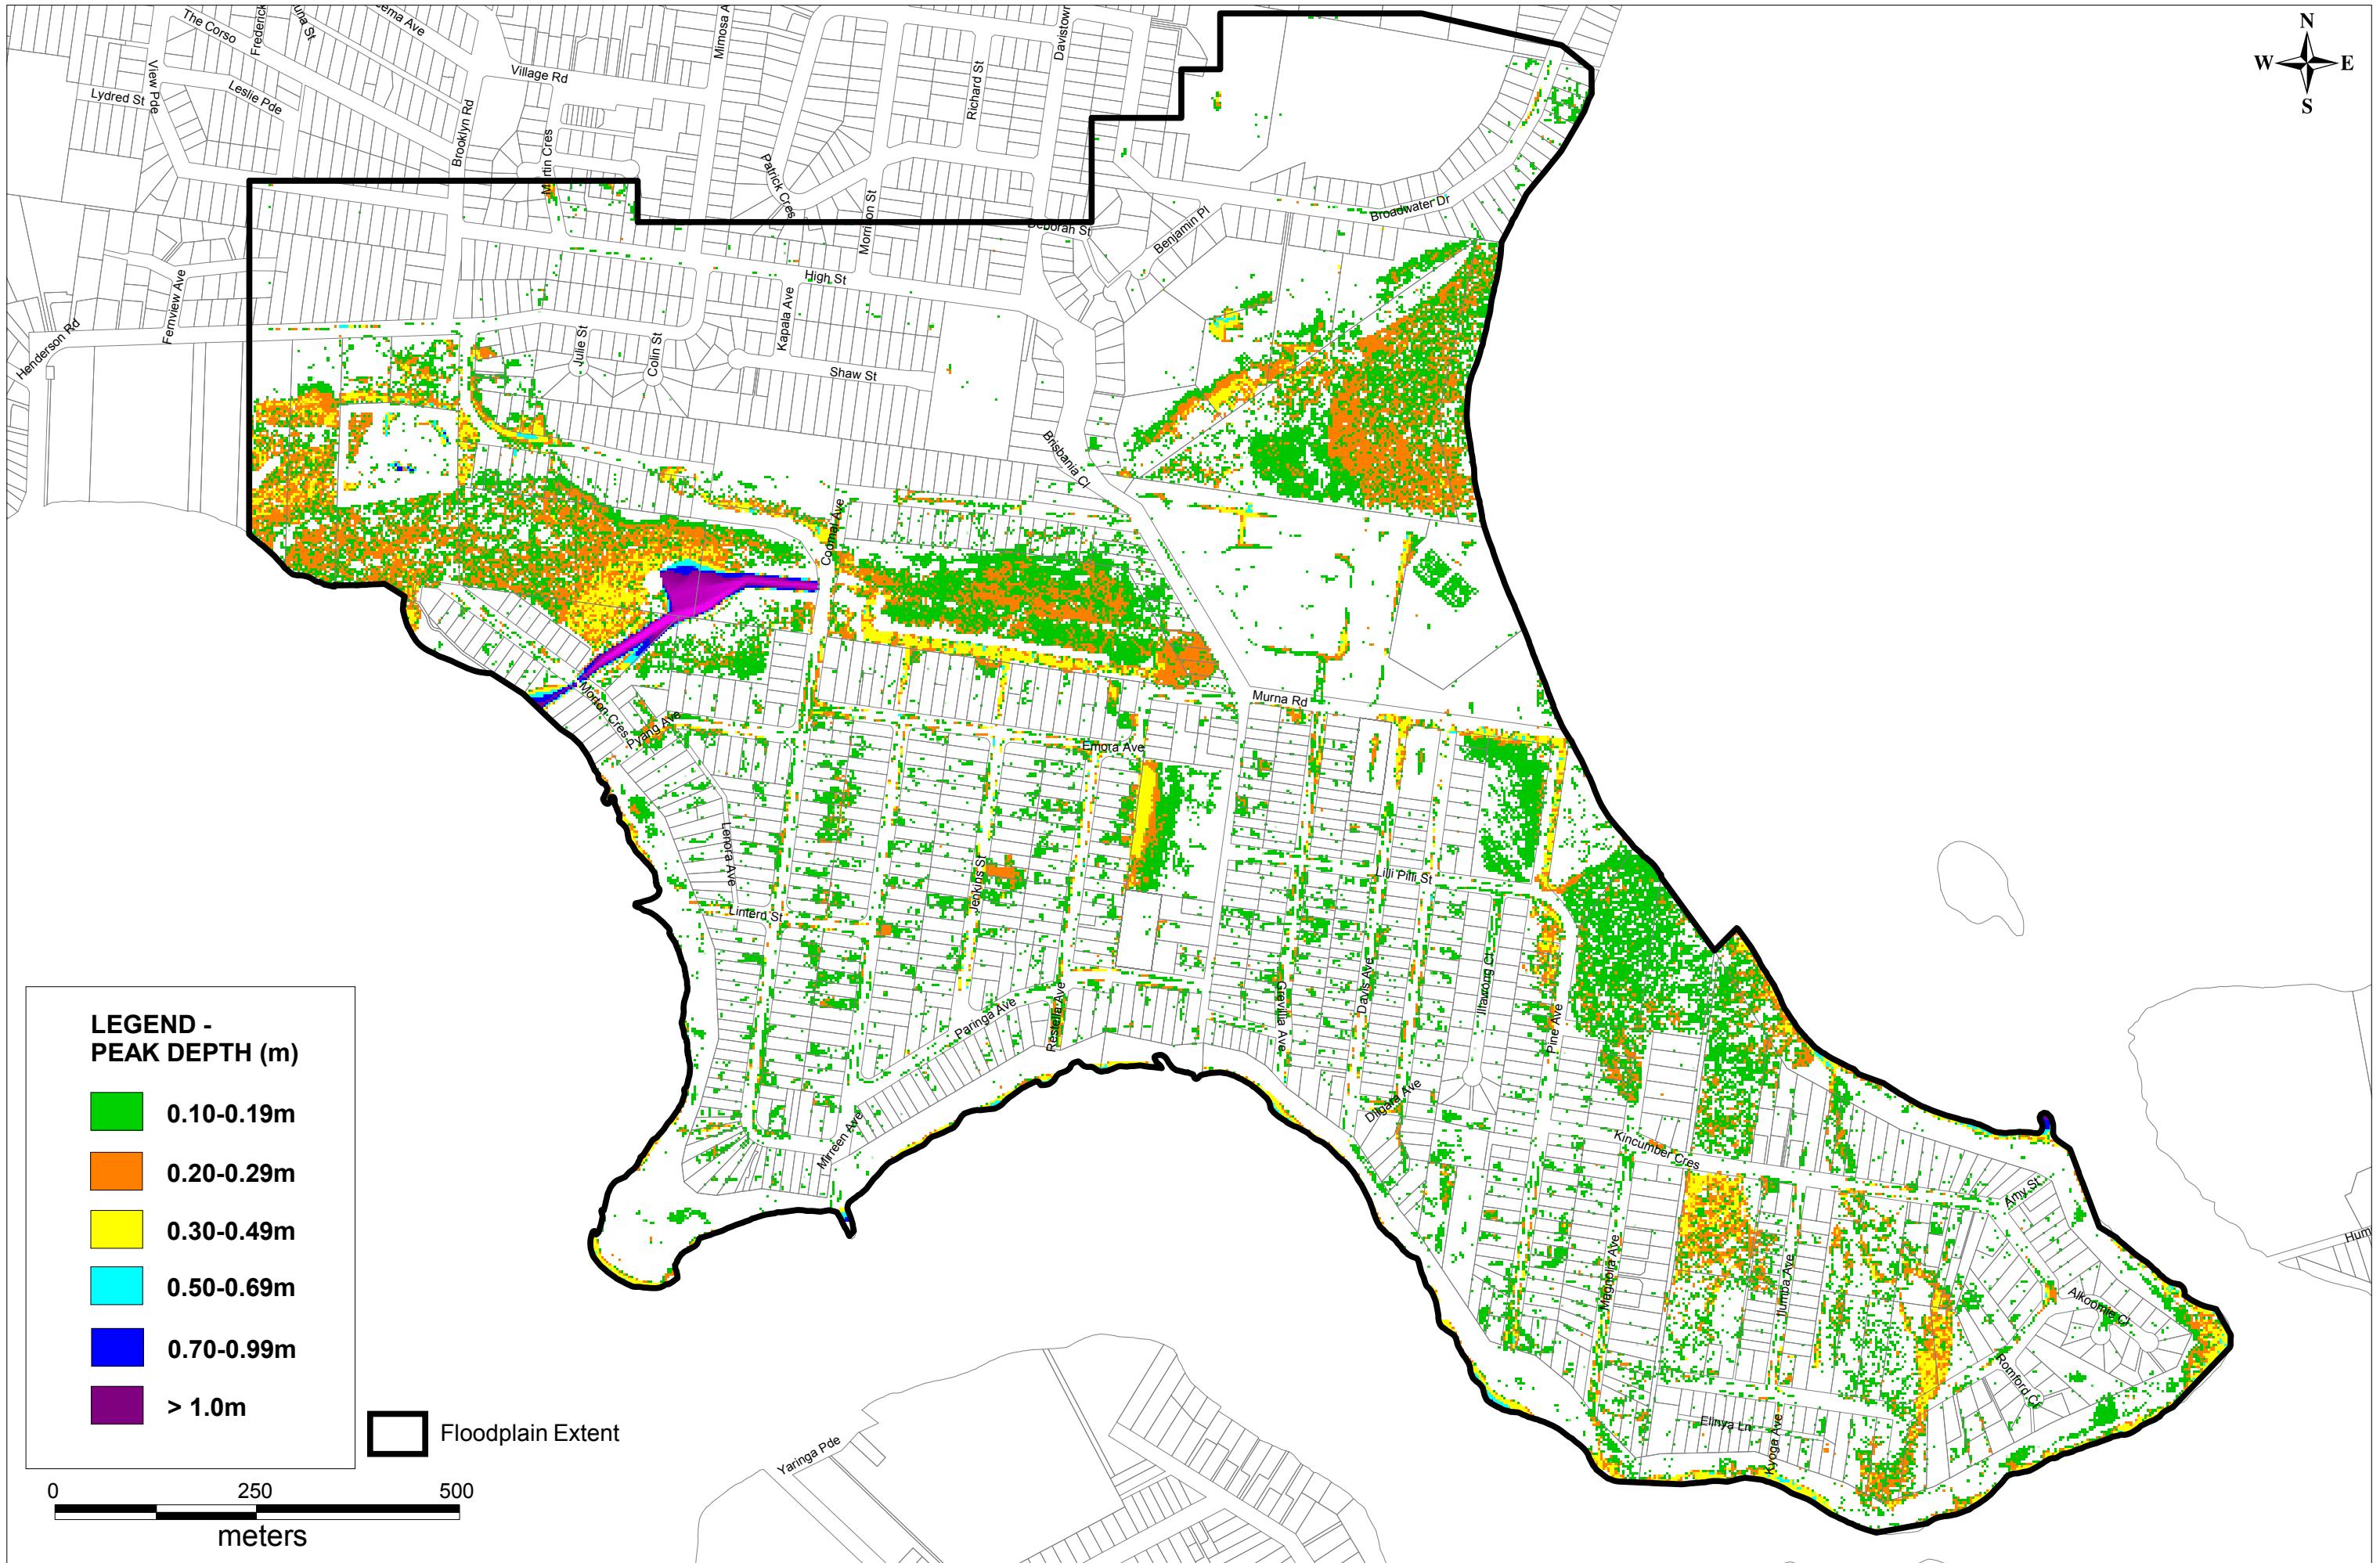
FIGURE 6.28  
PEAK DEPTH - 10% AEP

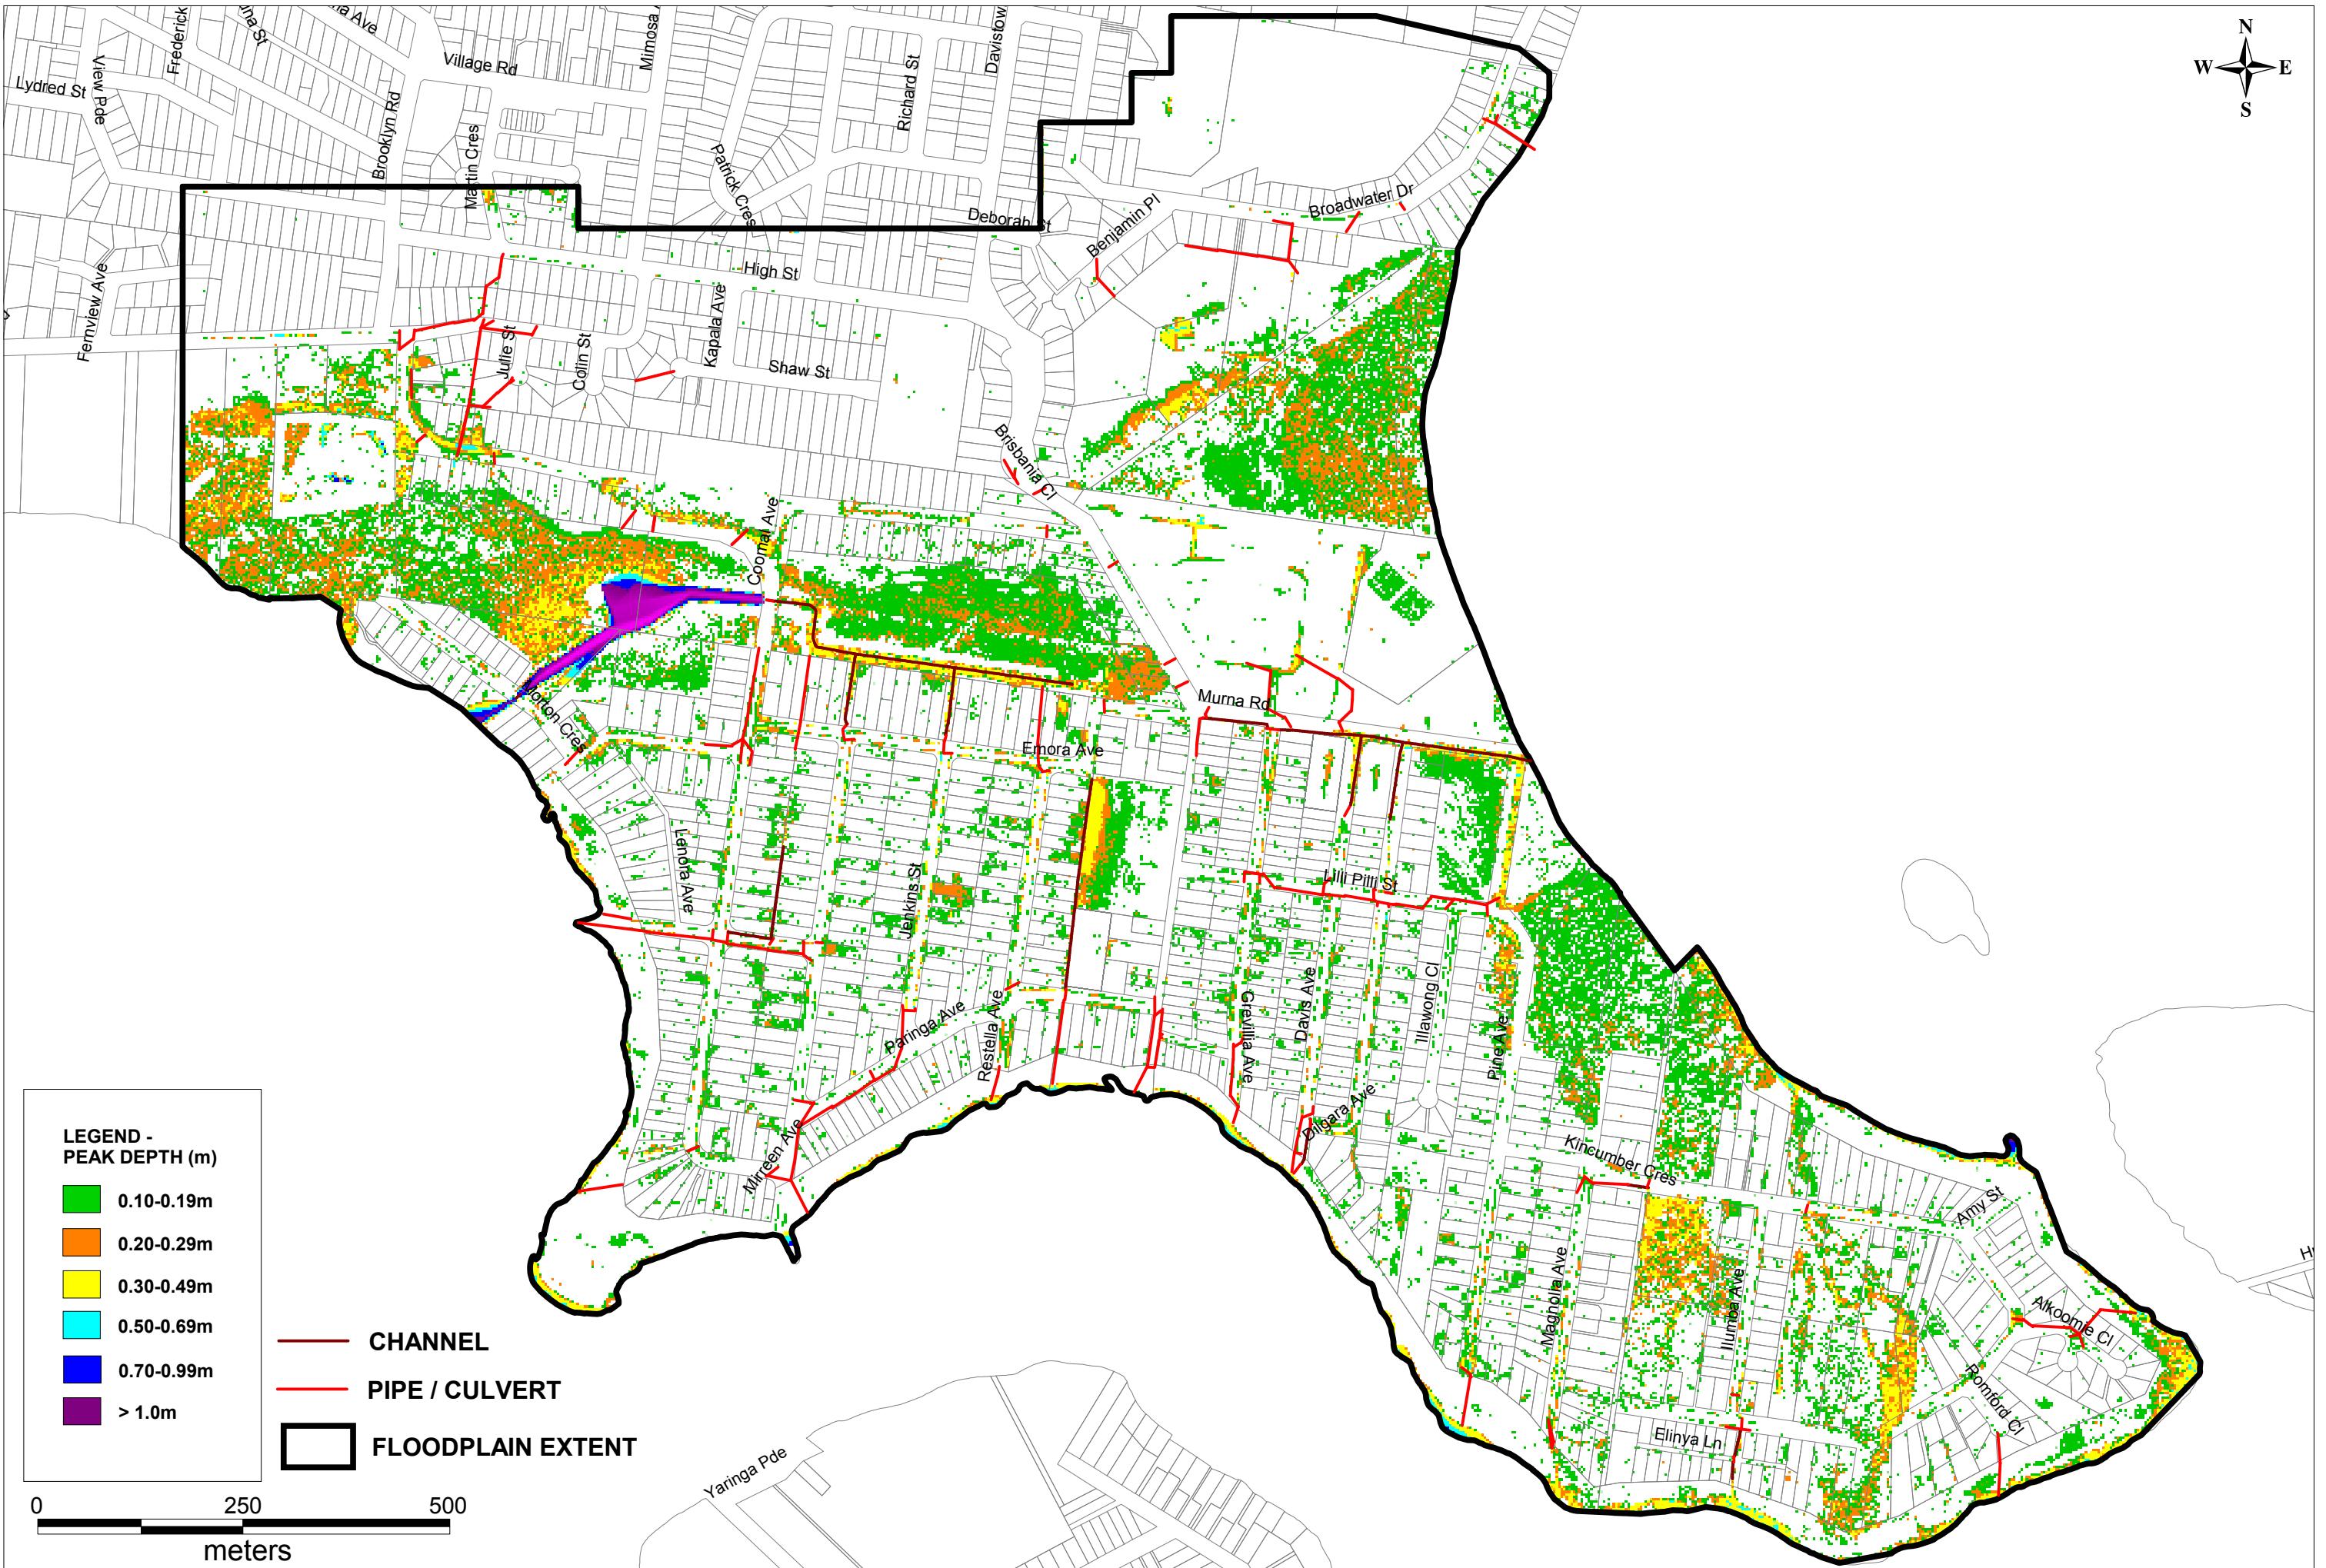
FIGURE 6.29  
PEAK DEPTH - 20% AEP

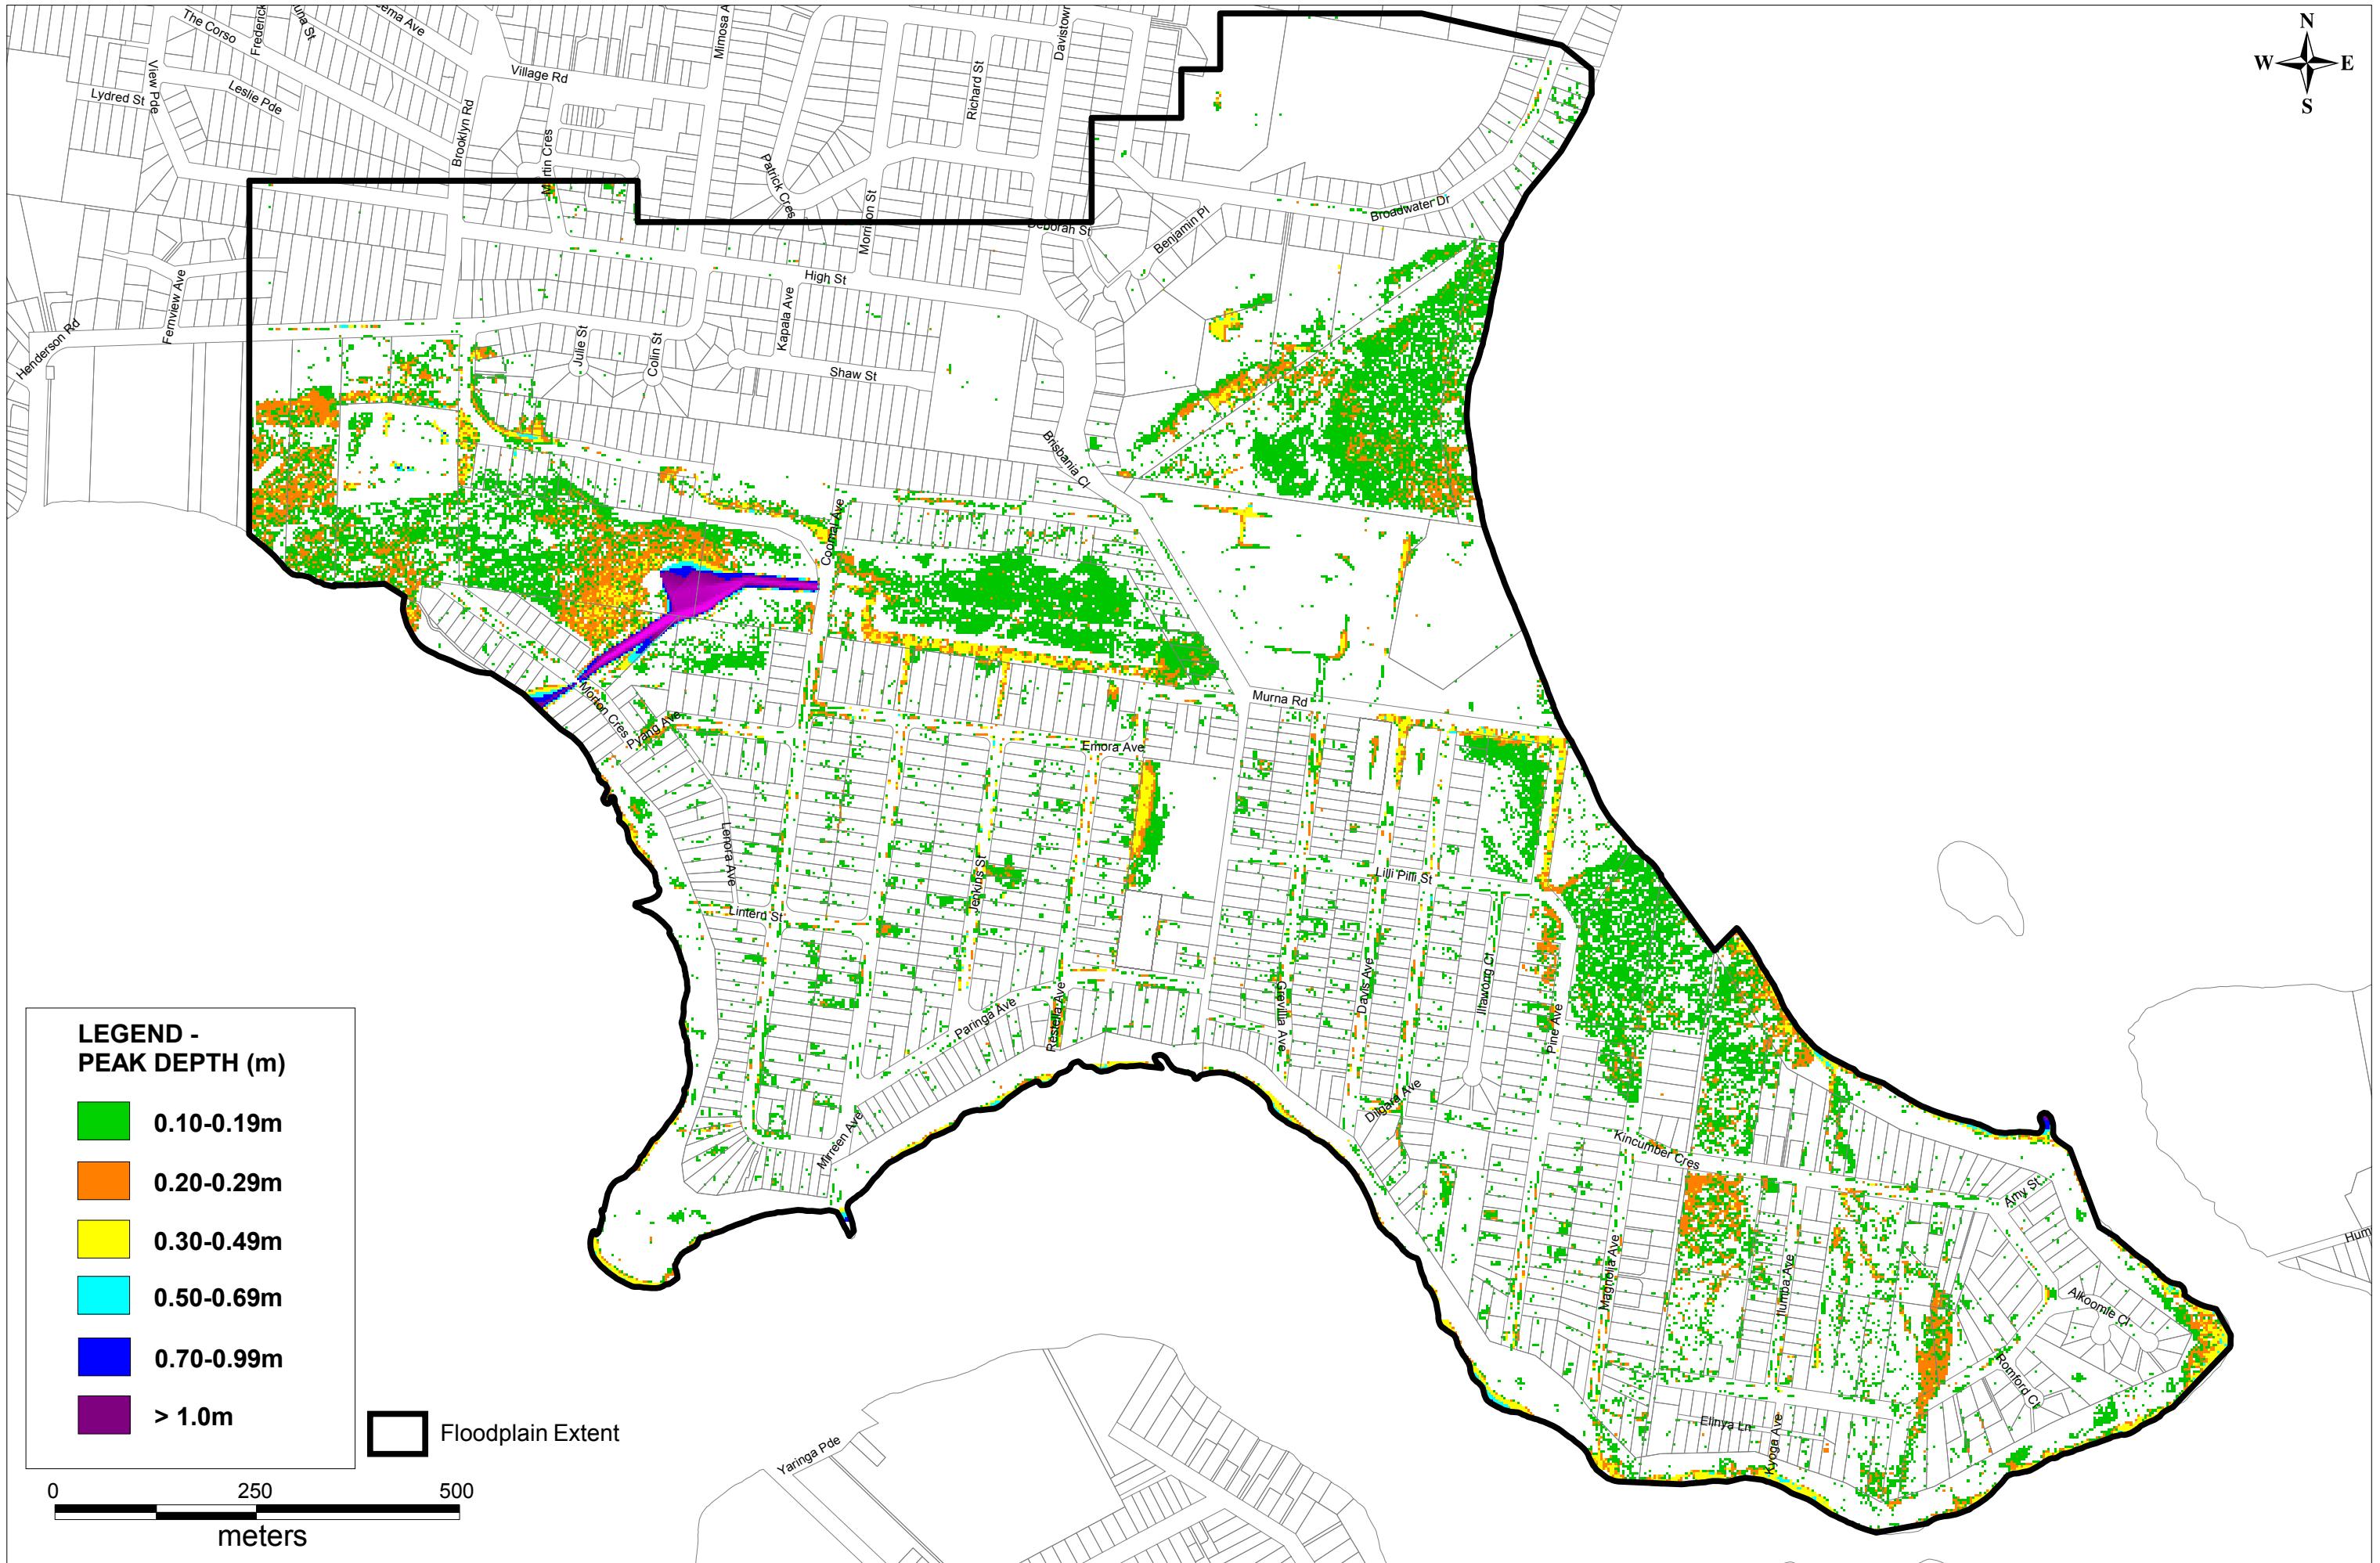
FIGURE 6.30  
PEAK DEPTH - 50% AEP

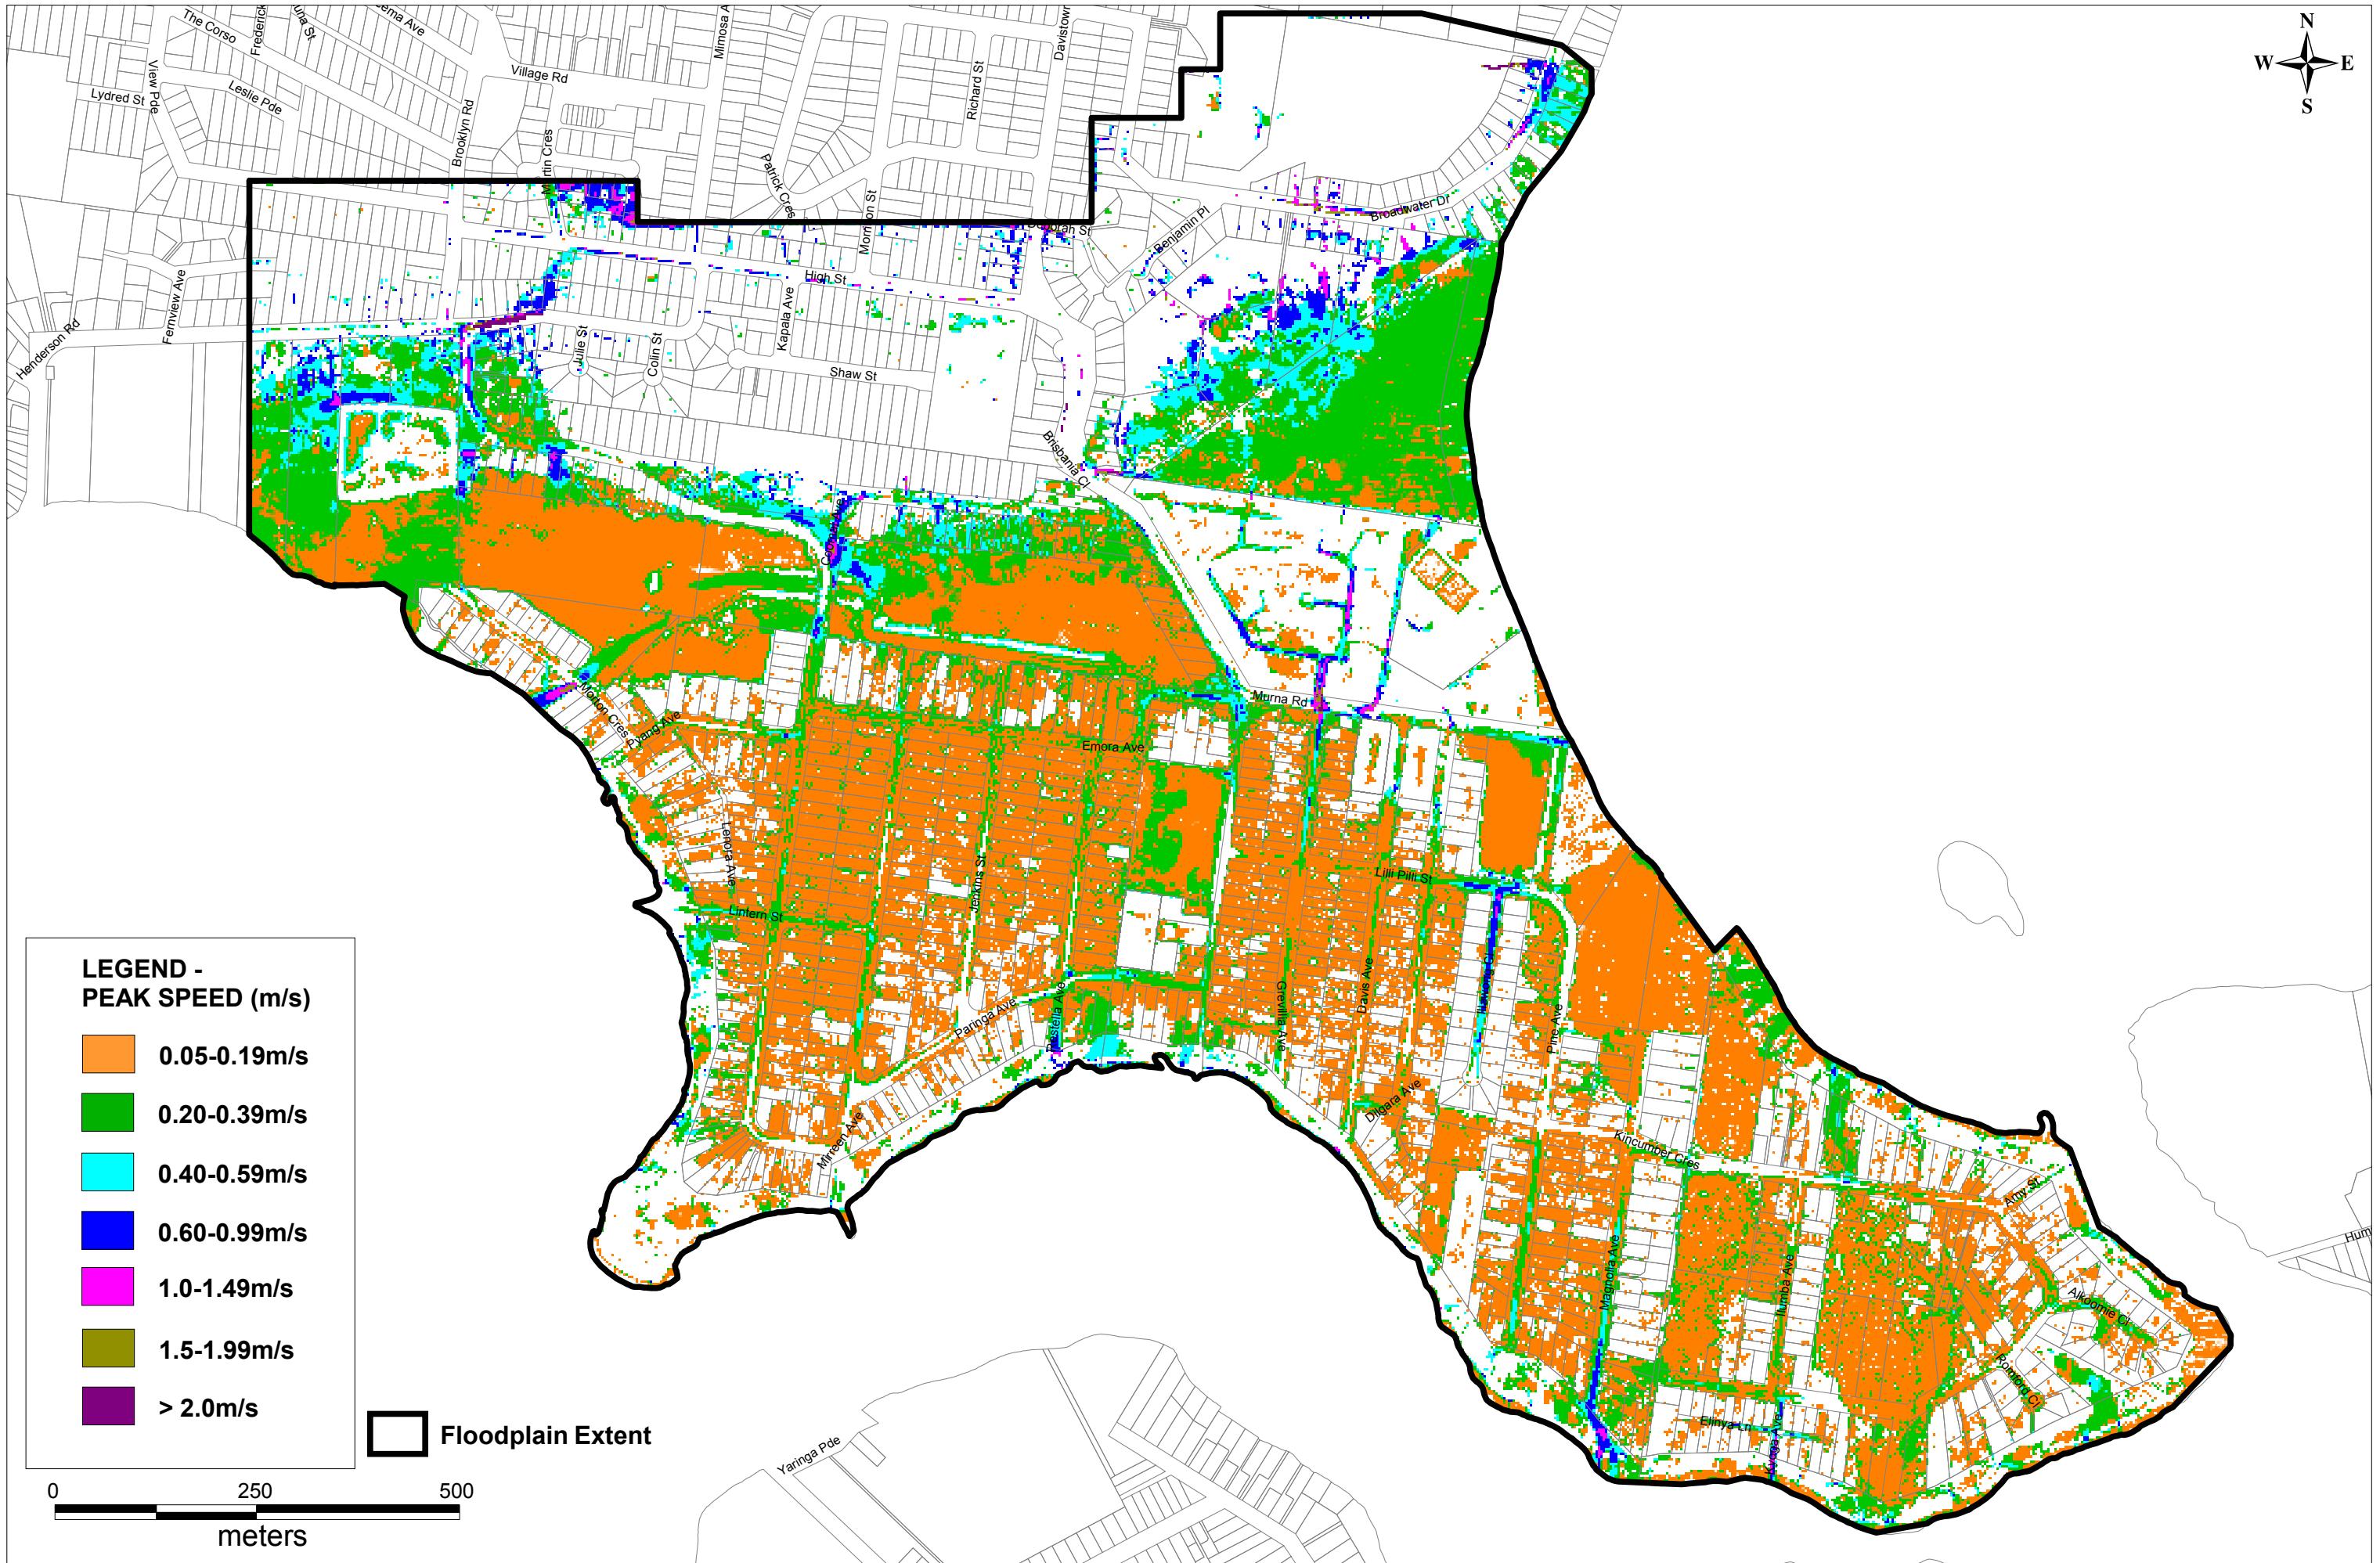
FIGURE 6.32  
PEAK SPEED - PMF
