## DAVISTOWN CATCHMENT FLOOD STUDY VOLUME 2 - FIGURES

Davistown Catchment Flood Study

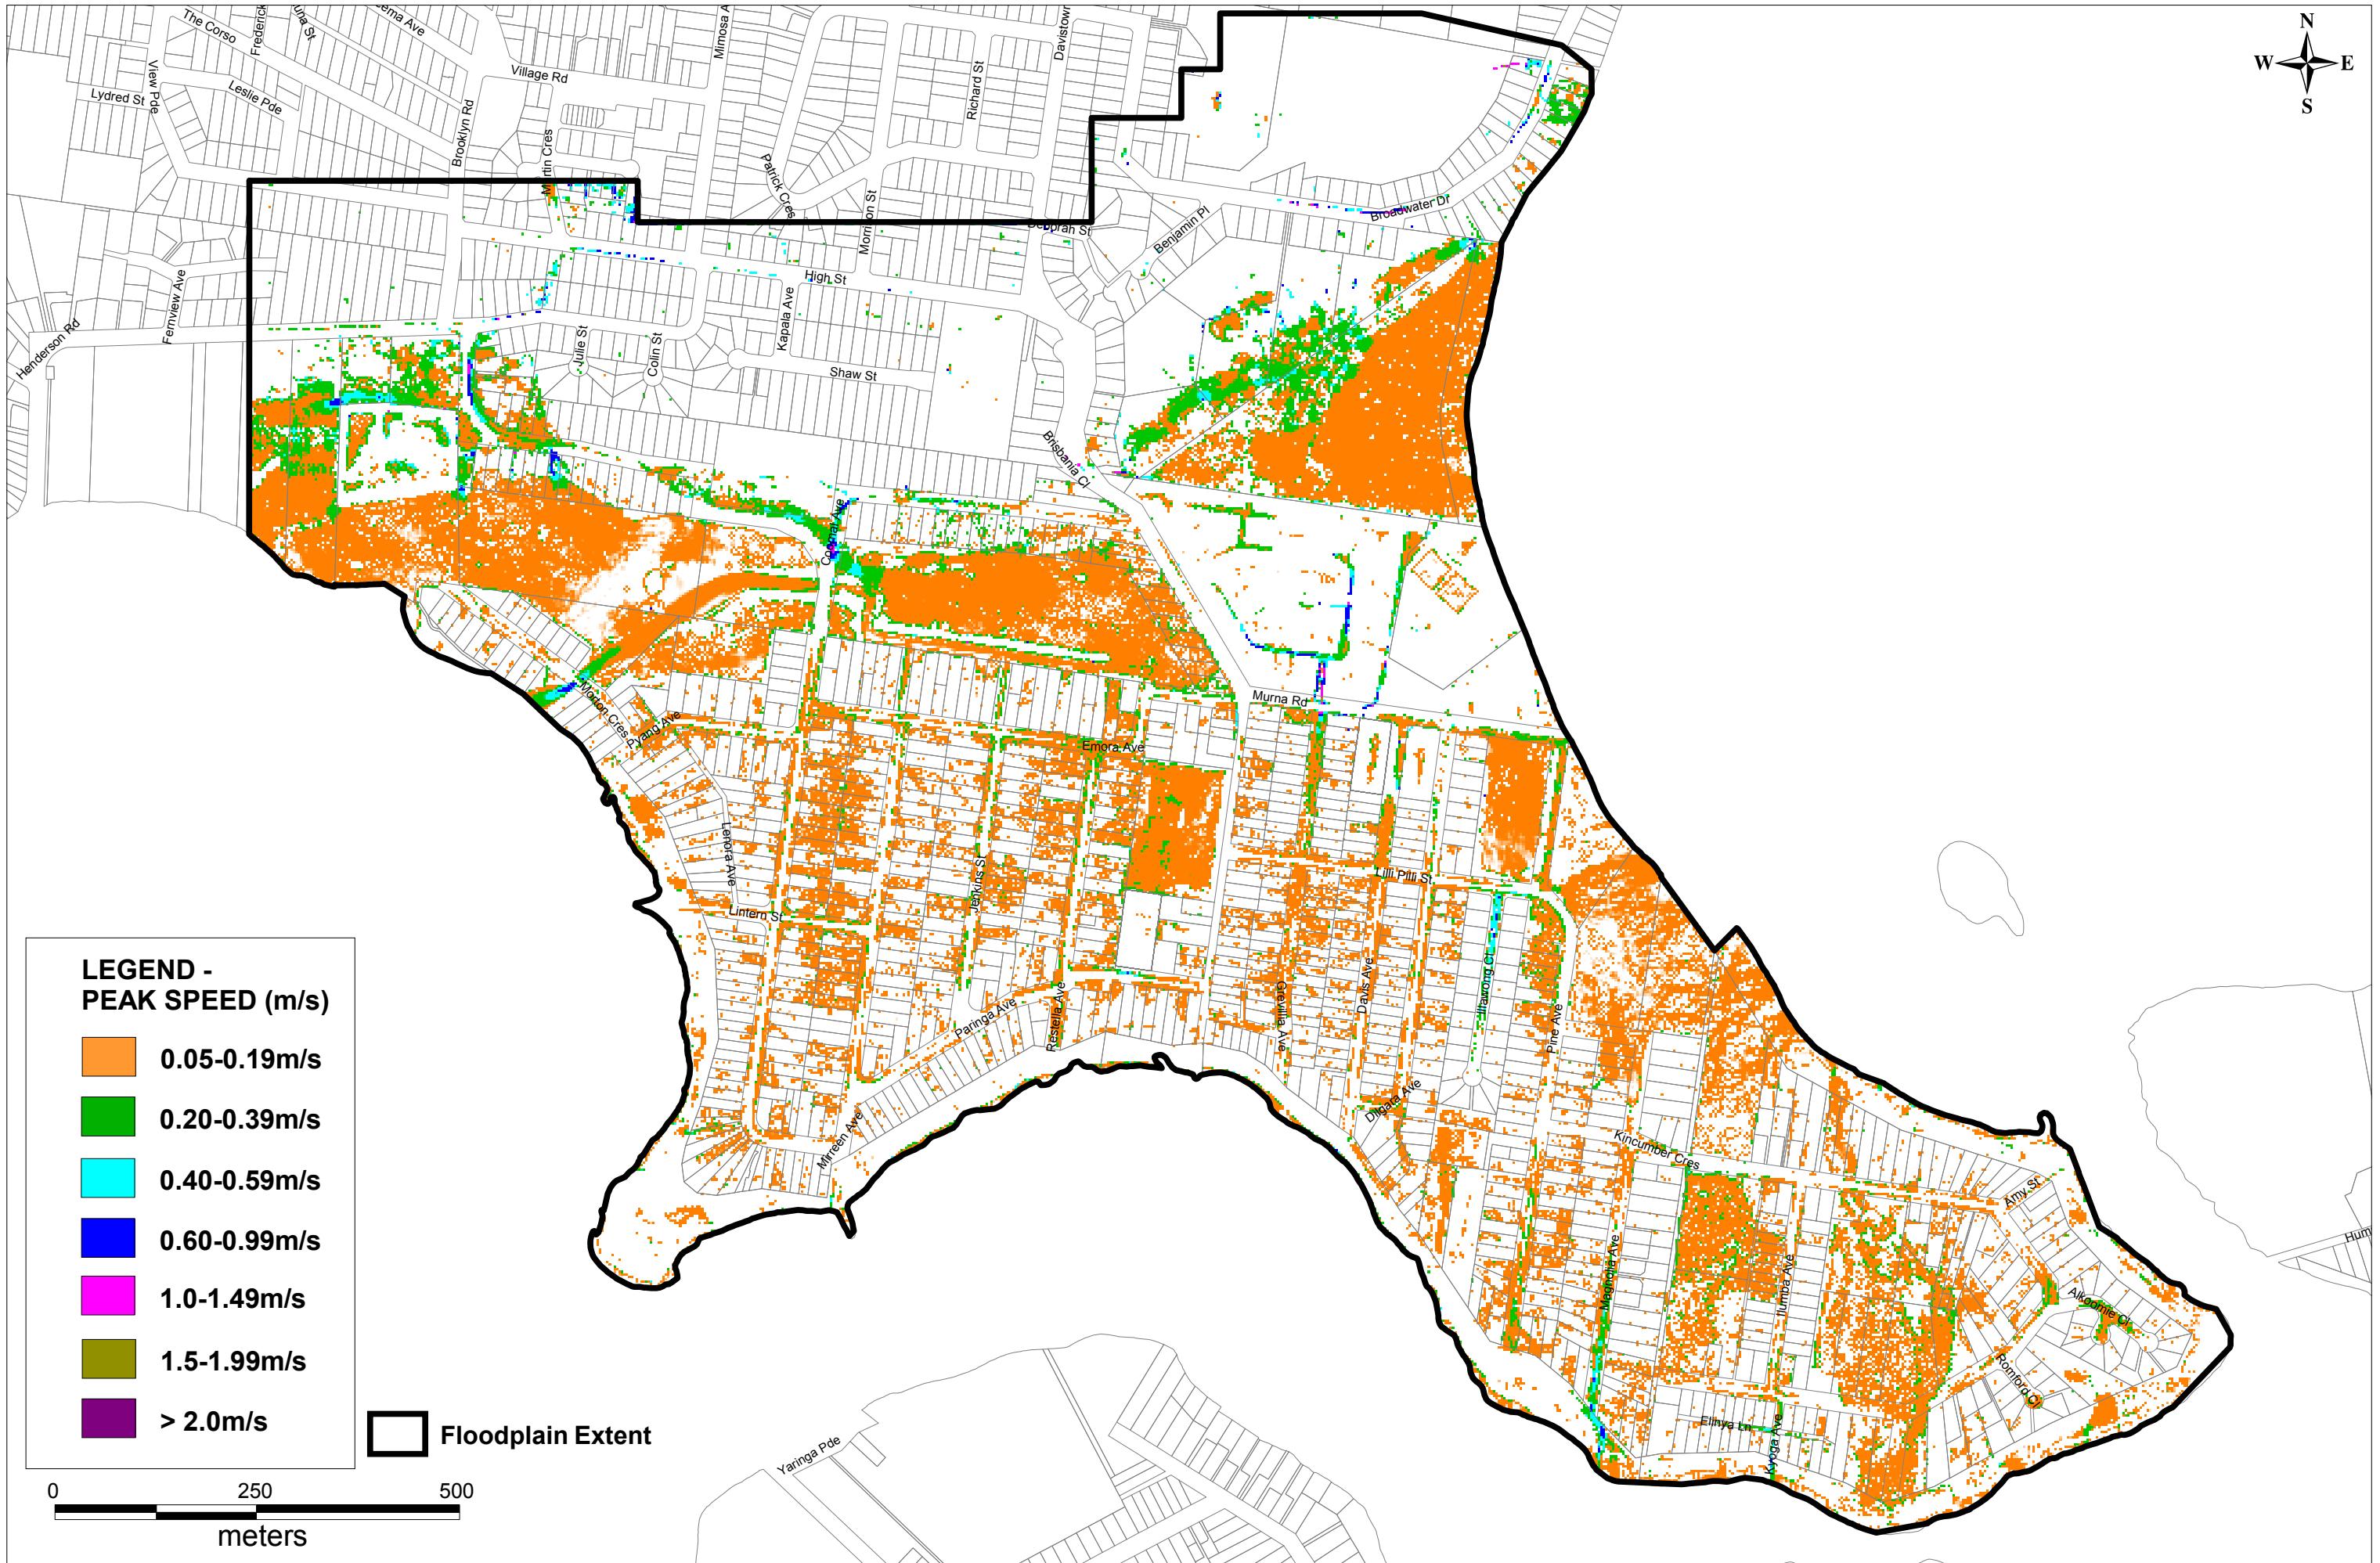
FIGURE 6.33  
PEAK SPEED - 0.5% AEP

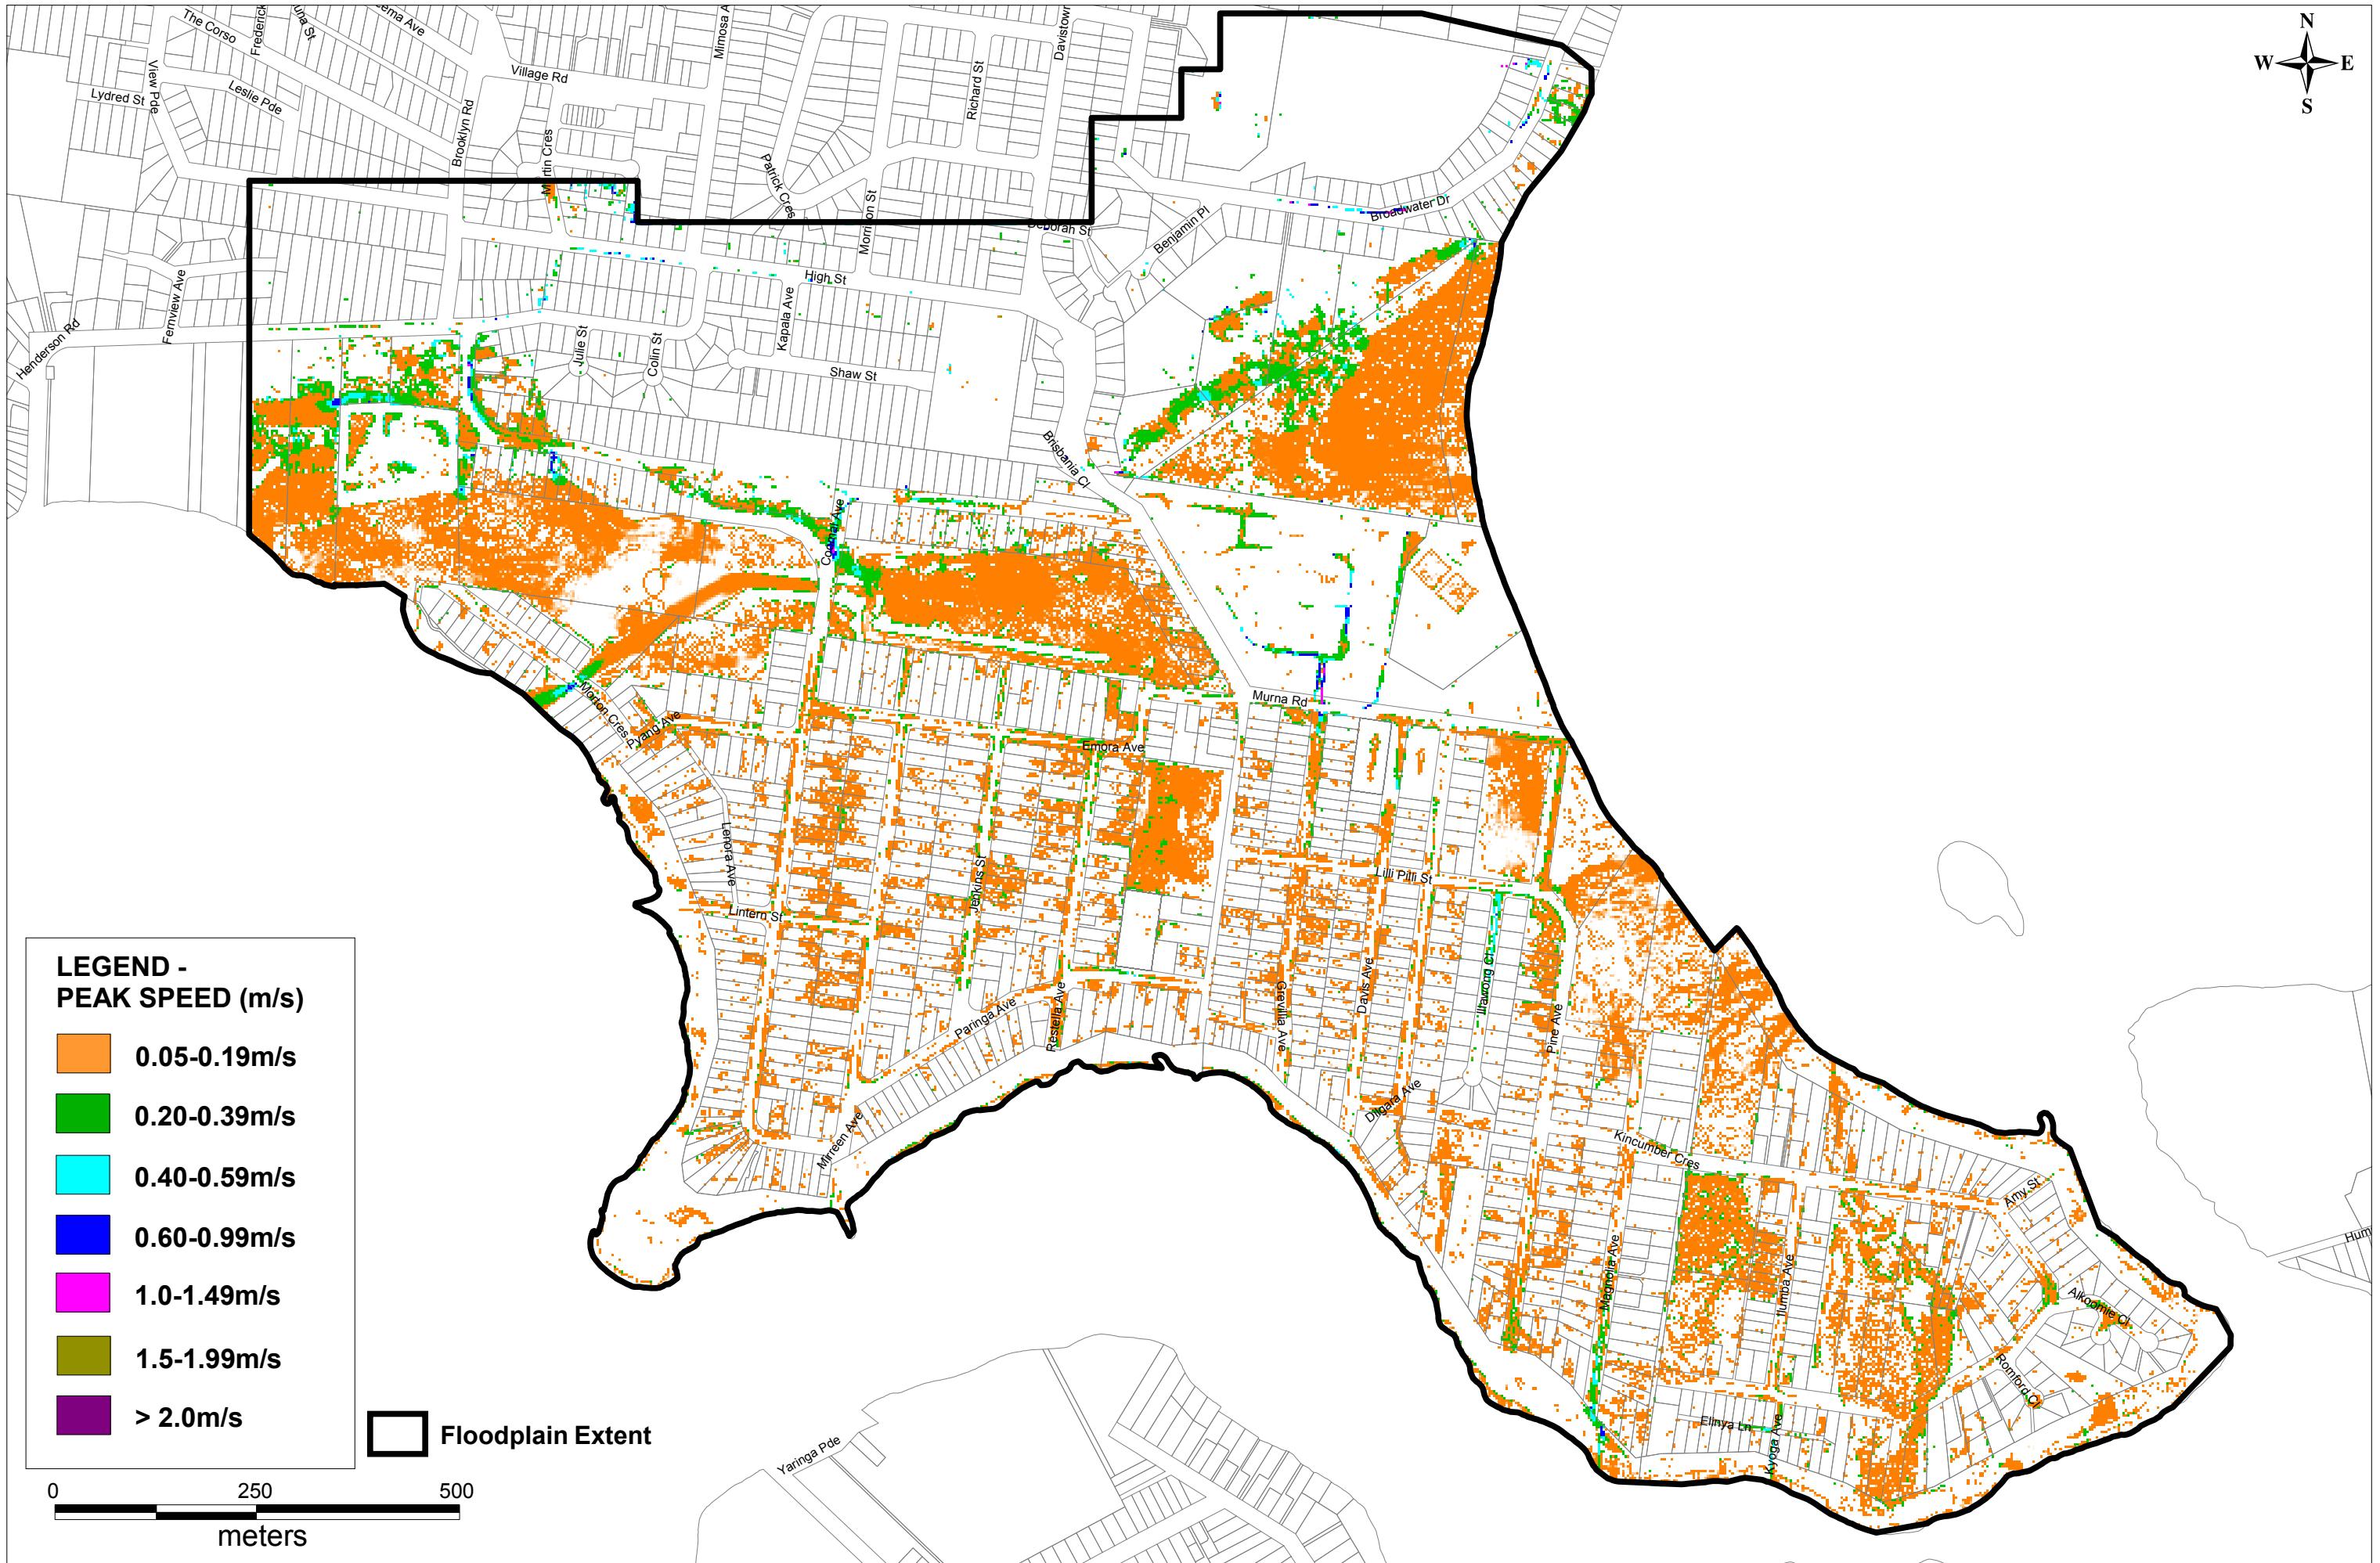
FIGURE 6.35  
PEAK SPEED - 2% AEP

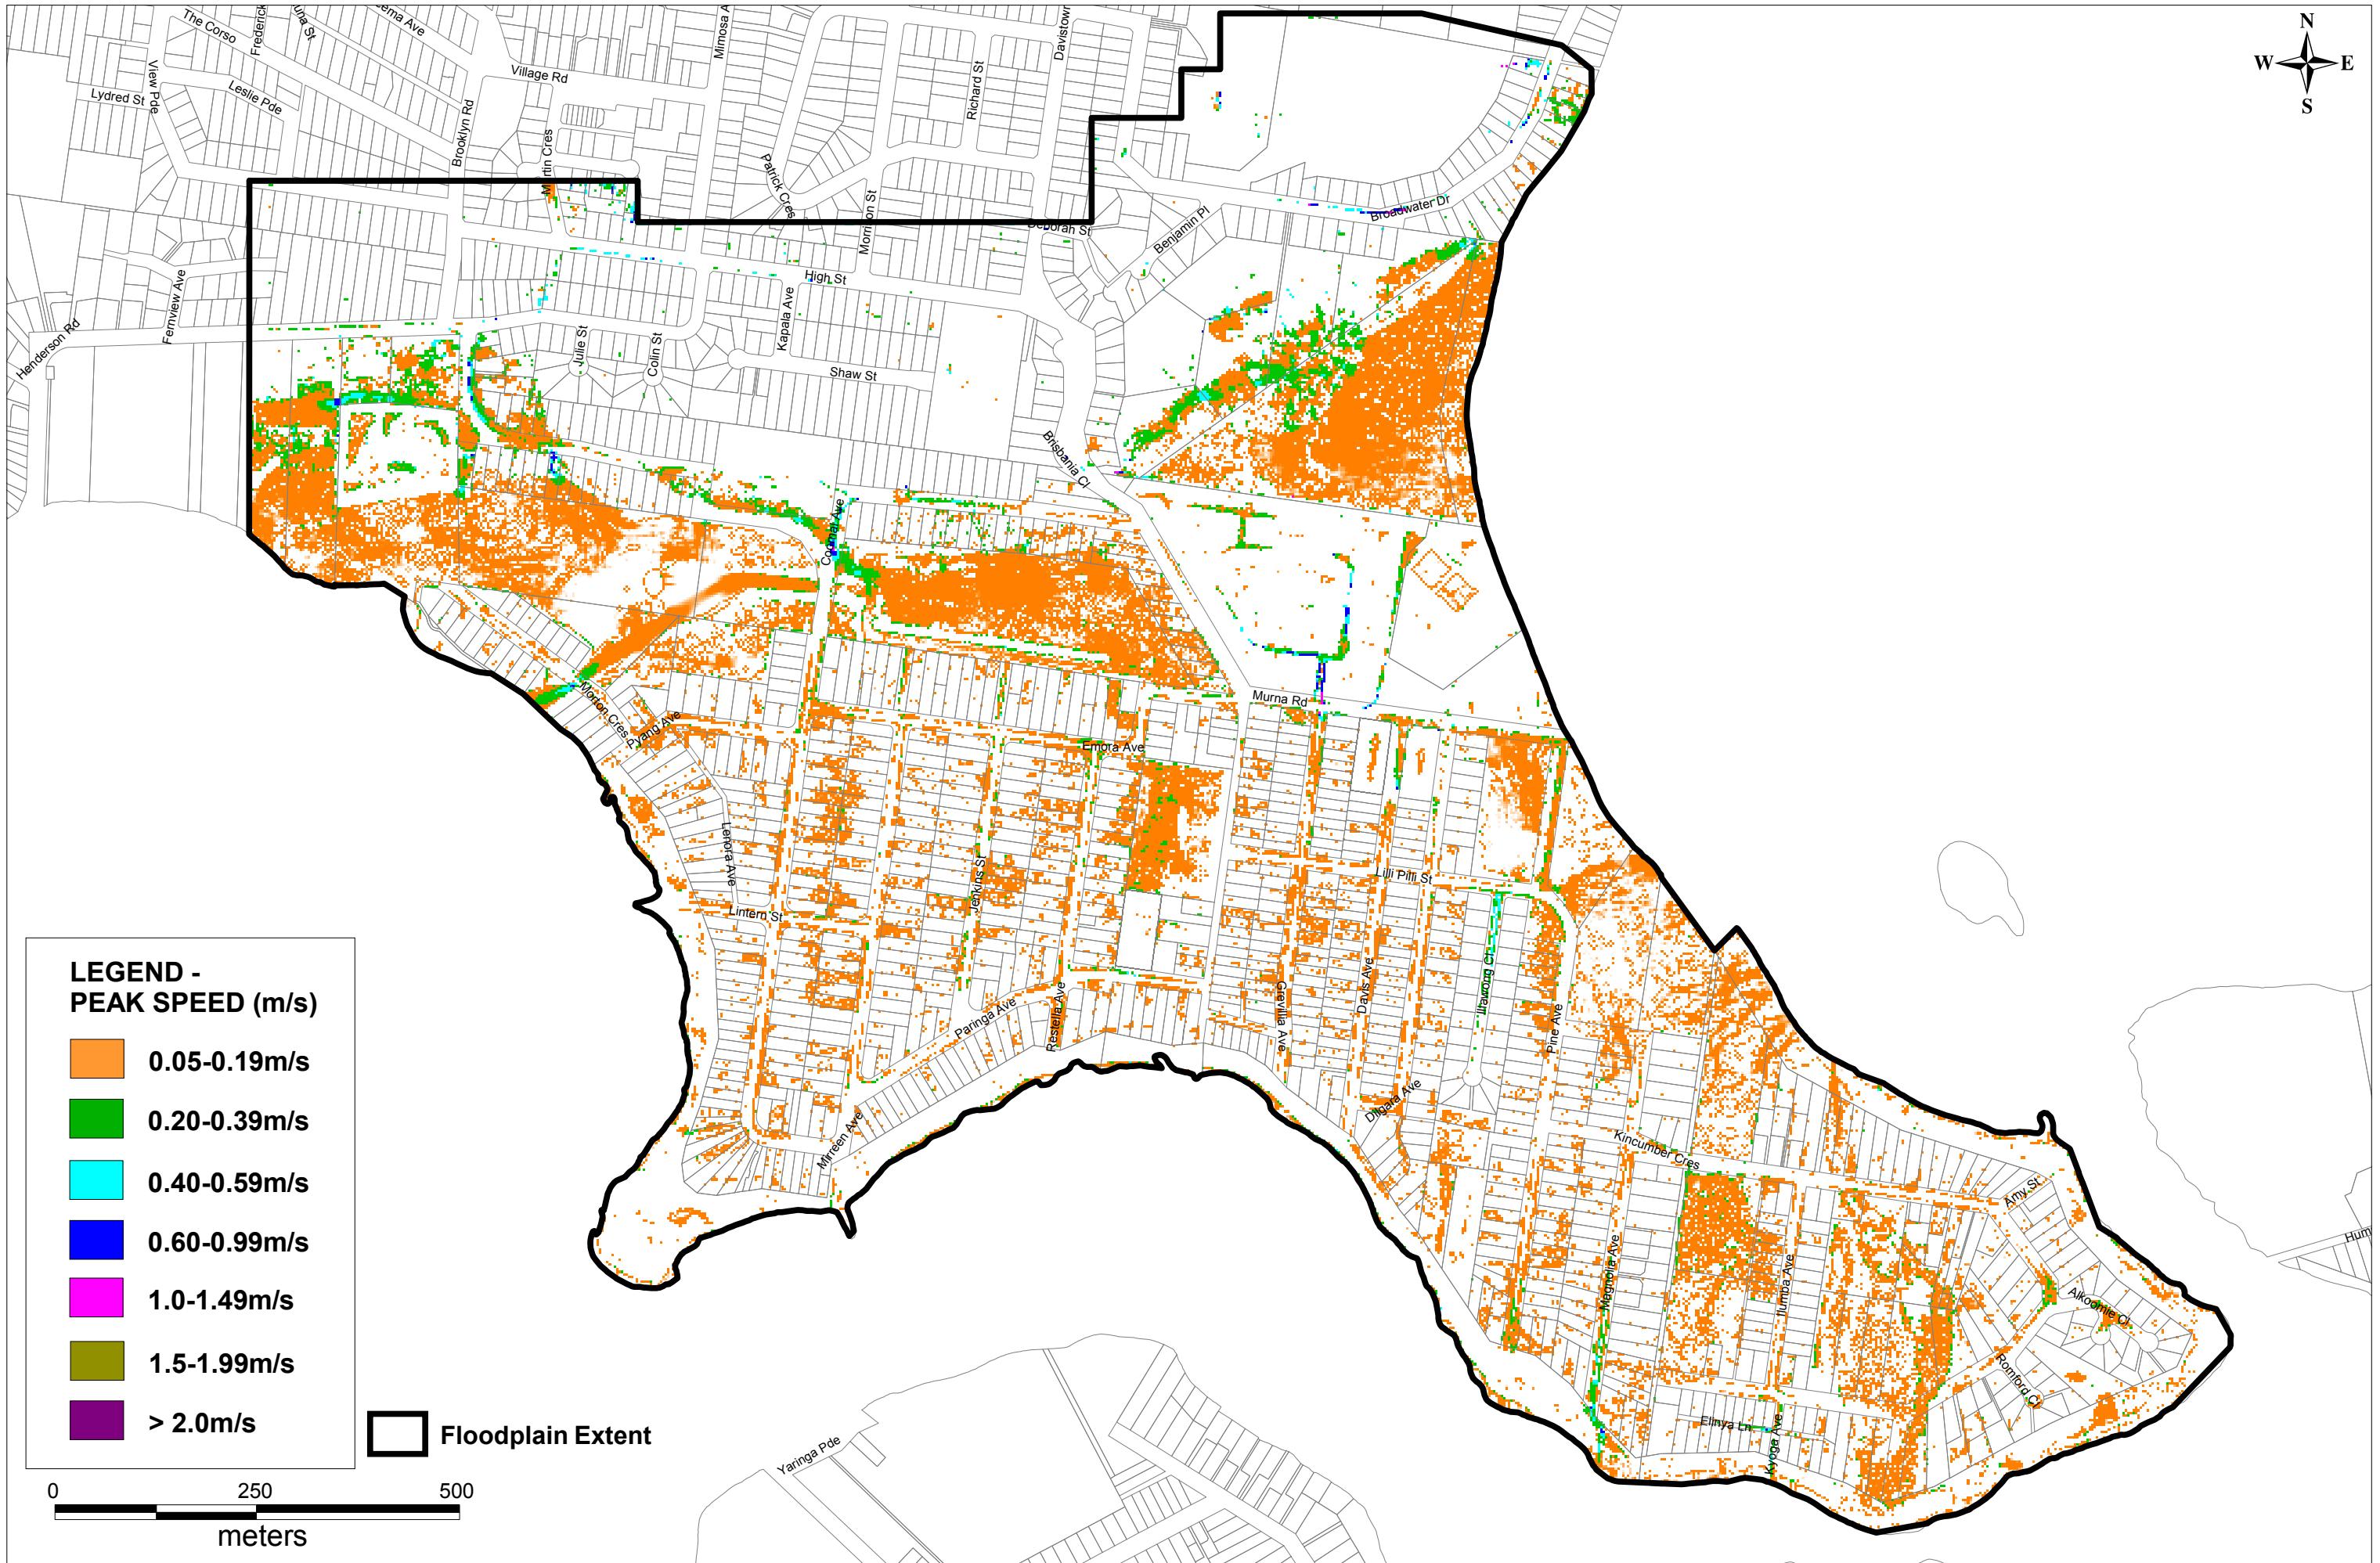
**FIGURE 6.36**  
PEAK SPEED - 5% AEP

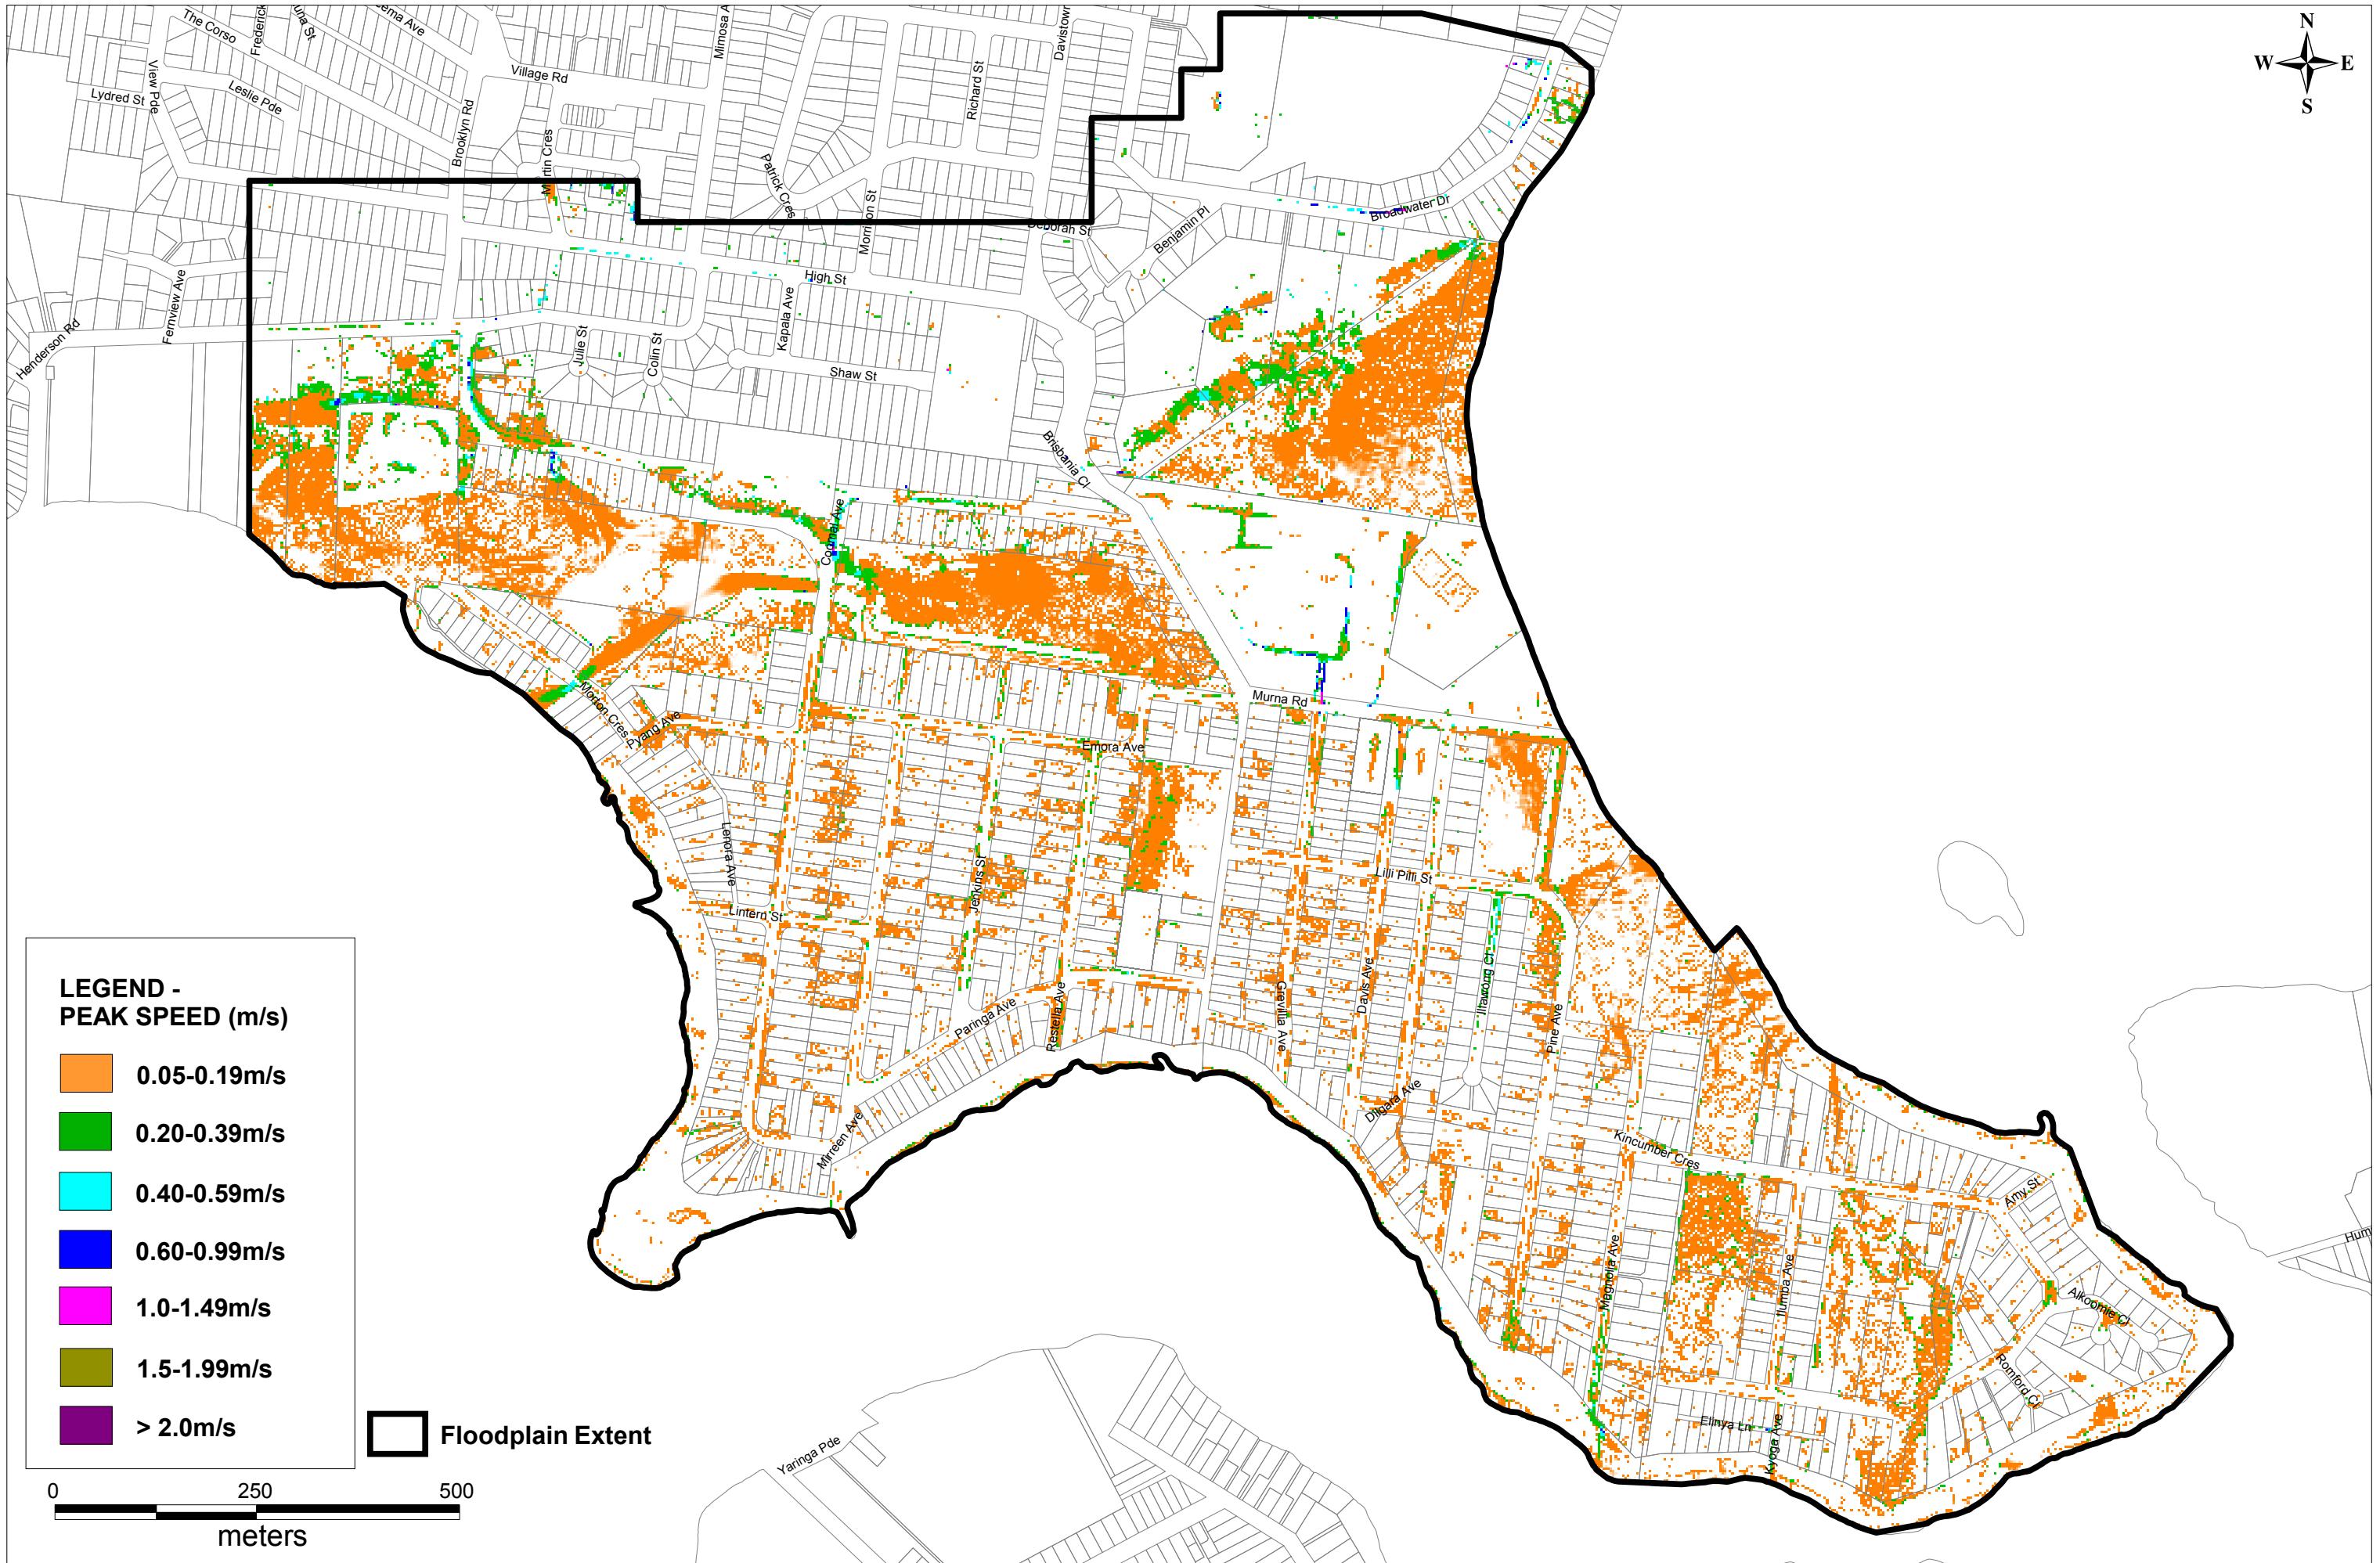
**FIGURE 6.37**  
**PEAK SPEED - 10% AEP**

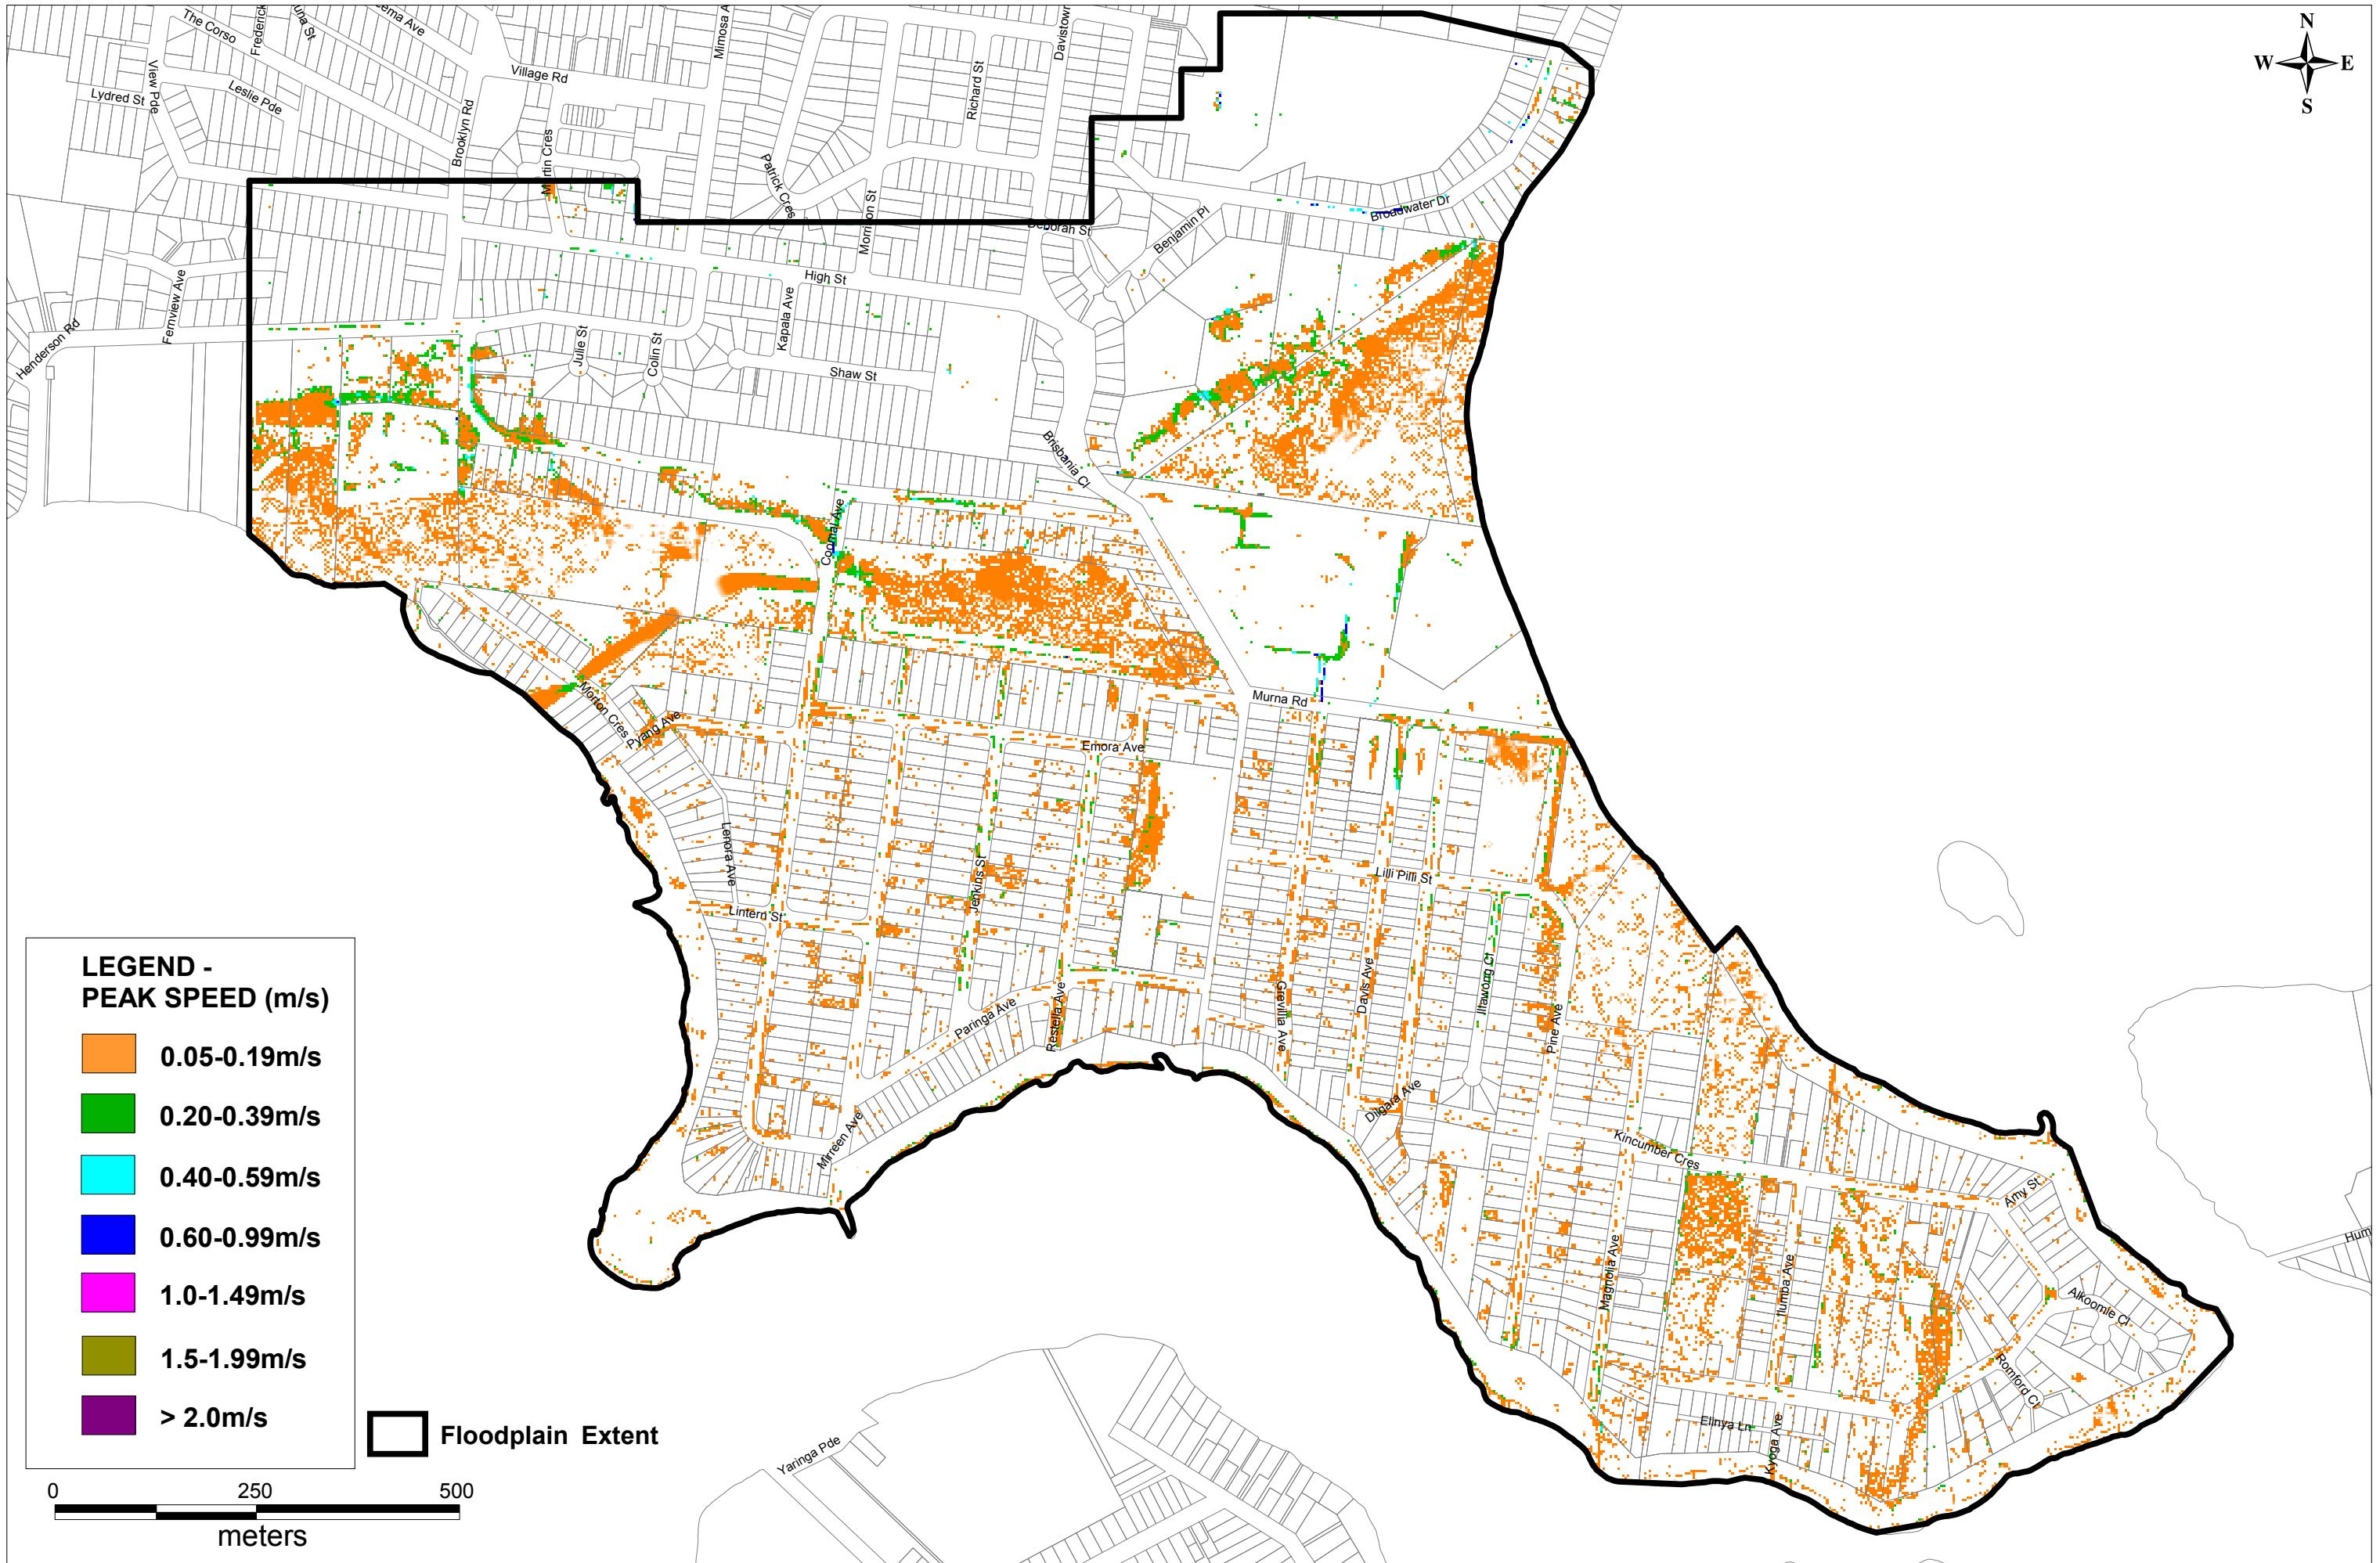
FIGURE 6.39  
PEAK SPEED - 50% AEP

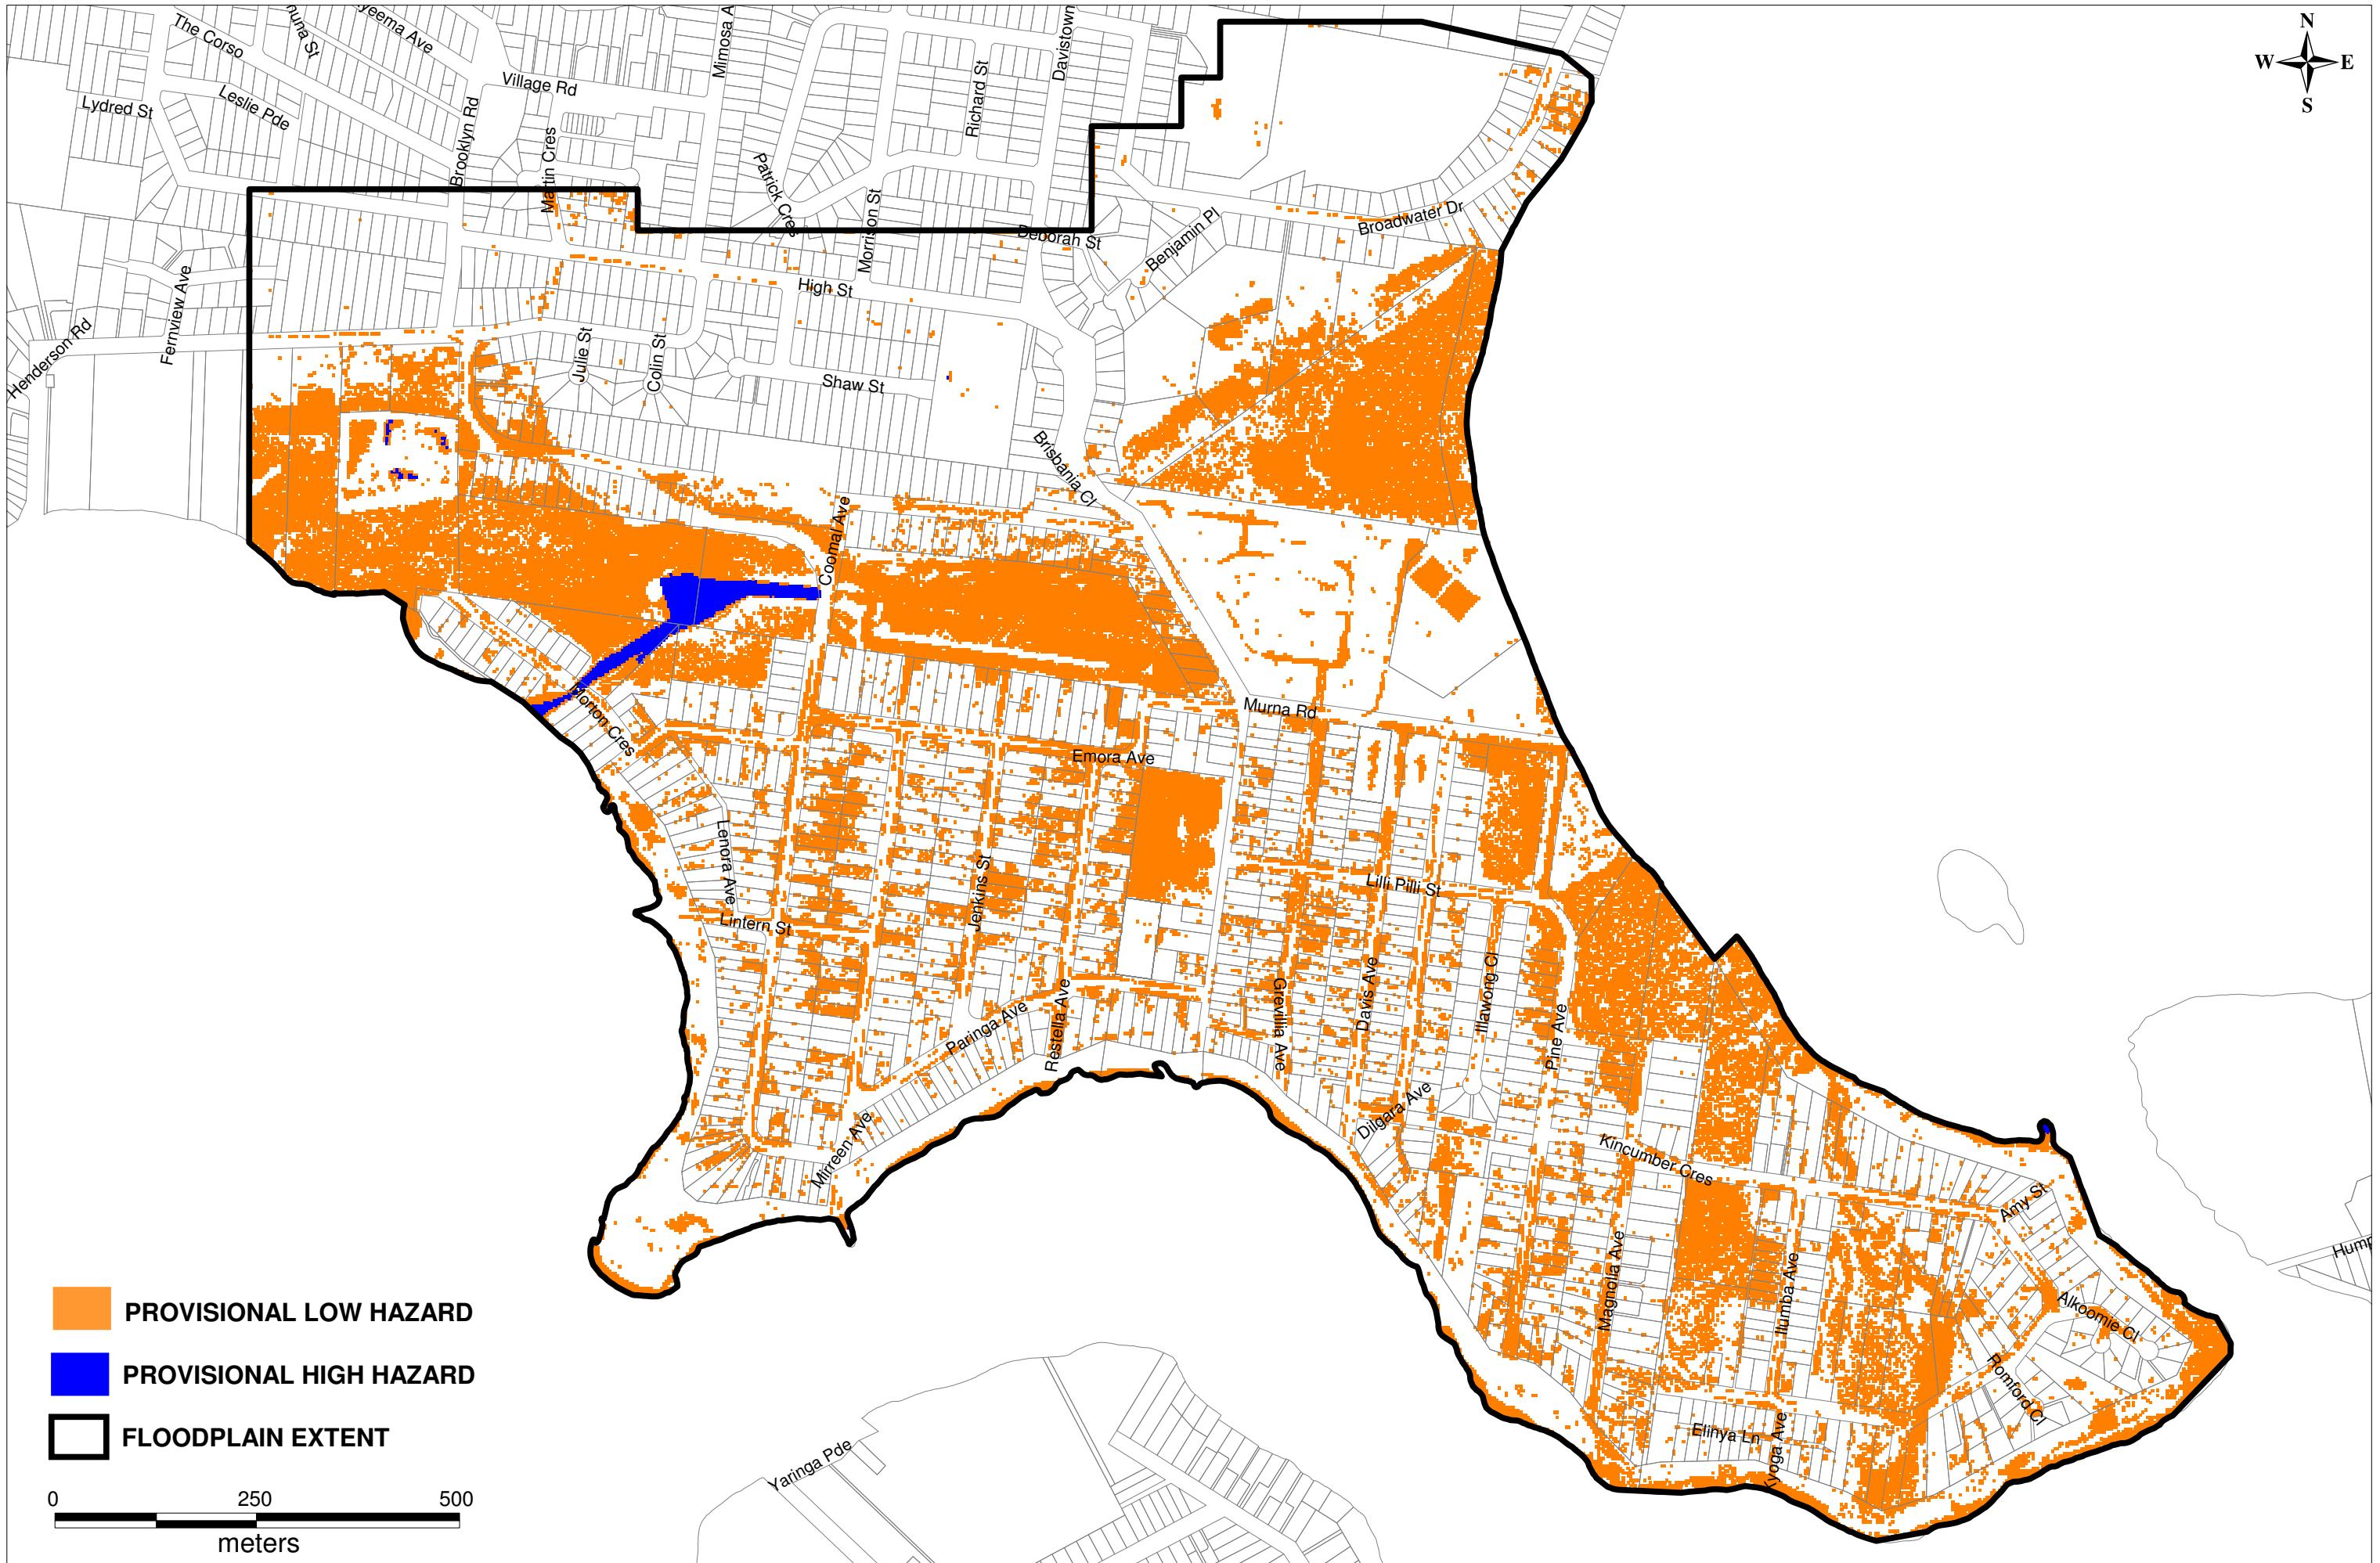
FIGURE 8.3  
PROVISIONAL HAZARD - 1% AEP
