## DAVISTOWN CATCHMENT FLOOD STUDY VOLUME 2 - FIGURES

Davistown Catchment Flood Study

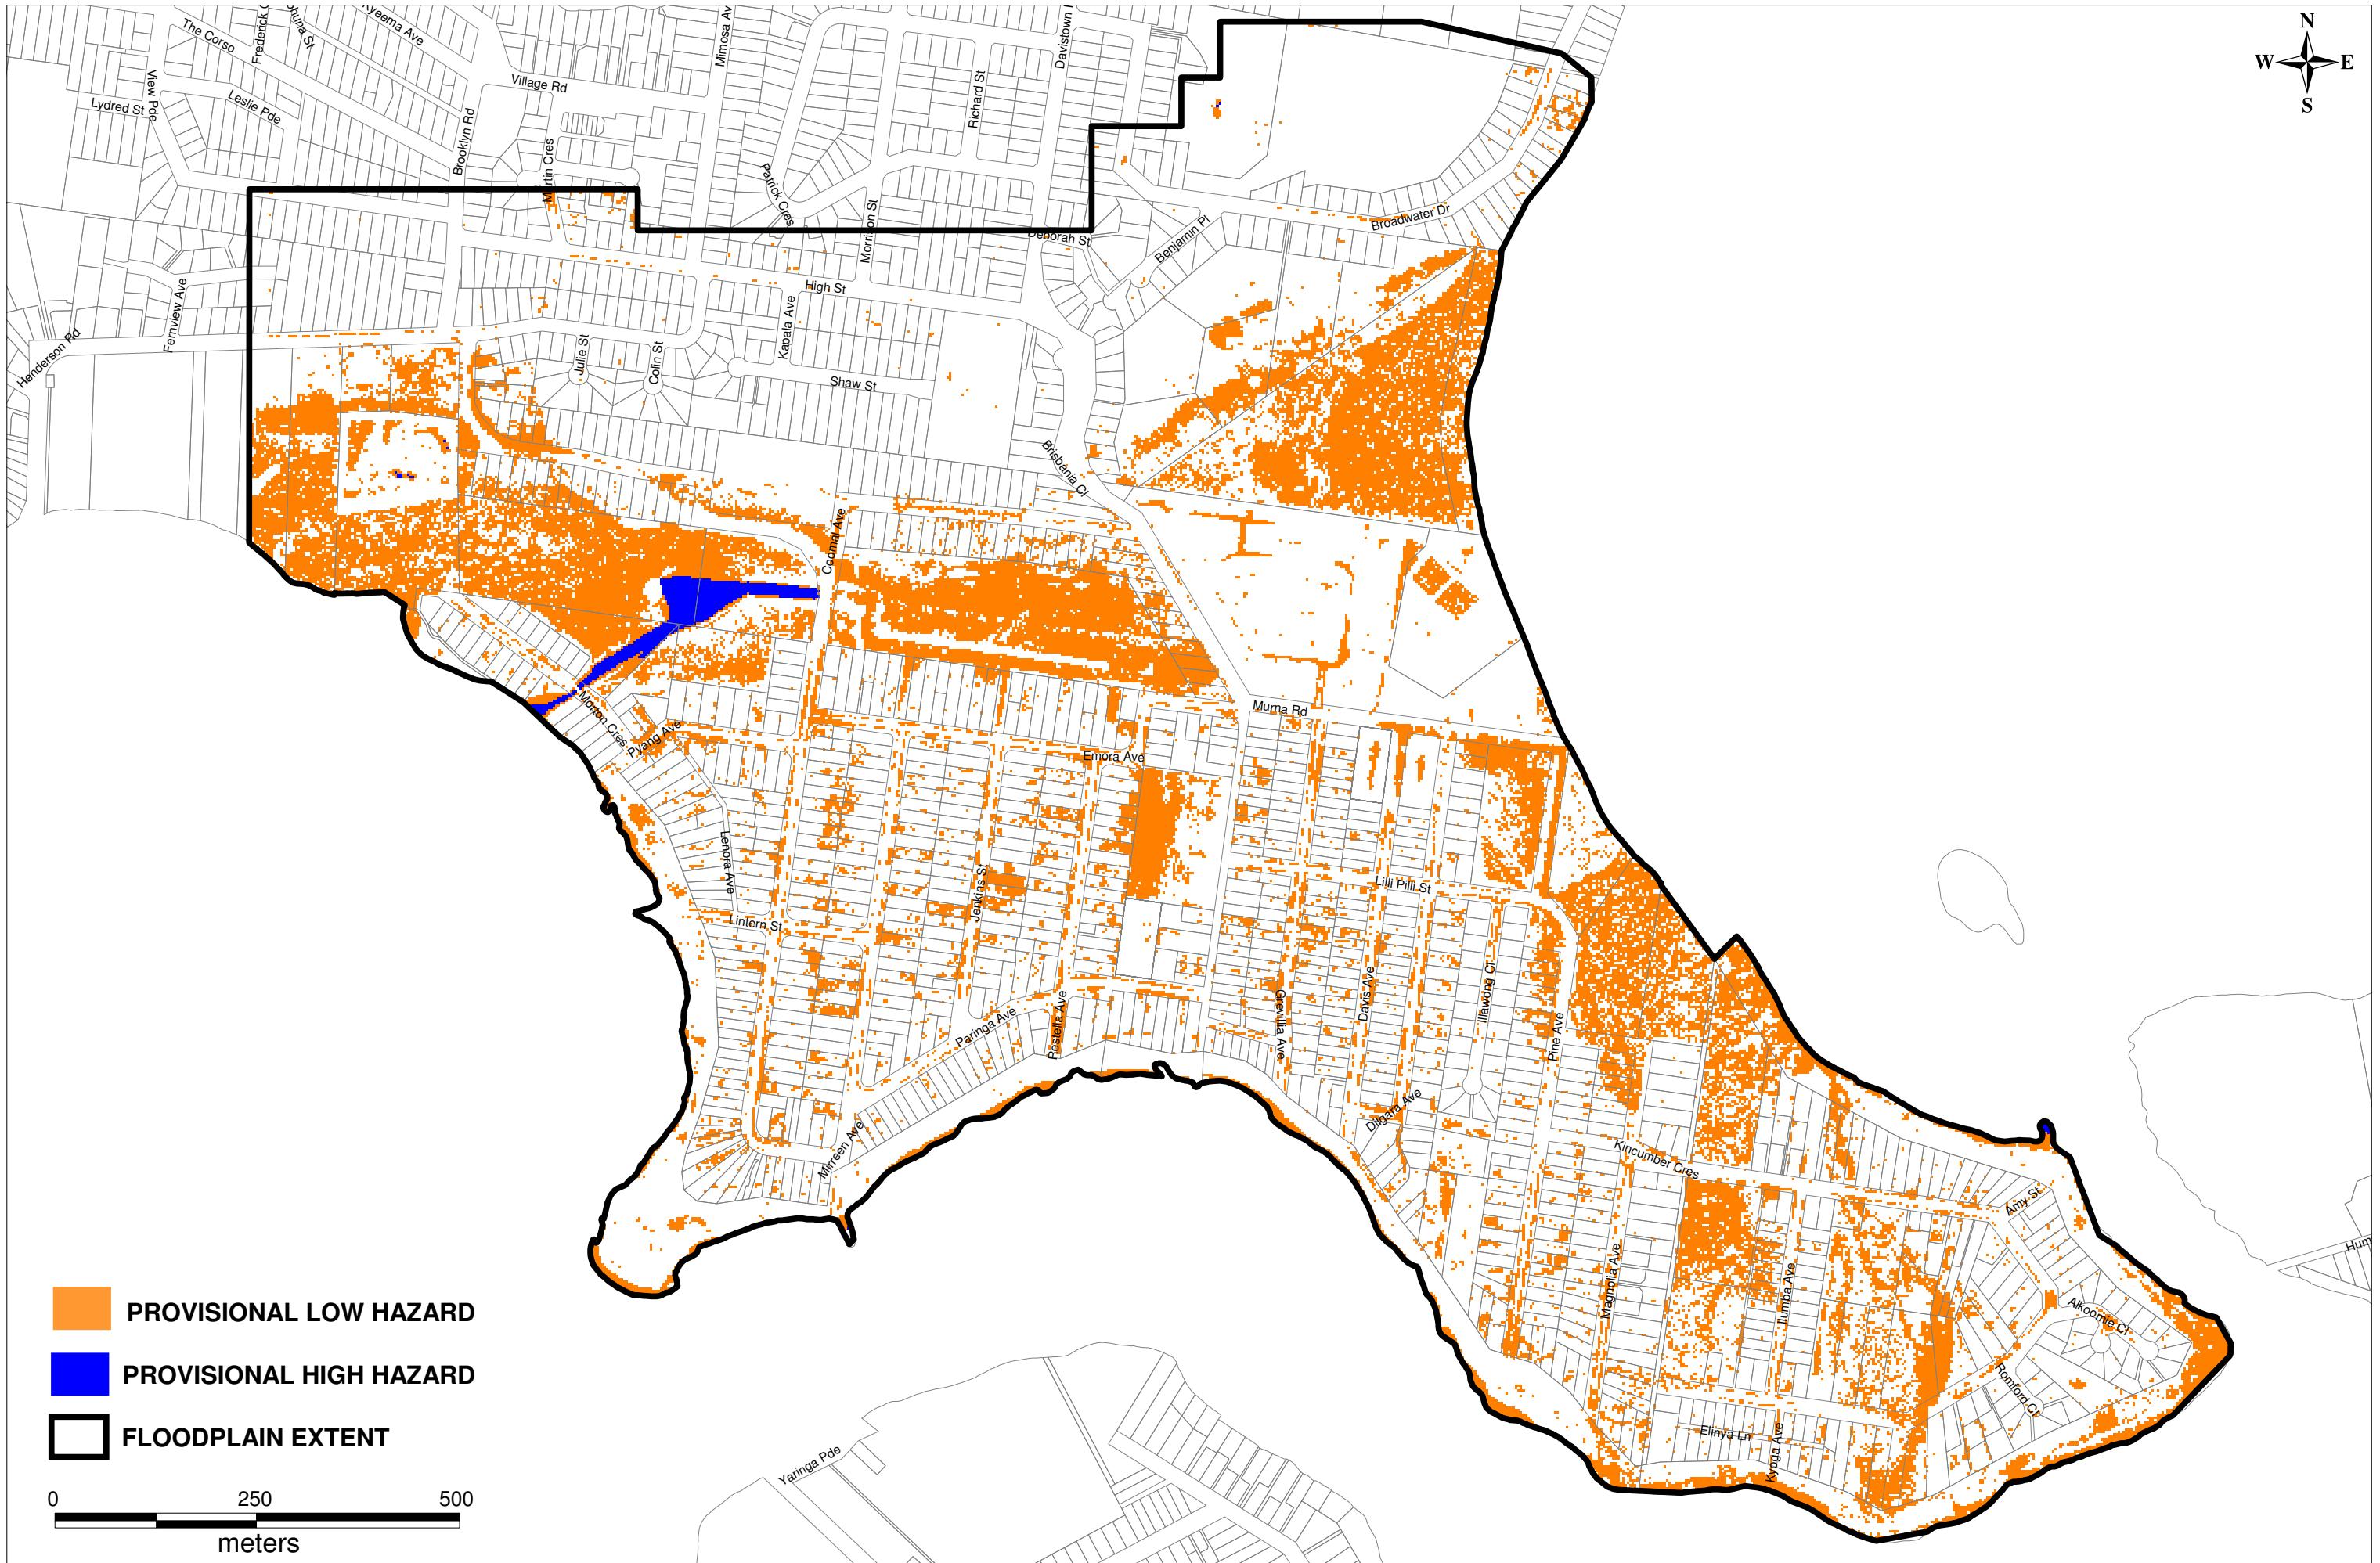
FIGURE 8.5  
PROVISIONAL HAZARD -20% AEP

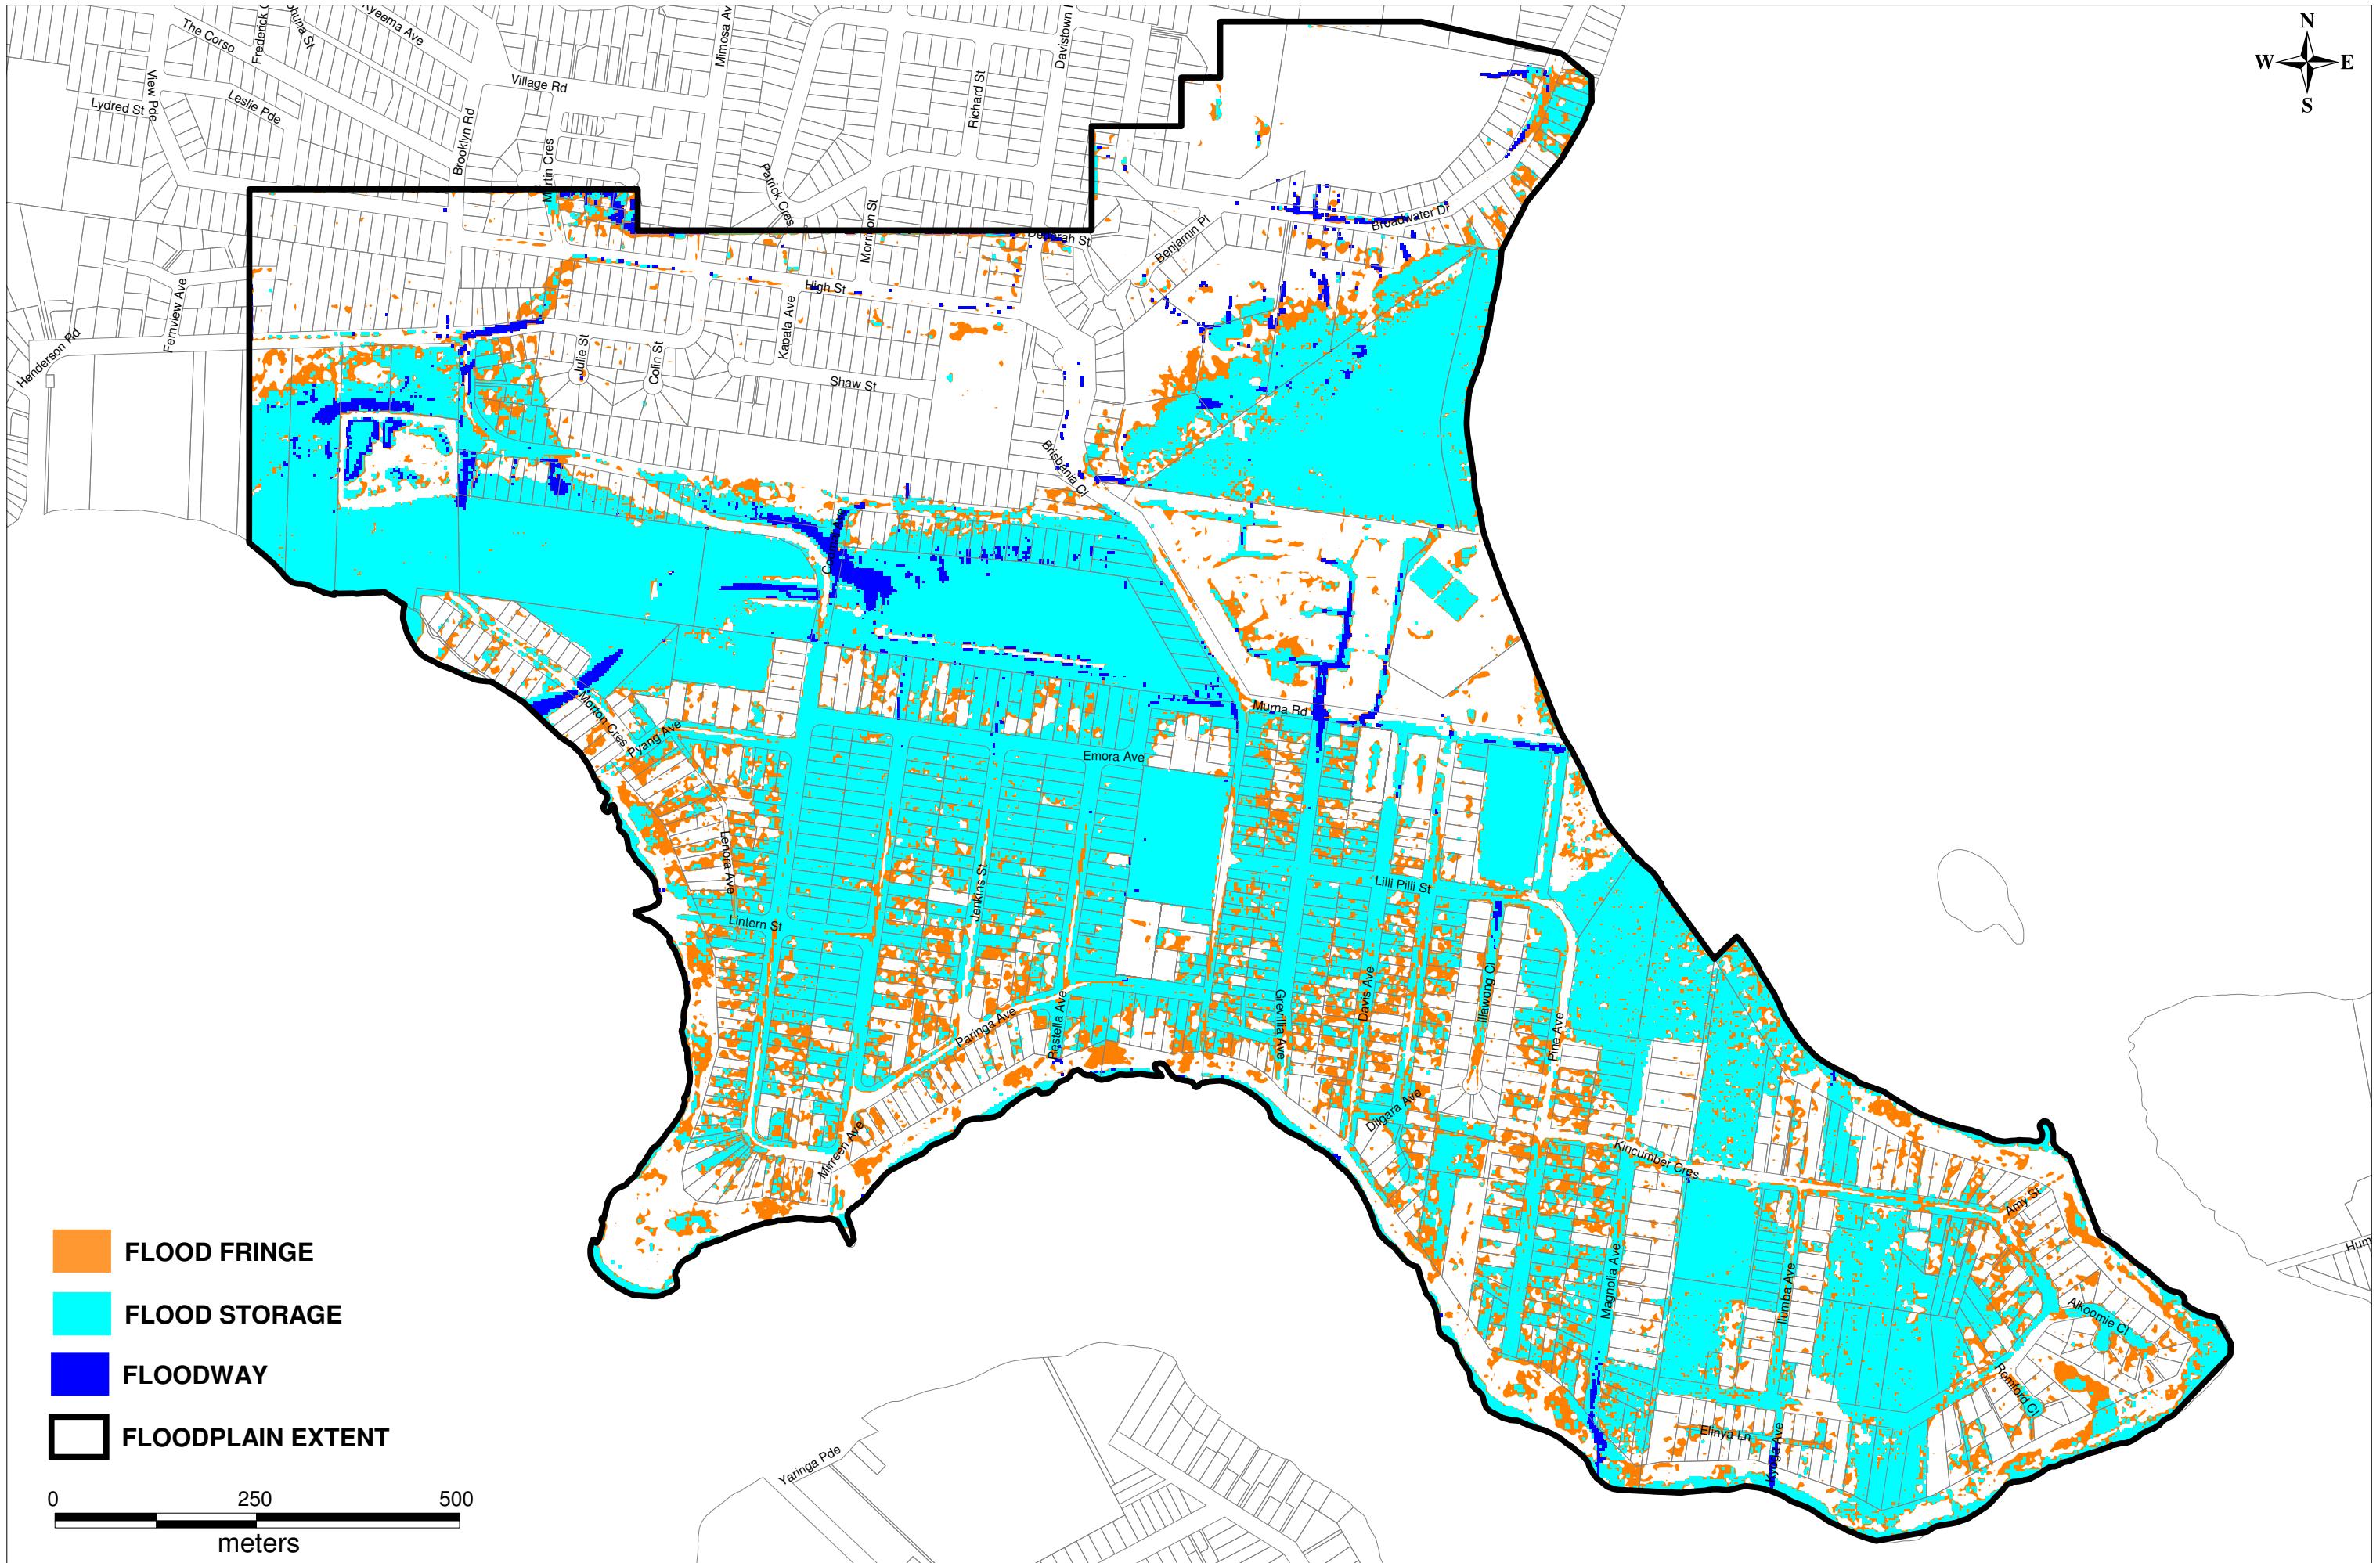
FIGURE 9.1  
HYDRAULIC CATEGORY - PMF

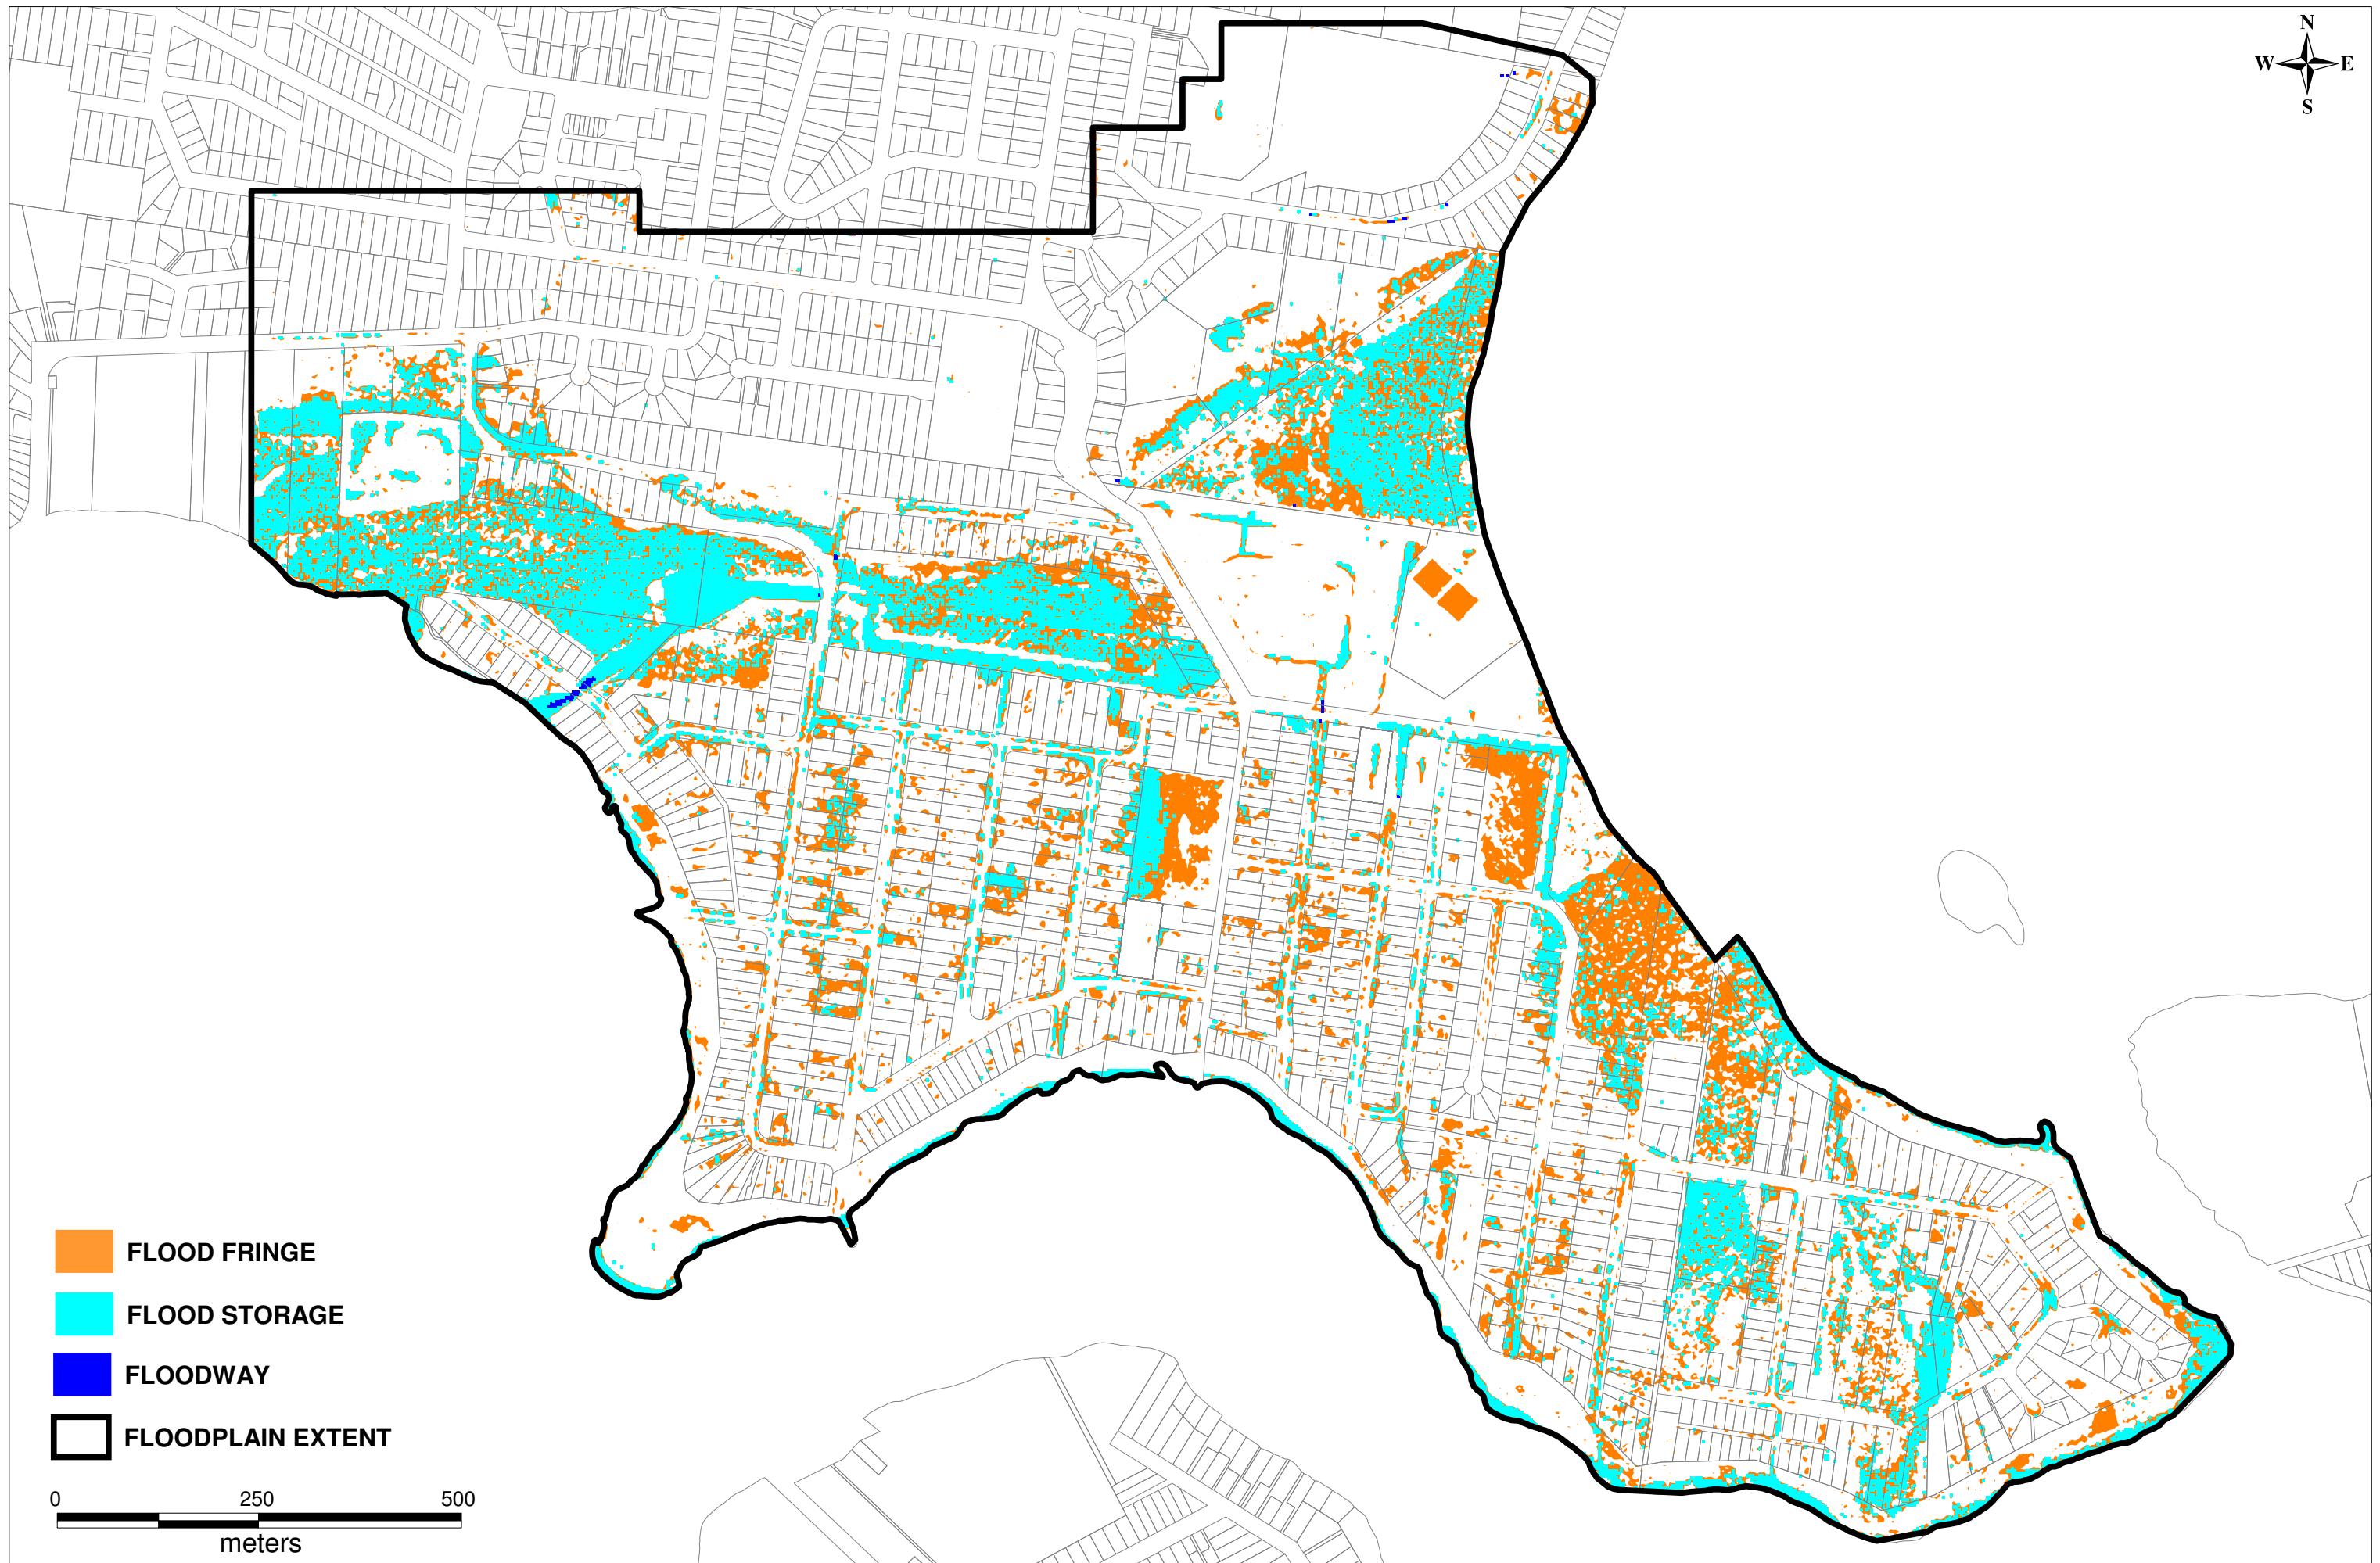
FIGURE 9.3  
HYDRAULIC CATEGORY - 5% AEP

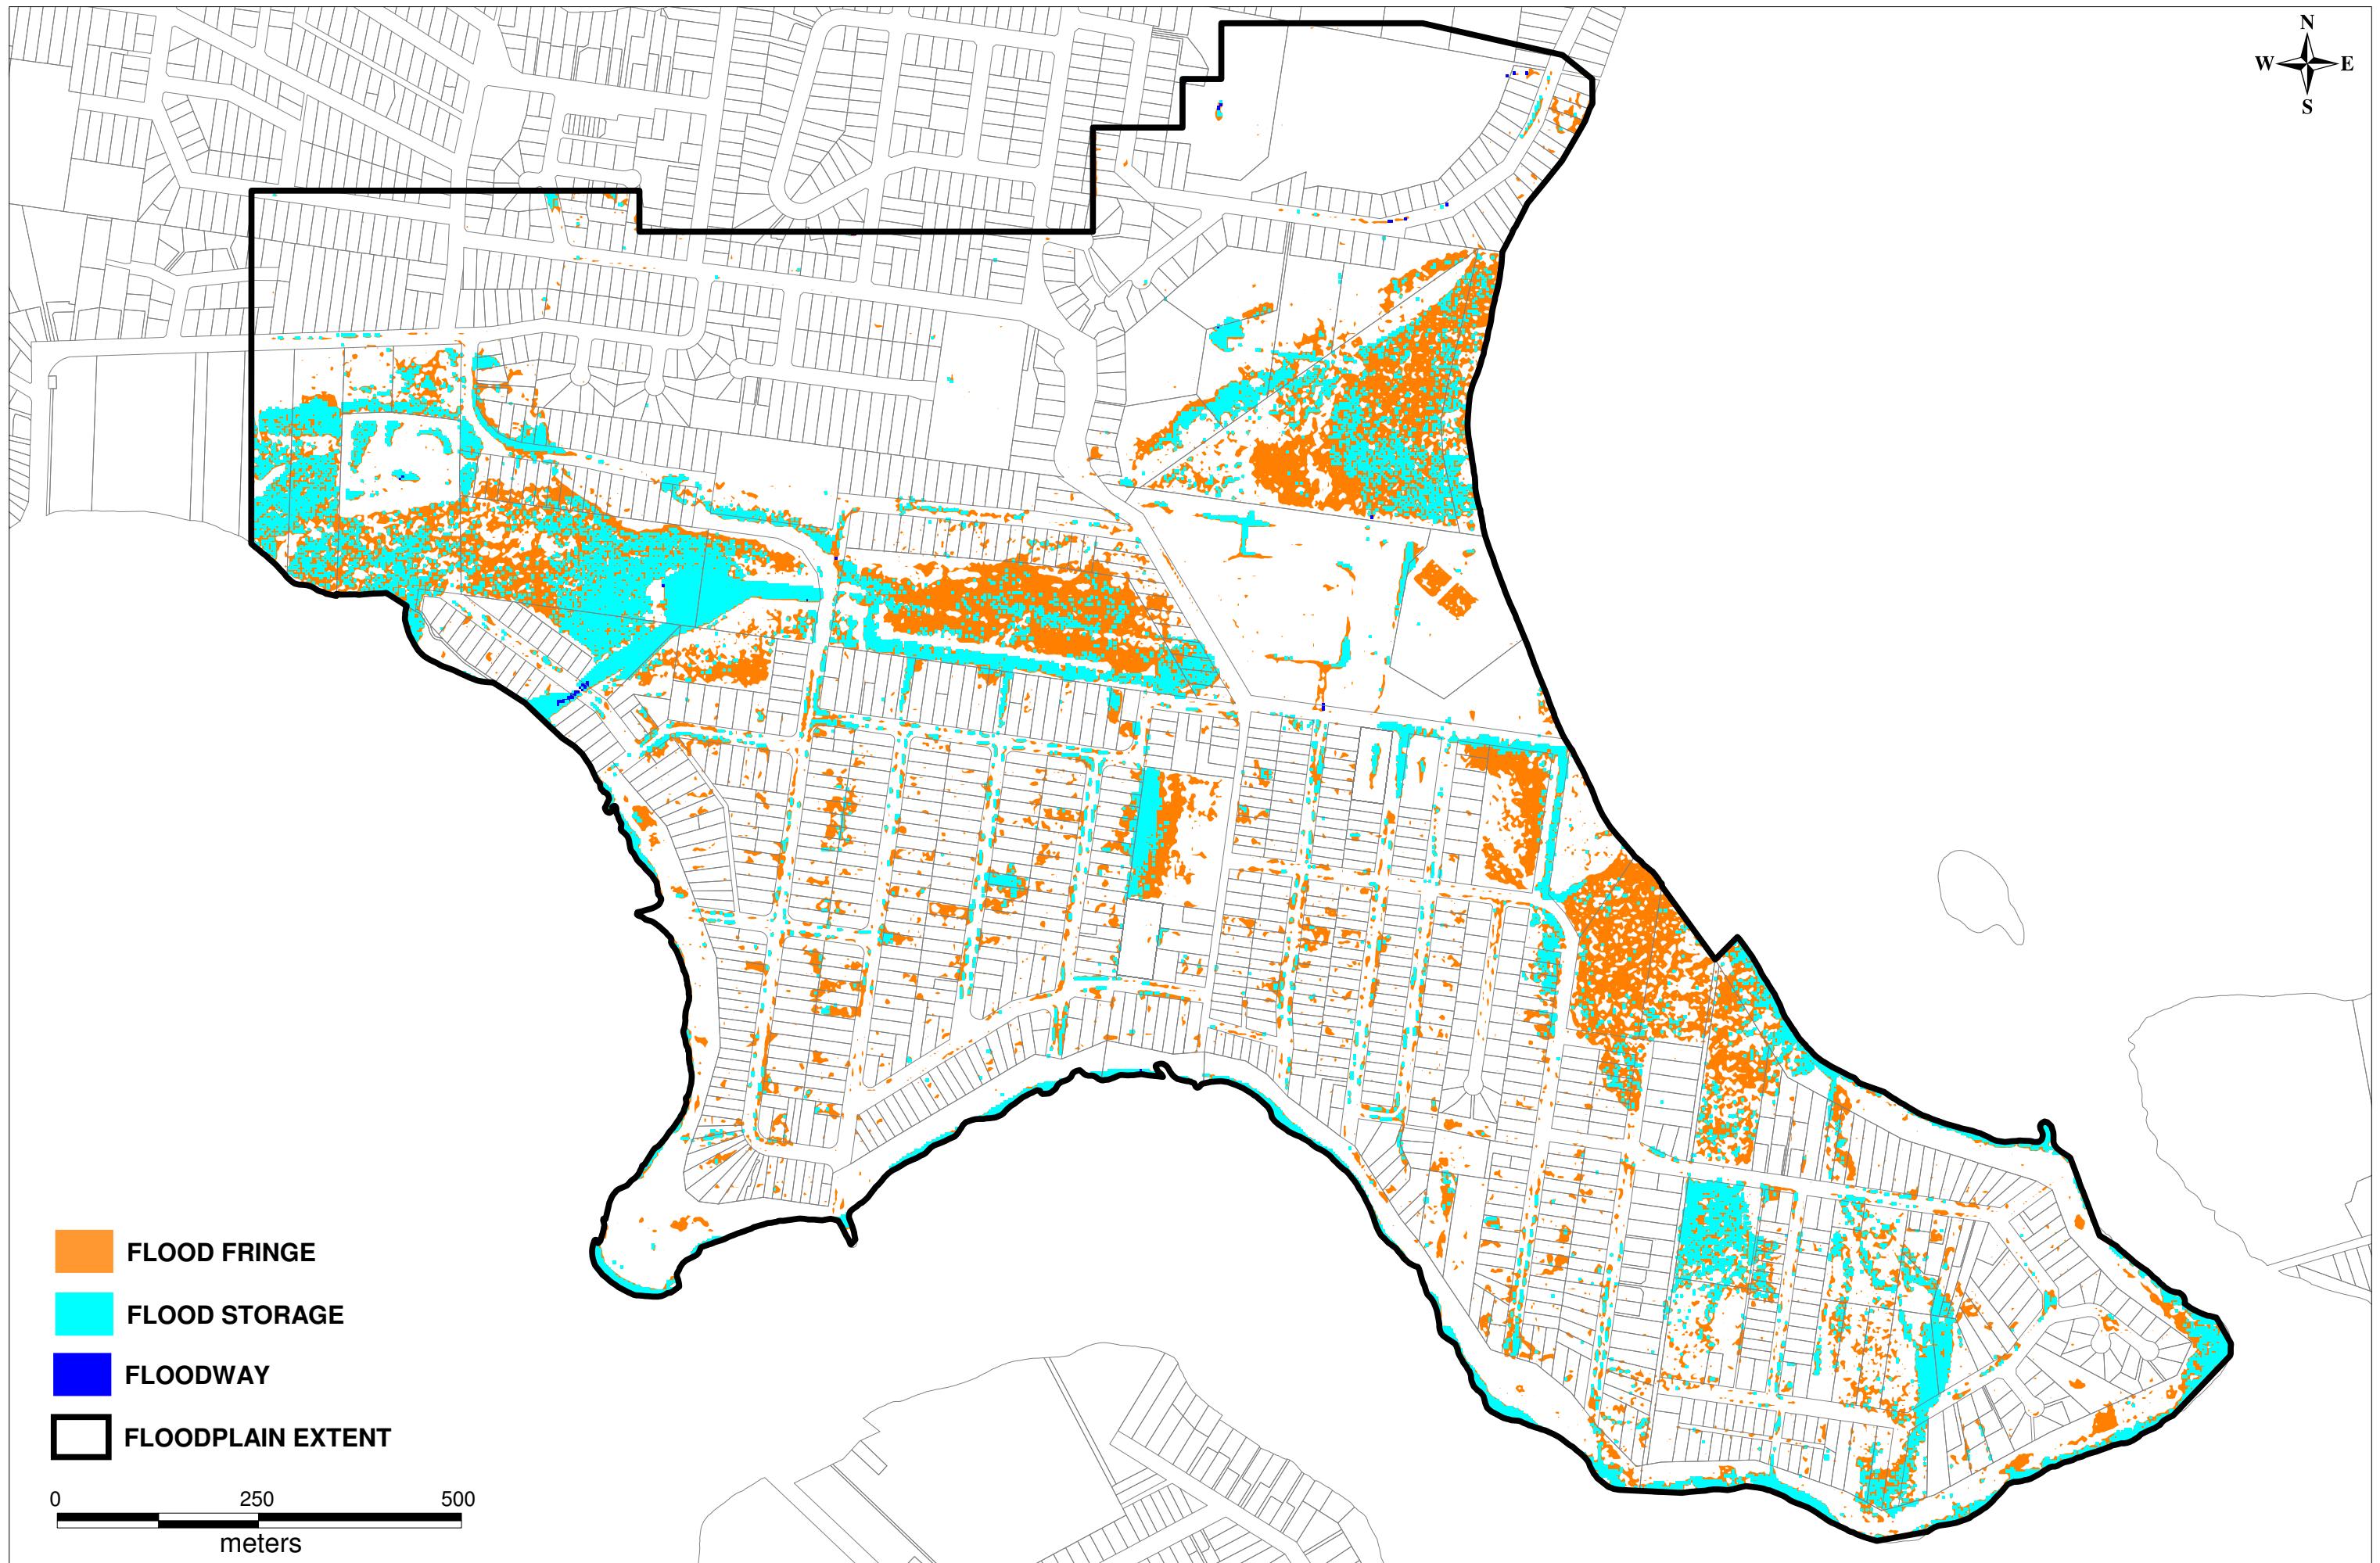
FIGURE 9.4  
HYDRAULIC CATEGORY - 20% AEP

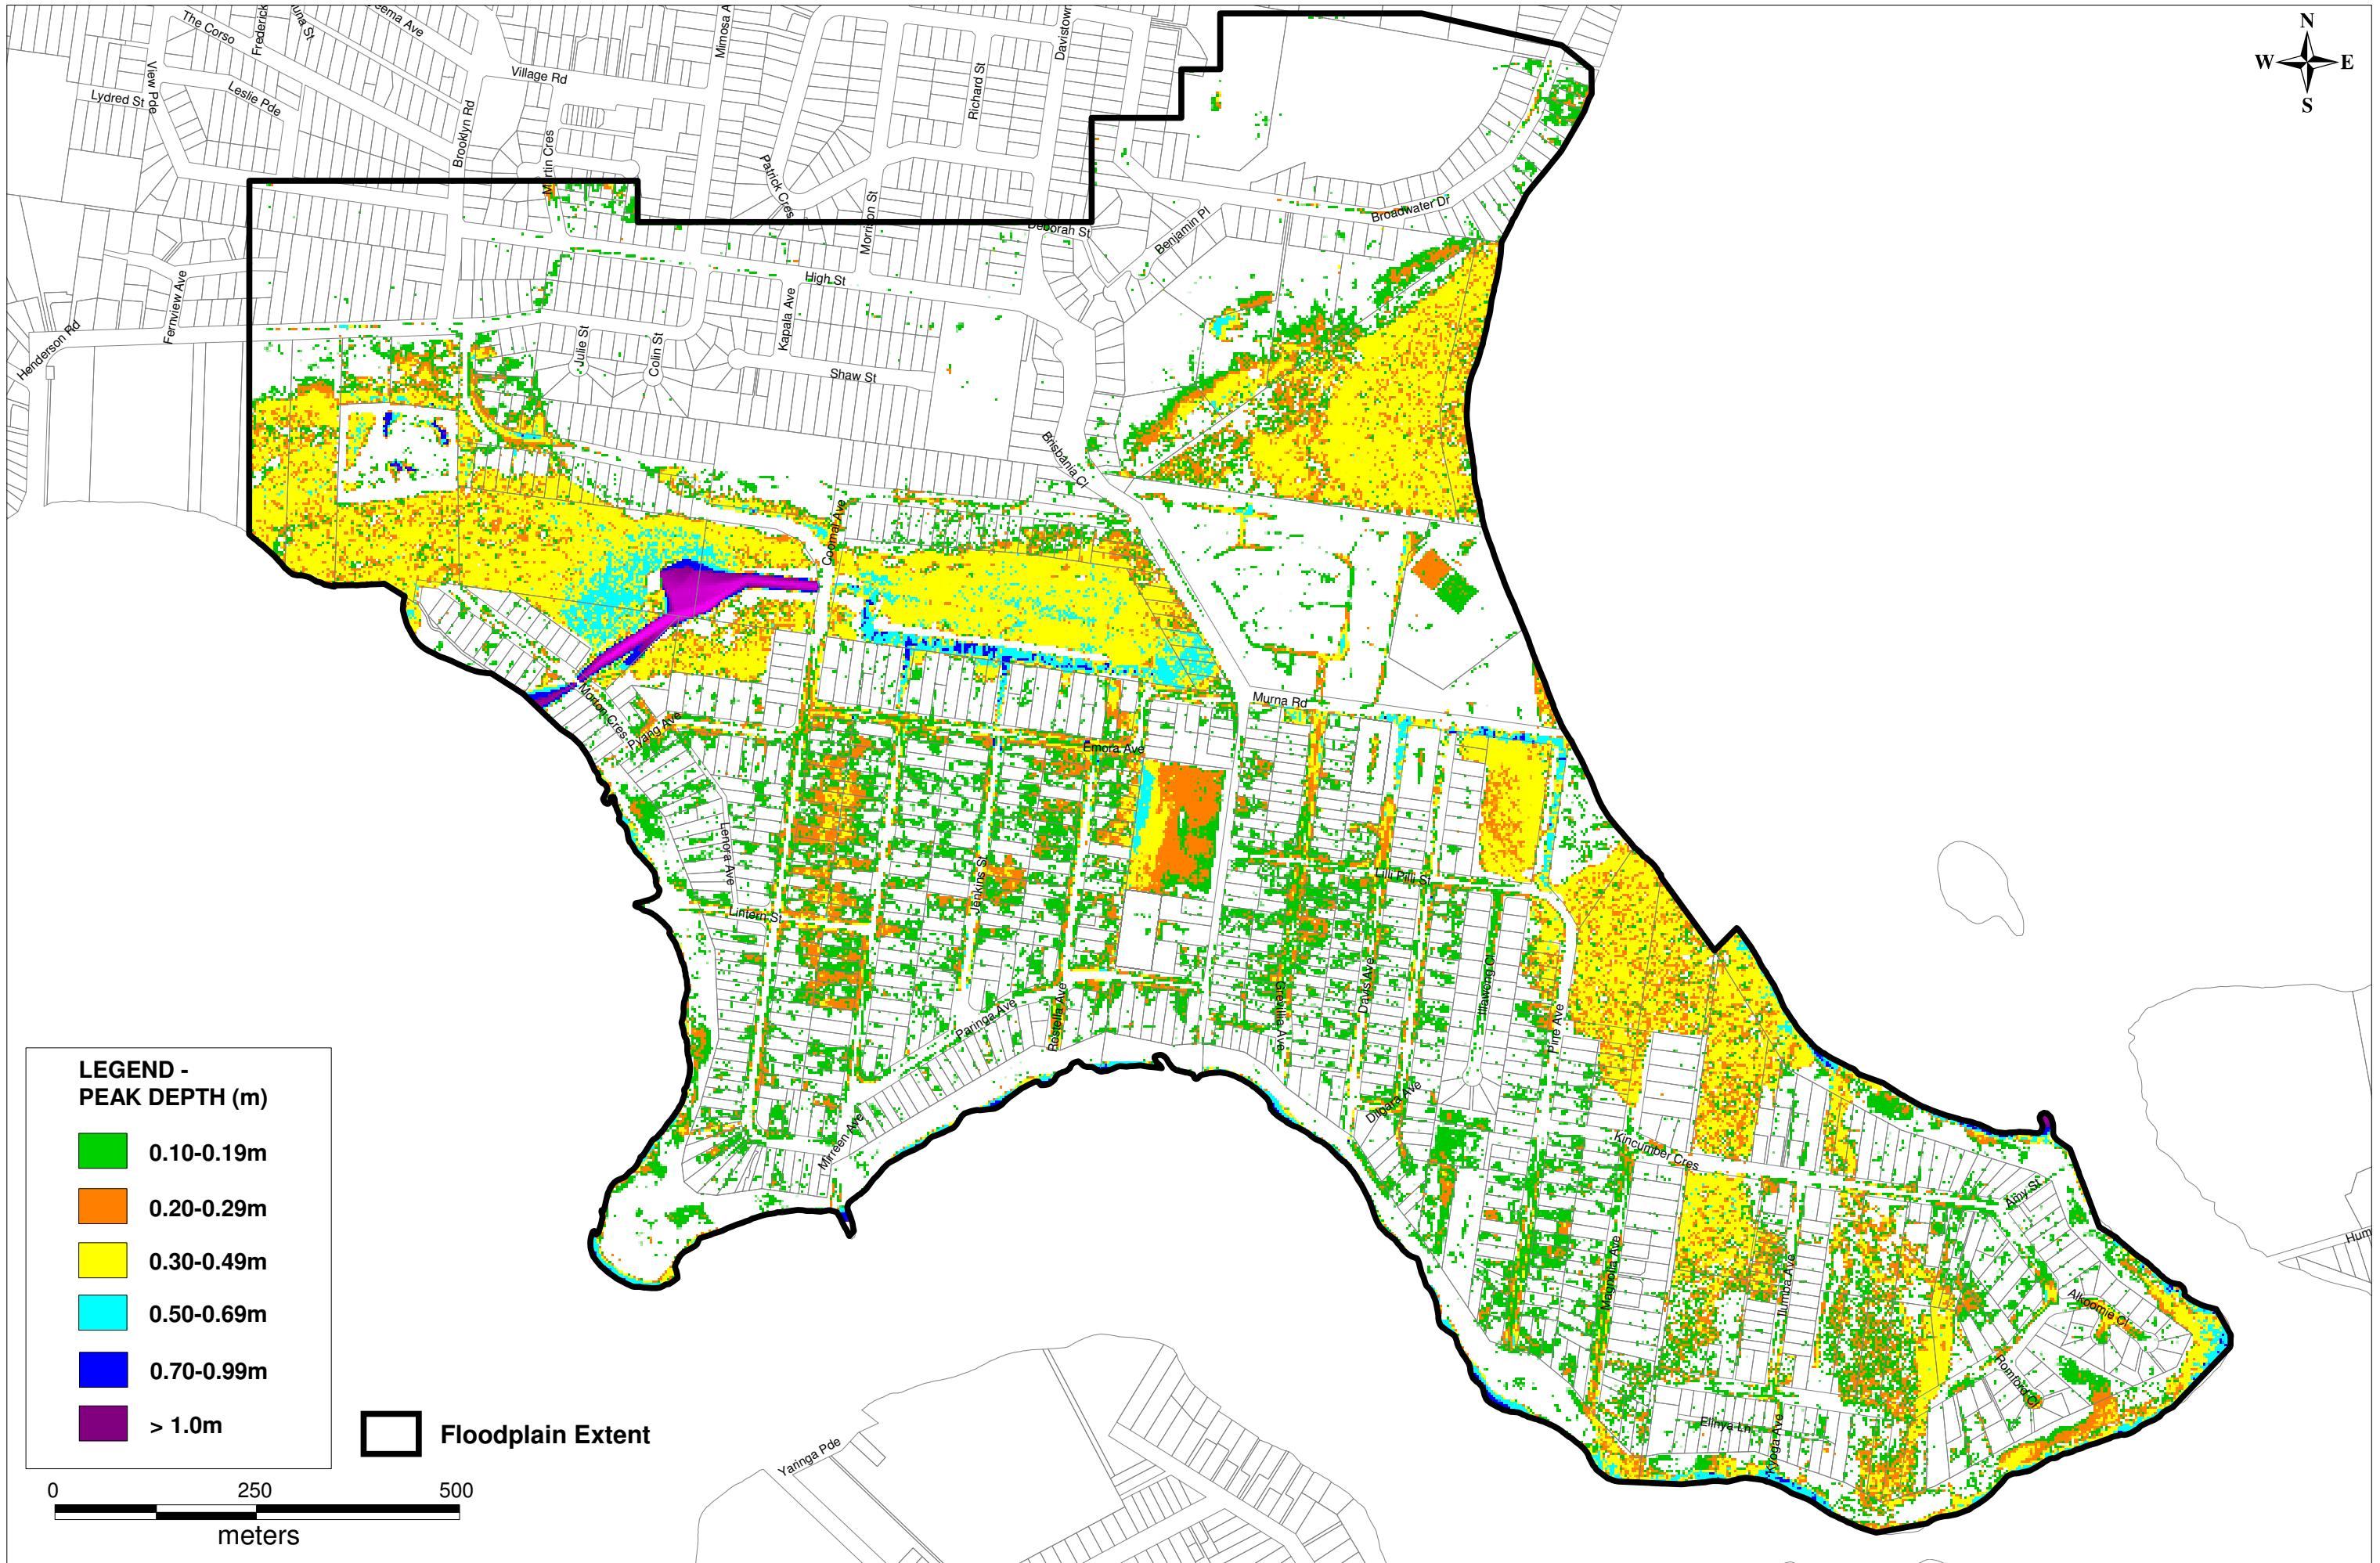
FIGURE 11.1

PEAK DEPTH - CLIMATE CHANGE 1% AEP 2h

30% INCREASE IN RAINFALL & 0.2m RISE IN ESTUARY LEVEL

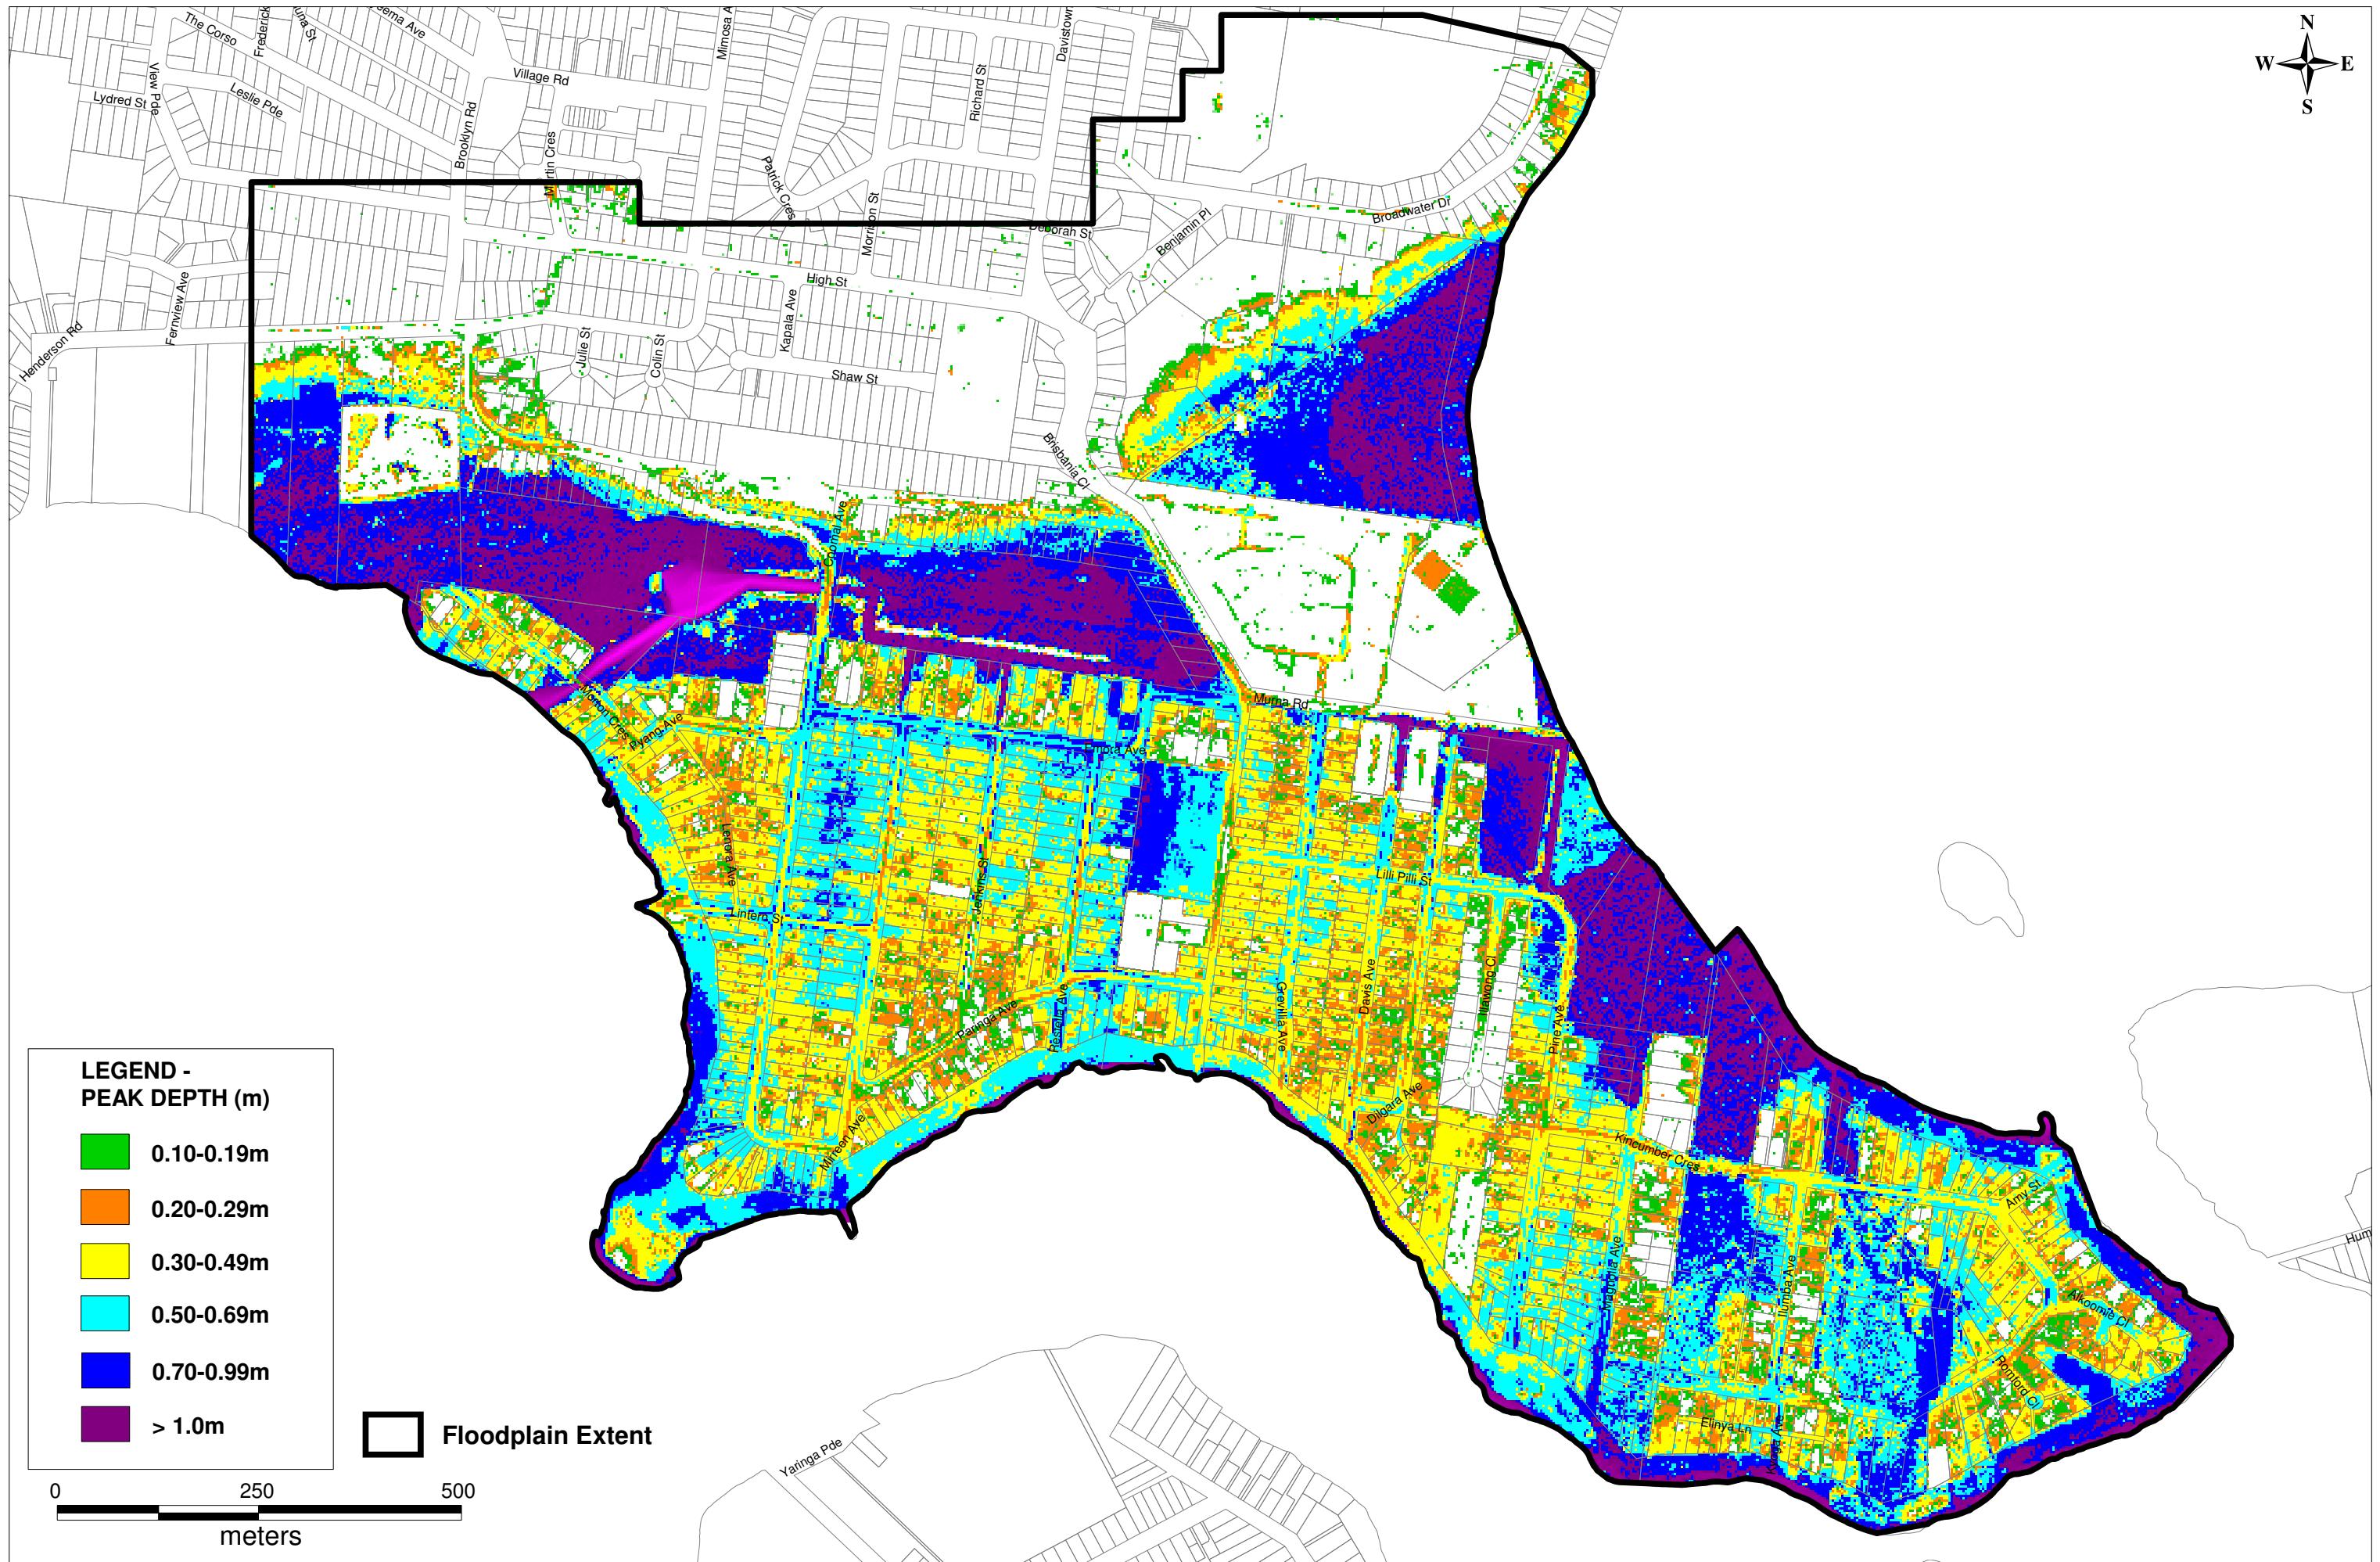
FIGURE 11.2

PEAK DEPTH - CLIMATE CHANGE 1% AEP 2h  
30% INCREASE IN RAINFALL & 0.91m RISE IN ESTUARY LEVEL
