MUDFLAT CREEK FLOOD STUDY

NOVEMBER 2006

GOSFORD CITY COUNCIL

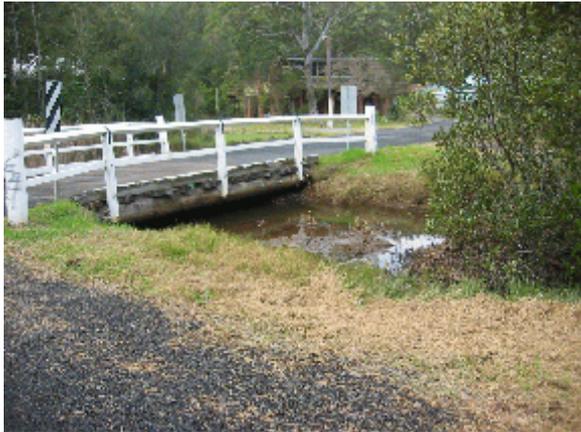
Photograph 1: Noble Road Bridge looking upstream.

Some of the significant features of the creek are illustrated in Photographs 1 to 10 as shown on the following pages and are referred to in Tables 1 and 2.

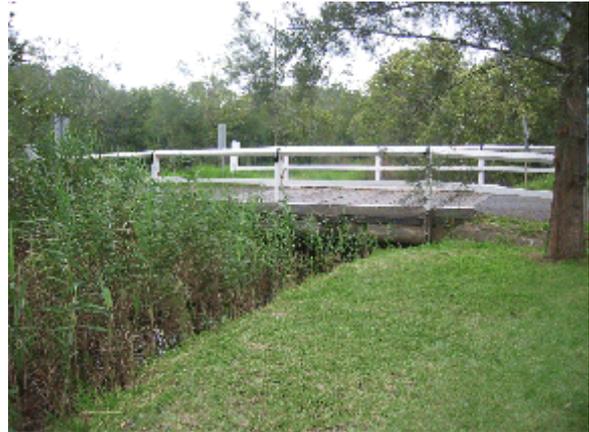
Photograph 2: Noble Road Bridge looking downstream. Note extent of reed and mangrove vegetation.

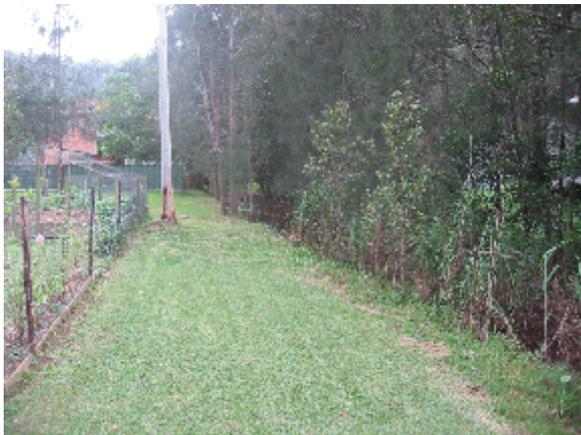
Photograph 3: Looking upstream from Noble Road Bridge. Note varying overbank area due to gardens, fences and sheds.

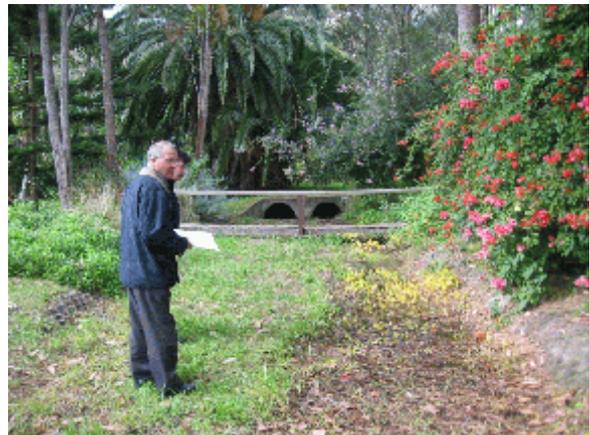
Photograph 4: Twin 900 mm diameter pipe outlet into Mudflat Creek at rear of 57 Fraser Road. Note siltation covering half of pipe at the outlet.

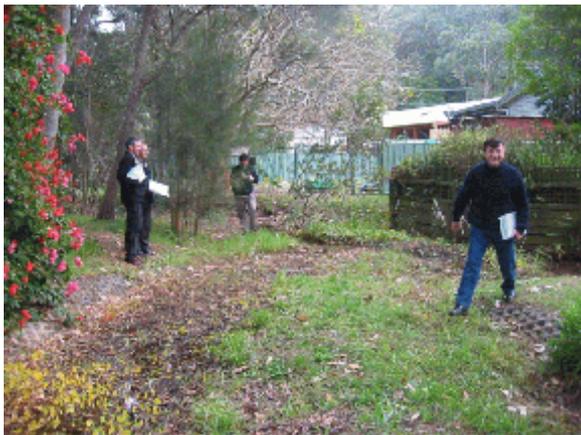
Photograph 5: Downstream of twin 900 mm diameter pipe outlet.

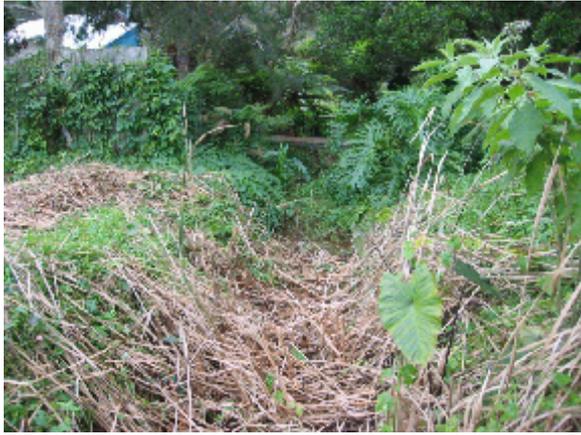
Photograph 7: Example of a heavily vegetated section of the creek upstream of Noble Road.

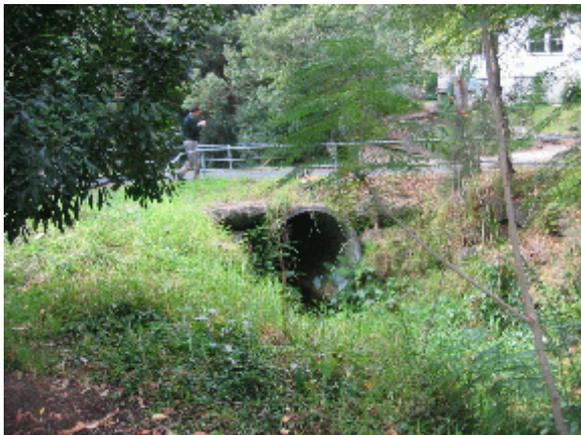
Photograph 9: Fraser Road culvert looking upstream.

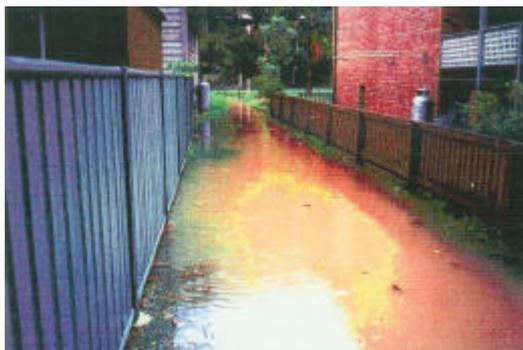
Photograph 11: Looking north along open channel between 57 and 59 Fraser Road - February 1999.

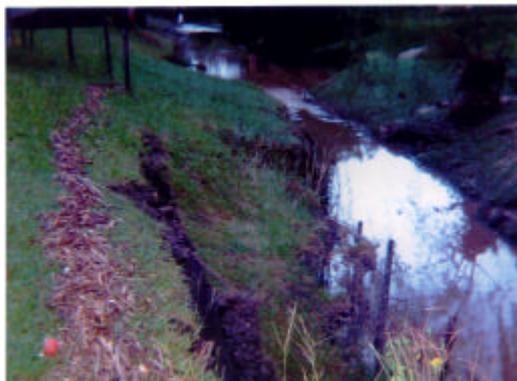
Photograph 14: Rear of 45 Fraser Road - February 1990.

- Photograph 14 being the only record for the July 1988 event. Unfortunately the Kincumber pluviometer was broken for this event and thus it cannot be used for calibration purposes,

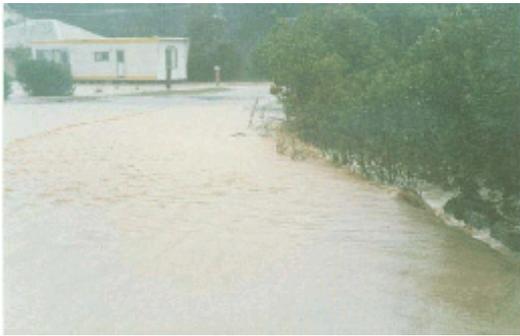
Photograph 17: Floodwaters crossing Noble Road and entering Hardys Bay. View looking south.

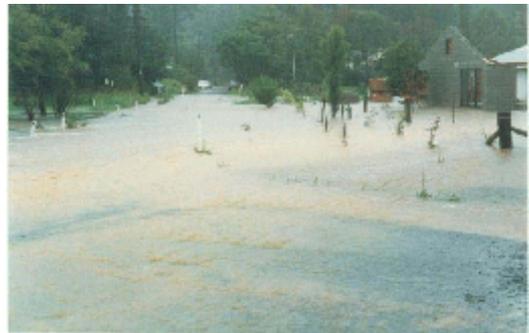
Photograph 20: Floodwaters crossing the north-eastern corner of Fraser Road with No. 37 Fraser Road under renovations. View looking south to culvert.

| Date of Flood | Ref. No. on Figure 3a | Location | Approx. Recorded Flood Level (mAHD) | Comments |
|---|---|---|---|--|
| | 5 | 37 Fraser Road | 4.3 | Reported flooding of house and yard, most likely caused by overland flow from Fraser Road rather than floodwaters rising from the creek (refer Photograph 20 - April 1988 event). |

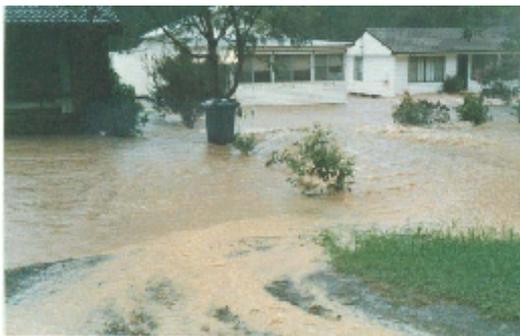
Photograph 21: No's 47, 49 & 51 Fraser Road showing runoff entering from Photograph 20. View looking south.

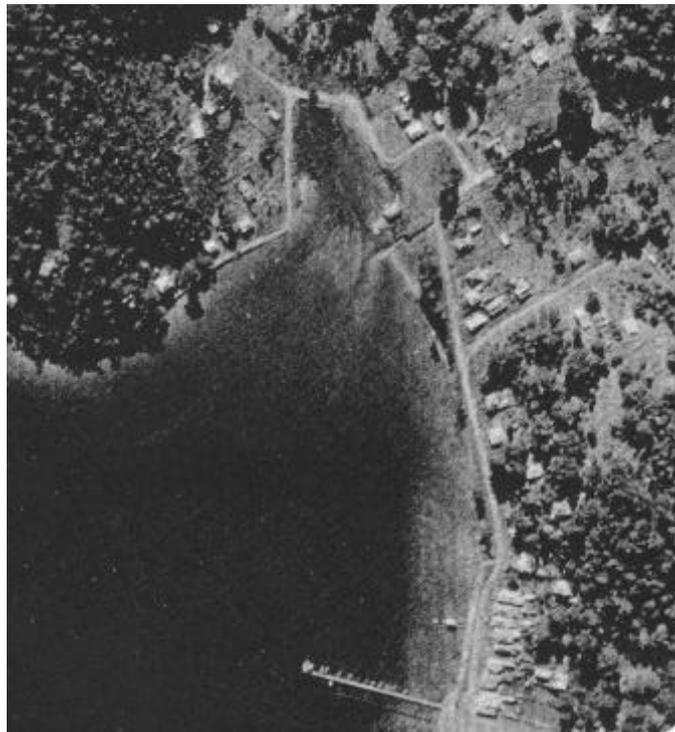
Photograph 27: 1954 Aerial Photograph.

The following flood photographs were collected from reports and local residents. Photographs 27 to 29 are aerial photographs that illustrate the changes in the extent of development over the last 50 years.

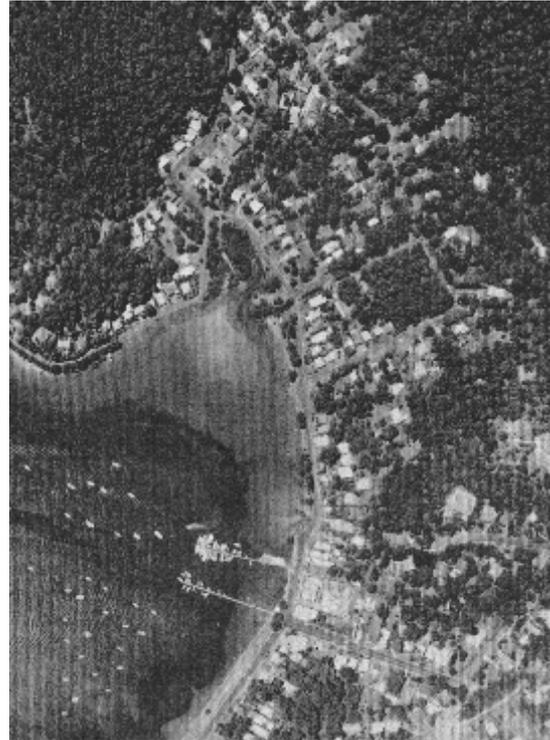
Photograph 29: 1999 Aerial Photograph
