# The Entrance Dredging Program

### Review of Environmental Factors

Client: Central Coast Council

Reference: PA2377MARP2008181227

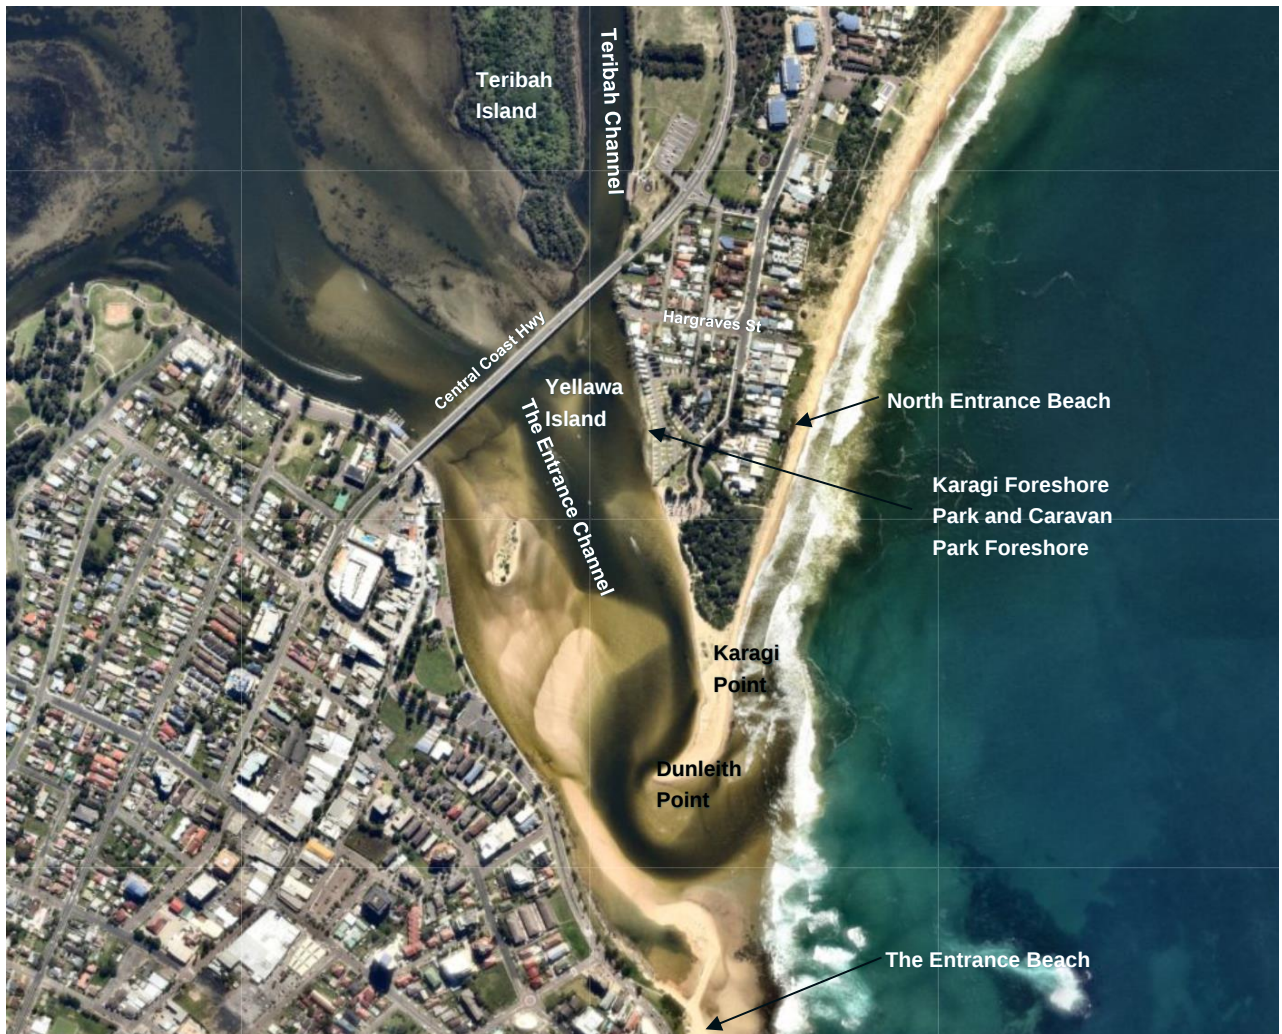
Figure 1: Study Area (NearMaps 31 August 2020)

The proposed area of dredging spans from the northern end of Terilbah Channel, downstream to The Entrance sand spit extending from Karagi Point (also known as Dunleith Point). Dredging to the west of the bridge to the vicinity of Picnic Point is also proposed. One sand island is located adjacent to the proposed dredge footprint, being Terilbah Island to the west of Terilbah Channel.

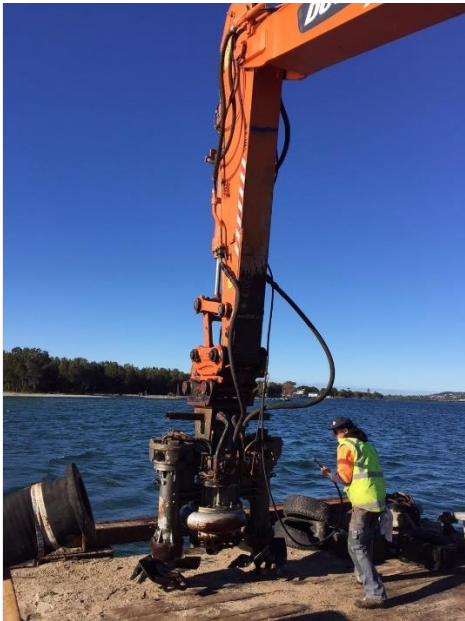
*Photo 1 Submersible pump and associated cutters*

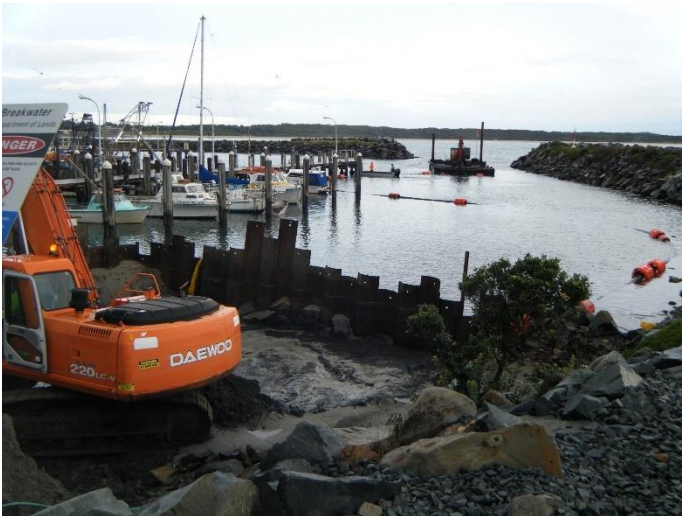
*Photo 2 Excavator and barge arrangement*

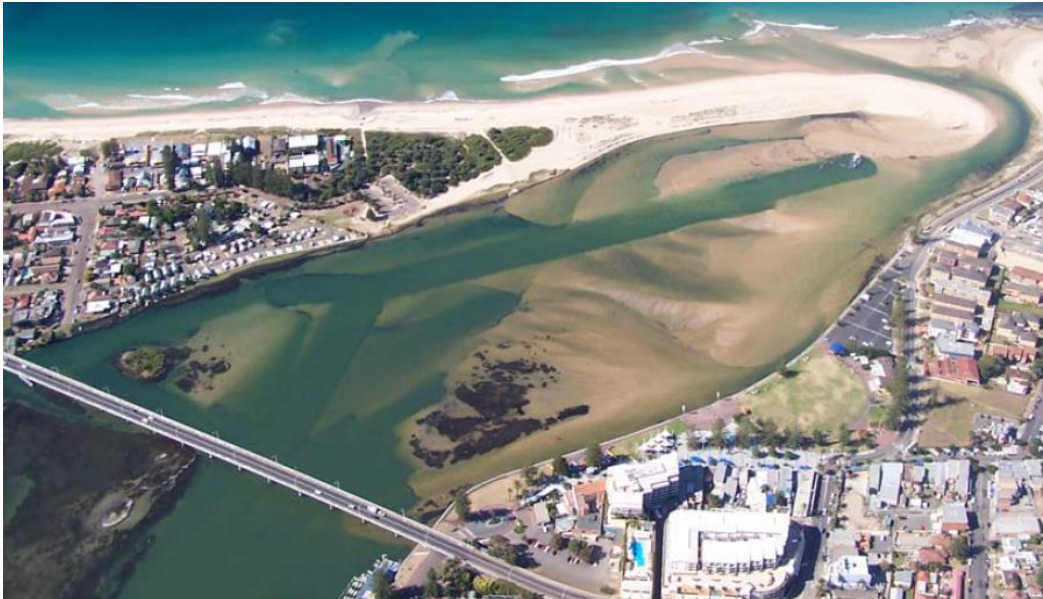
Photo 3 The Entrance System

The dredging would generally be undertaken as per previous dredging campaigns of The Entrance Channel and is predominantly designed to enhance the ebb tide flow (out flow) from the estuary. The dredge strategy was developed following trial dredging investigations in 1991 and has been refined following annual maintenance dredging that has been carried out in The Entrance Channel since 1993. The previous strategy involved staged dredging by Council using a Council-owned small (10/8) cutter suction dredger (CSD)<sup>2</sup>, but will now use dewatering areas in accordance with EPA requirements. The typical arrangement of the dredge footprint covers approximately 2.5 km's of channels and sumps within The Entrance System as shown in **Figure 2** and **Photo 3**.

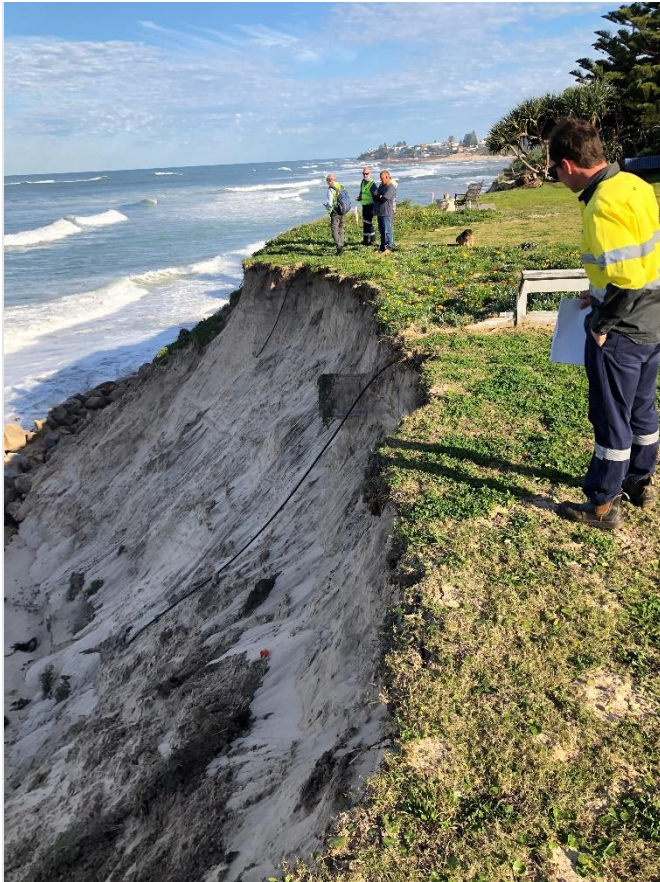
*Photo 5: Erosion of The Entrance North, looking south, 19 July 2020*

The estuary eastern beach is renourished on a regular basis. Recently, a small sand spur was also placed in the vicinity of the boundary of Karagi Foreshore Park and the Dunleith Tourist Park foreshore. **Photos 6** and **7** show the effects of erosion in this area.

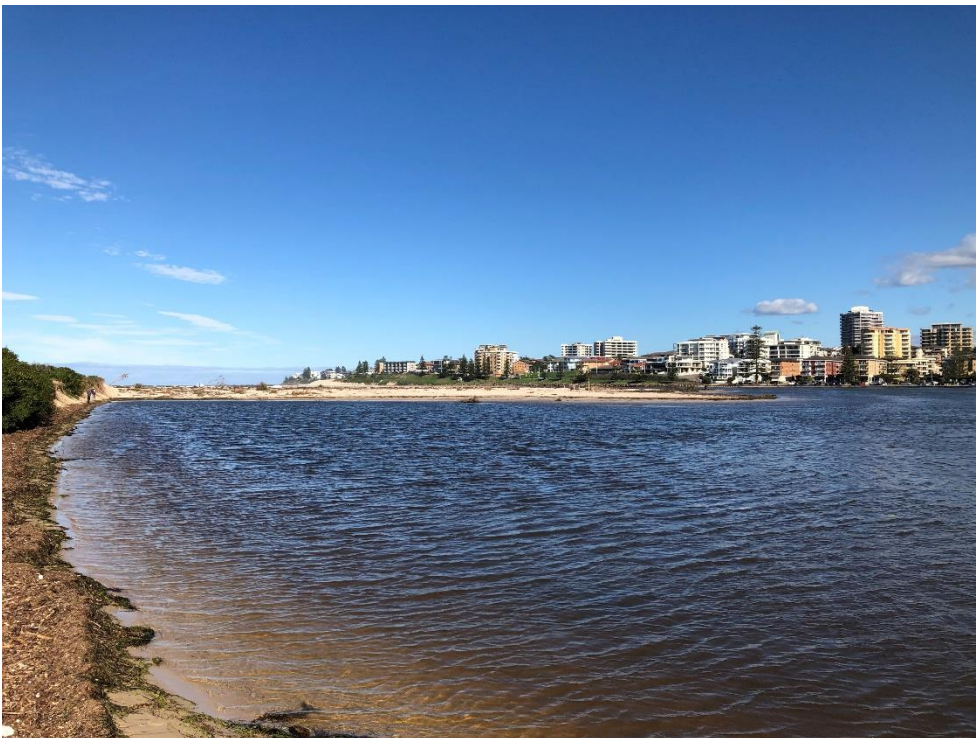
*Photo 6: Estuary Eastern beaches view east from Karagi Foreshore Park towards the sand spit, 31 July 2020*

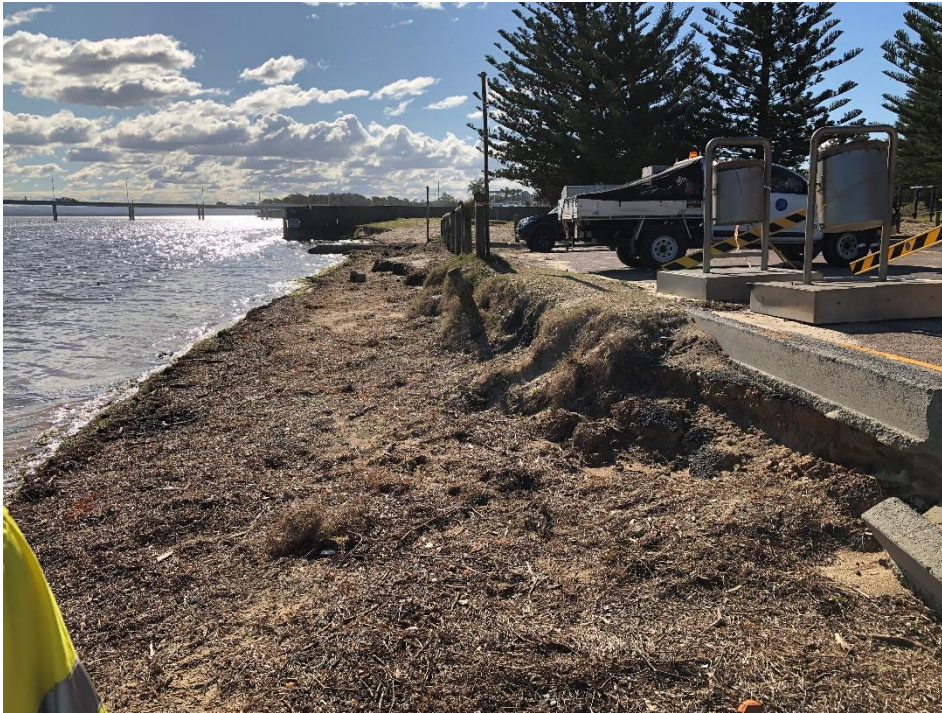
*Photo 7: Estuary Eastern beaches view west from Karagi Foreshore Park towards Dunleith Tourist Park, 31 July 2020*

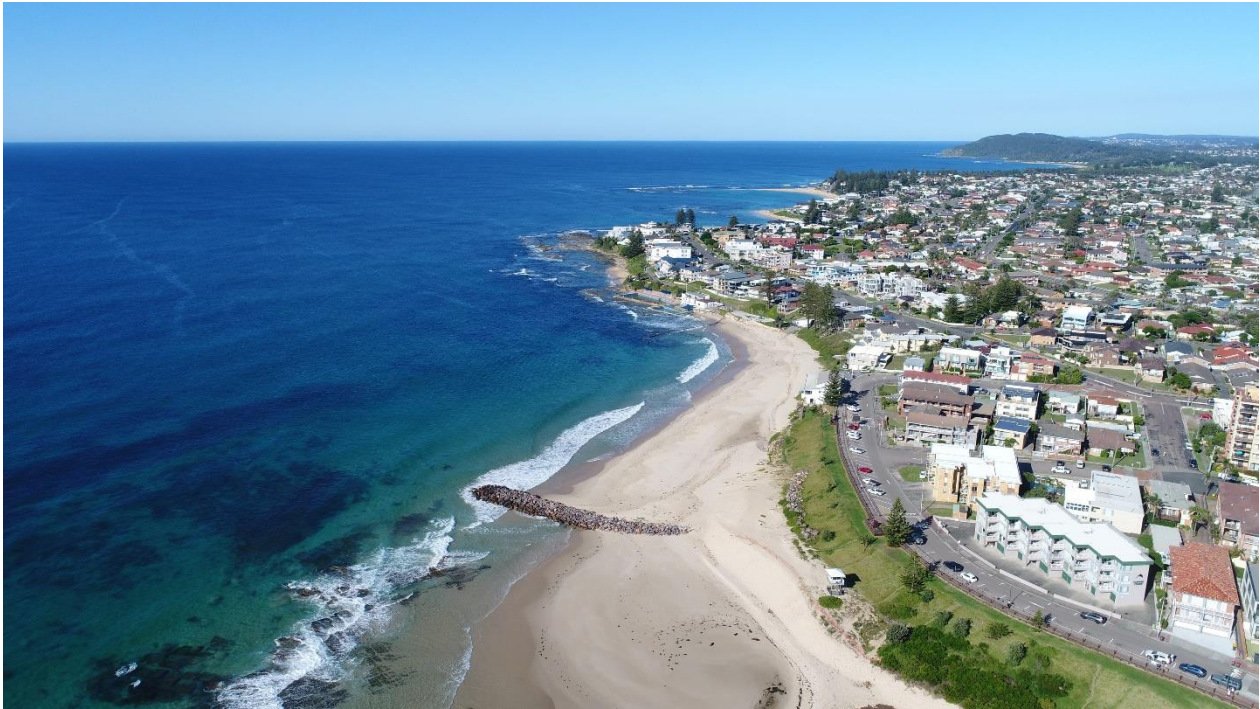
*Photo 8: The Entrance South beach and constructed groyne, May 2020*

A groyne was constructed on the southern side of The Entrance in 2017, designed to trap sand on The Entrance Beach to the south, as shown in **Photo 8**. Sand from the 2018 dredging works was pumped to The Entrance Beach, which is currently relatively well nourished. Sand from the 2020 dredging campaign is not proposed to be pumped to The Entrance Beach.

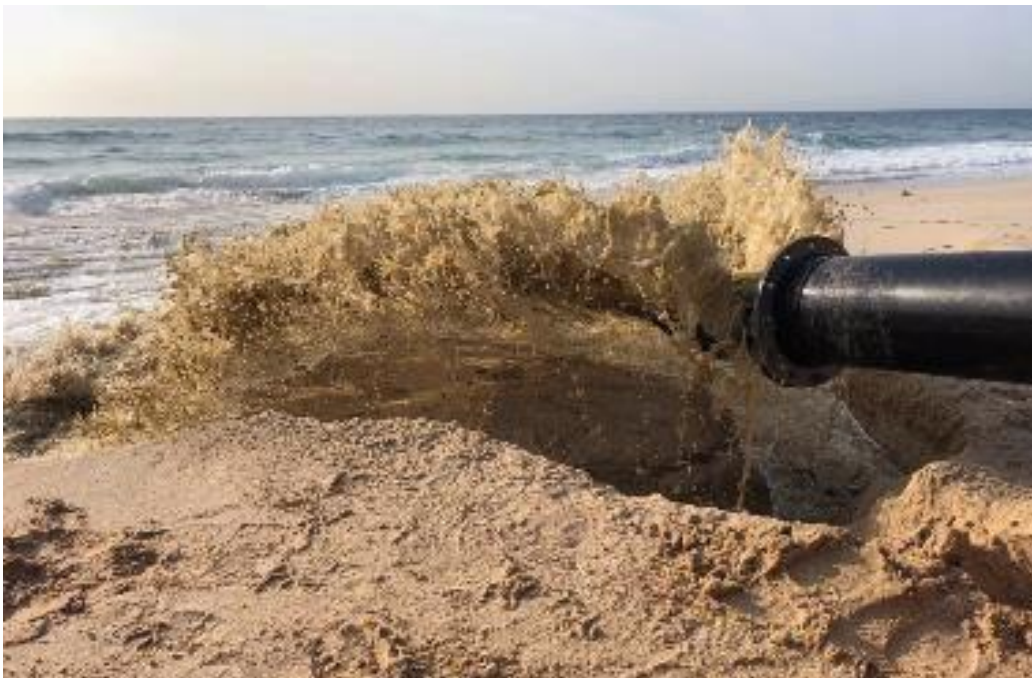
*Photo 9: Dredged sand deposition showing energy dissipation via deflector plate*

To minimise localised erosion at the discharge location, the dredged sand is sprayed upwards to dissipate energy using a deflector plate as shown in **Photo 9**. This is undertaken from an elevated pipeline outlet onto the subaerial (above water) profile of the beach, below the edge of the erosion scarp where possible.

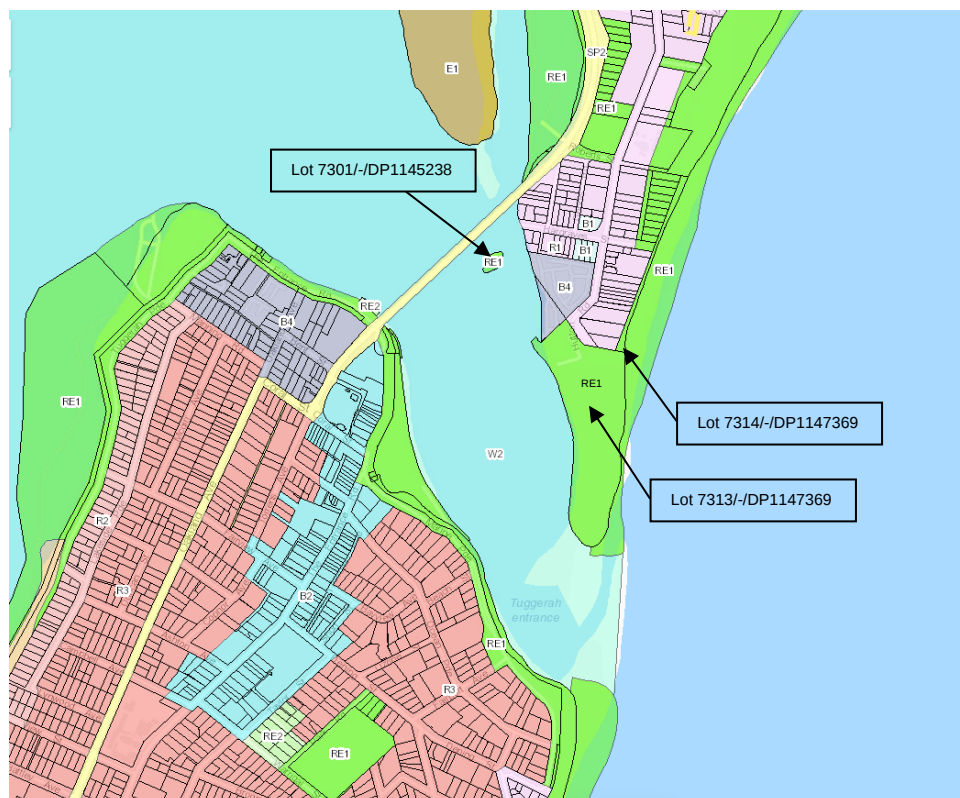
Figure 4 Land zoning in the region of the proposed works

The land above MHW in the immediate vicinity of the works is Crown Land (Lot 7313/-/DP1147369 and Lot 7314/-/DP1147369) under the management of Council (refer **Figure 4**). It is classified Public Recreation (RE1) under the Wyong Local Environmental Plan 2013. The proposed beach nourishment along North Entrance Beach falls on Lot 7314/-/DP1147369 and a seaward parcel of land zoned RE1 with no lot number.

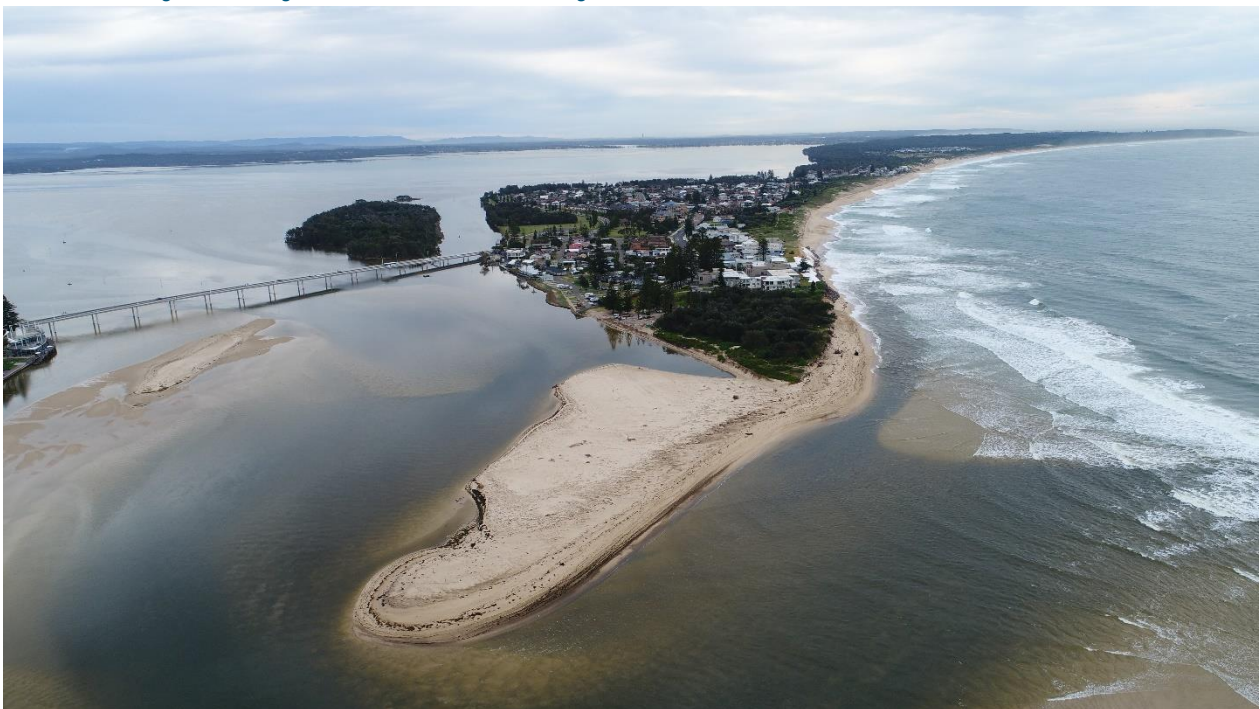
*Photo 13 Proposed works area at The Entrance, 13 August 2020*

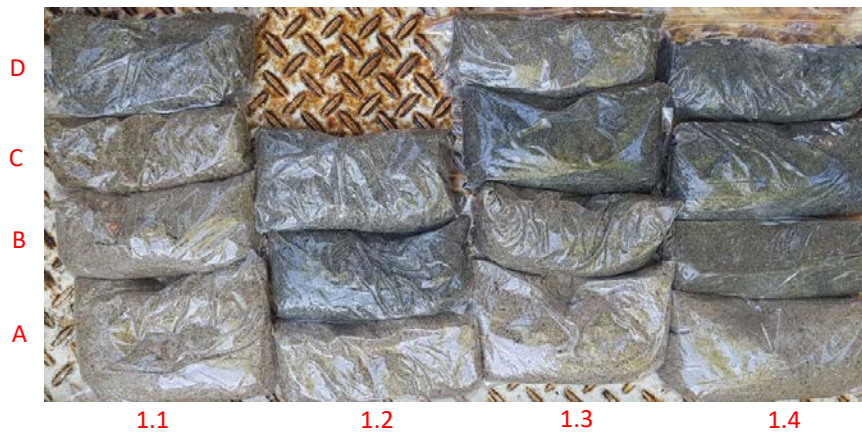
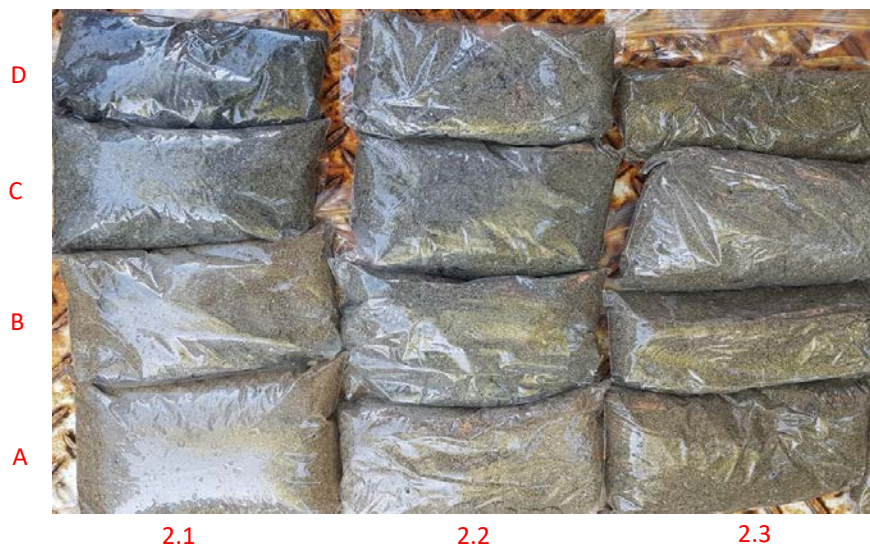
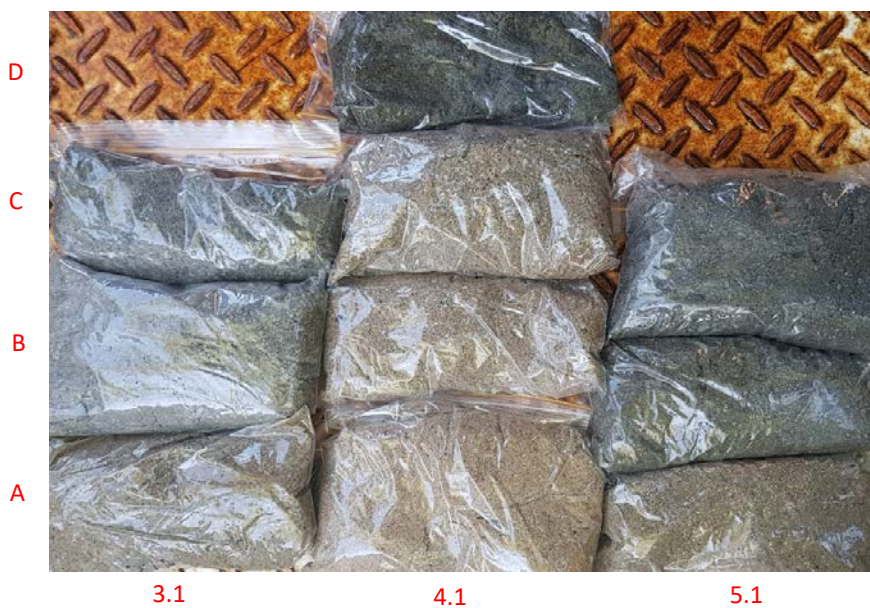
Photograph of composite sample for each Core ID and Sample ID.
